NYC Department of Education
Building Condition Assessment Survey 2023 - 2024

Architectural Inspection

Asset: CAMBRIA HEIGHTS ACADEMY - QUEENS, 188-04 91ST AVENUE, New York, 11423

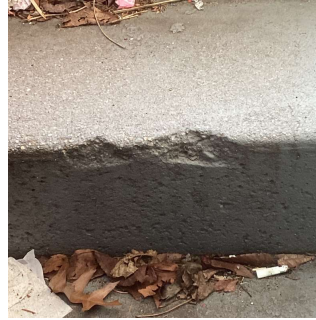
Facade B - AW4

AREAWAY STAIRS: DETERIORATED TREADS/RISERS/NOSINGS

REPAIR

PRIORITY 3

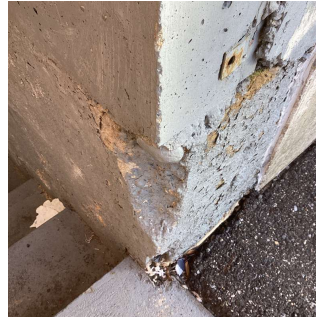
Facade B - AW4

AREAWAY WALLS: CRACKS AND SPALLING

REPAIR

PRIORITY 3

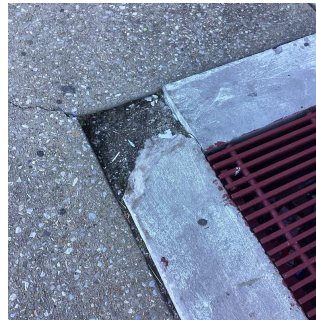
Facade D - AW5

AREAWAY WALLS: DETERIORATED COPING STONE

REPLACE

PRIORITY 4

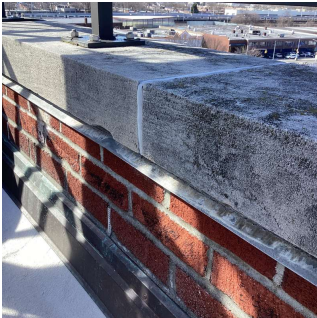
Violations	Facade A - AW7 No violations recorded.
AWNINGS AND CANOPIES	
Condition	Inspected
Deficiency	2 - Between Good and Fair No deficiencies recorded
CHIMNEY	
Material Type(s)	Inspected Masonry
Condition	2 - Between Good and Fair
Deficiency	No deficiencies recorded
COPING	
Condition	Inspected 3 - Fair
Deficiency	CAST STONE: CRACKED/BROKEN PIECES
Roof Plan reference

Deficiency Quantity	50
Quantity Uom	L.F.
Potential Action	REPLACE-IN-KIND
Urgency of Action	PRIORITY 4
Purpose of Action	LEVEL 2
Deficiency Photo1

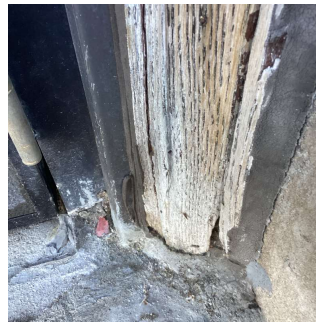
Facade A

WOOD: DETERIORATED DOOR AND FRAME - MAJOR DETERIORATION

REPLACE

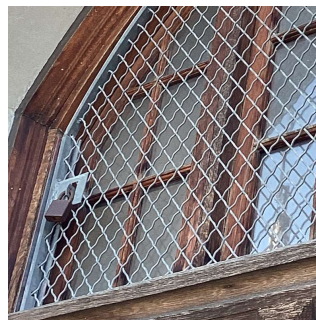
Facade A

WOOD: EXCESSIVELY WEATHERED

REPLACE

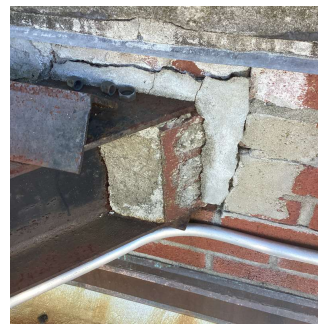
Roof 1

BRICK: MINOR CRACKS, SPALLING

REPAIR

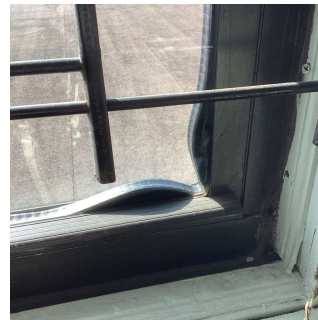
Roof 1 - Bulkhead

Question	Response
EXTERIOR	
ROOF	
Roofing	
ROOFING	
Deficiency Photo1	 
Violations	Roof 1 No violations recorded.
Deficiency	MODIFIED BITUMEN: FLASHING: CAP FLASHING DAMAGED
Roof Plan reference	 
Deficiency Quantity	10
Quantity Uom	L.F.
Potential Action	REPLACE
Urgency of Action	PRIORITY 4
Purpose of Action	LEVEL 2
Deficiency Photo1	 
Violations	Roof 1 No violations recorded.
ROOFING DRAINS	Inspected
Condition	2 - Between Good and Fair
Deficiency	No deficiencies recorded
Specialties	Inspected
BULKHEAD/PENTHOUSE	Inspected
Condition	3 - Fair
Deficiency	BULKHEAD/PENTHOUSE WINDOWS: DAMAGED, DETERIORATED WINDOWS

30
S.F.
REPLACE
PRIORITY 4
LEVEL 2

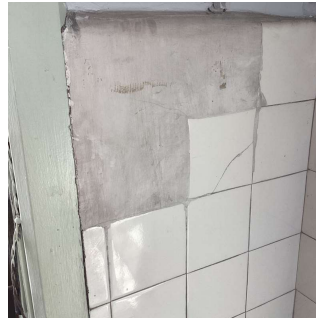
Roof 1 - Bulkhead

**BULKHEAD/PENTHOUSE WALLS/INTERIOR: BRICK
CRACKS/SPALLING**

30
S.F.
REPLACE
PRIORITY 3
LEVEL 2

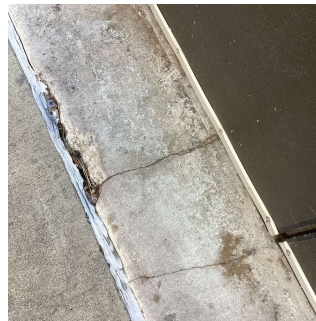
Facade C

STONE: CRACKS/SPALLING - MINOR

10
S.F.
REPAIR
PRIORITY 3
LEVEL 2

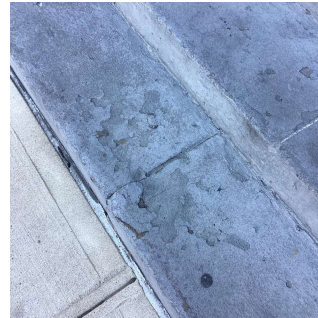
Facade A

Deficiency	STONE: WORN-OUT TREAD/RISER/NOSING
Roof Plan reference

10
S.F.
REPLACE
PRIORITY 4

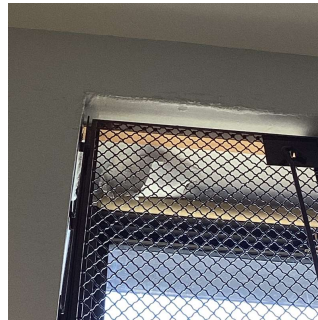
Facade D - Stair B/3

ALUMINUM - DOUBLE HUNG: AIR/WATER INFILTRATION

30
L.F.
REPLACE TRIM, SILLS OR WEATHERSTRIPPING
PRIORITY 5
LEVEL 2

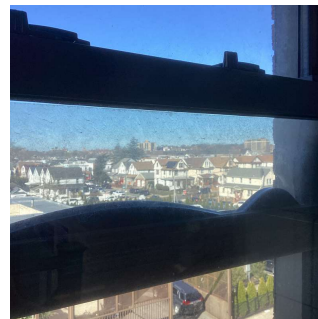
Facade D - Stair A/3

ALUMINUM - DOUBLE HUNG: AIR/WATER INFILTRATION, DETERIORATED JOINTS WITH DAMAGED CAULKING

10
L.F.
MAINTENANCE
PRIORITY 3
LEVEL 2

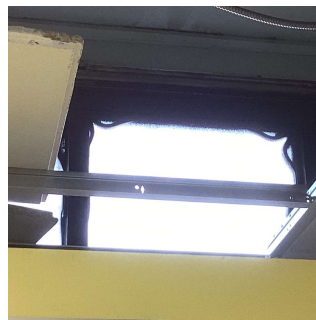
Basement - Custodial Office 003A
No violations recorded.

Installation Year	2003
Source of Installation	Custodial Staff
Deficiency	ALUMINUM - OTHER: AIR/WATER INFILTRATION, DETERIORATED JOINTS WITH DAMAGED CAULKING
Roof Plan reference

Deficiency Quantity	30
Quantity Uom	L.F.
Potential Action	MAINTENANCE
Urgency of Action	PRIORITY 3
Purpose of Action	LEVEL 2
Deficiency Photo1

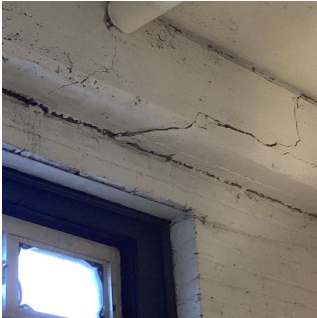
Deficiency	STEEL COLUMNS/BEAMS: DETERIORATED CONCRETE FIREPROOFING
------------	---

Deficiency Location/Instance	Basement - Electrical Panel Room
------------------------------	----------------------------------

Question	Response
INTERIOR	
STRUCTURAL	
COLUMNS/BEAMS/BEARING WALLS	
Deficiency Quantity	30
Quantity Uom	S.F.
Potential Action	REPLACE
Urgency of Action	PRIORITY 3
Purpose of Action	LEVEL 5
Deficiency Photo1

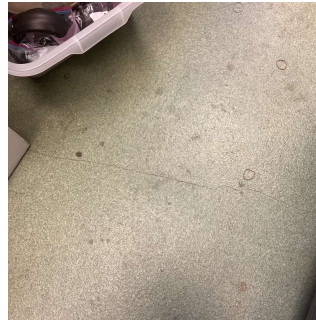
Deficiency	EPOXY FLOORING: CRACKS/SPALLING
Deficiency Location/Instance	Room 305A
Deficiency Quantity	10
Quantity Uom	S.F.
Potential Action	REPLACE
Urgency of Action	PRIORITY 3
Purpose of Action	LEVEL 2

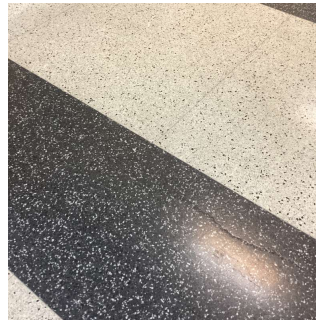
Corridor near Stair B/3

TERRAZZO: CRACKS

REPLACE

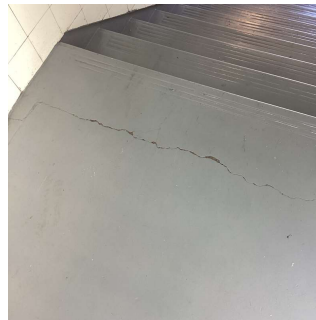
Stair A/2

CONCRETE: CRACKS/SPALLING - MAJOR

REPLACE
