NYC Department of Education
Building Condition Assessment Survey 2023 - 2024

Architectural Inspection

Asset: P.S. 224 ANNEX - QUEENS, 221-21 CORBETT ROAD, New York, 11361

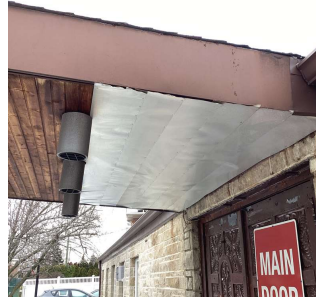
Facade A

Question	Response
Architectural	
EXTERIOR	Inspected
AREAWAY	Inspected
Instance on AW1-AW3	Inspected
Instance Condition	2 - Between Good and Fair
Instance Quantity	3
Instance Quantity Uom	EACH
Deficiency	No deficiencies recorded
AWNINGS AND CANOPIES	Inspected
Condition	3 - Fair
Deficiency	METAL: DETERIORATION/DAMAGED/MISSING PIECES
Roof Plan reference

Deficiency Quantity	50
Quantity Uom	S.F.
Potential Action	REPLACE
Urgency of Action	PRIORITY 4
Purpose of Action	LEVEL 2

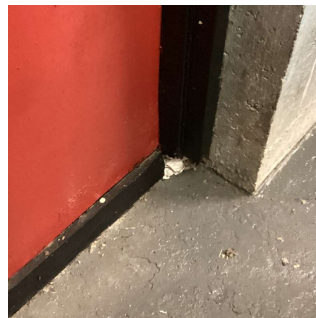
Facade F

METAL: DETERIORATED DOOR AND FRAME - MAJOR DETERIORATION

REPLACE

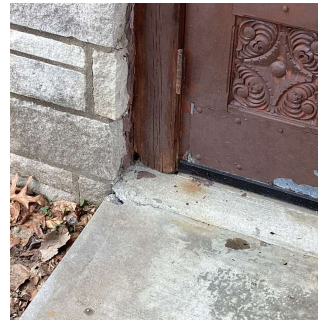
Facade A

WOOD: DETERIORATED DOOR AND FRAME - MAJOR DETERIORATION

REPLACE

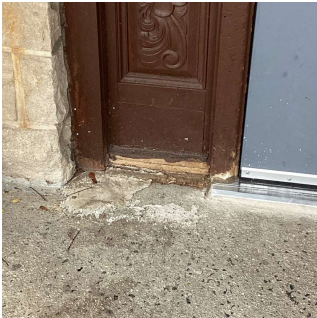
Question	Response
EXTERIOR	
DOORS	
TRANSOM/SIDE LIGHT	
Deficiency Quantity	20
Quantity Uom	S.F.
Potential Action	REPLACE
Urgency of Action	PRIORITY 4
Purpose of Action	LEVEL 2
Deficiency Photo1

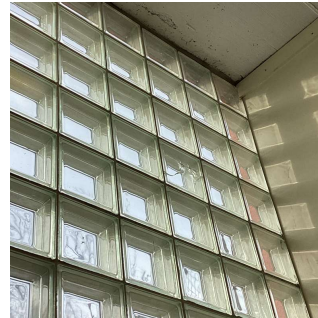
Facade E

Violations	<p>Facade D</p> <p>No violations recorded.</p>
EXTERIOR WALLS	
Material Type(s)	Masonry
Replacement Quantity	14,000
Replacement Uom	S.F.
Instance on All Facades	Inspected
Instance Condition	4 - Between Fair and Poor
Instance Quantity	14,000
Instance Quantity Uom	S.F.
Deficiency	GLASS BLOCK: CHIPPED/ BROKEN PIECES
Roof Plan reference

Deficiency Quantity	20
Quantity Uom	S.F.
Potential Action	REPLACE-IN-KIND

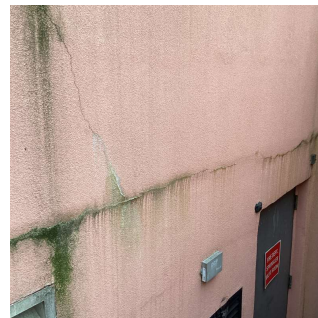
Facade F

STUCCO CEMENT SURFACE: CRACKS, SPALLING

REPLACE

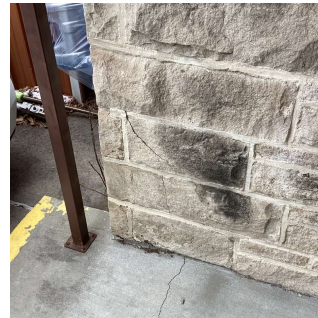
Facade B

STONE: CHIPPED/SPALLED/BROKEN PIECES - MAJOR

REPLACE

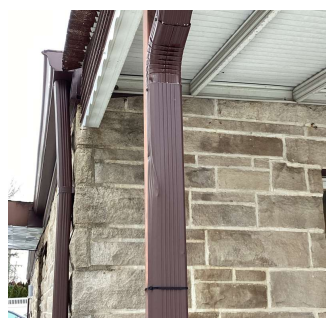
Question	Response
EXTERIOR	
PARAPETS	
Instance on All Facades - East Building	Inspected
Instance Condition	2 - Between Good and Fair
Instance Quantity	2,000
Instance Quantity Uom	C.F.
Deficiency	No deficiencies recorded
PLAZA DECK	
	Does not Exist
ROOF	
	Inspected
Roofing	
	Inspected
Replacement Quantity	11,000
Replacement Uom	S.F.
ROOF HATCH/SMOKE HATCH	
	Does not Exist
LEADERS, GUTTERS, DOWNSPOUTS, SCUPPERS	
	Inspected
Condition	3 - Fair
Deficiency	DAMAGED/MISSING
Roof Plan reference

Deficiency Quantity	10
Quantity Uom	L.F.
Potential Action	REPLACE
Urgency of Action	PRIORITY 4
Purpose of Action	LEVEL 2
Deficiency Photo1

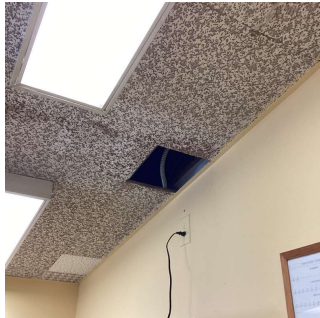
Instance Quantity	500
Instance Quantity Uom	S.F.
Does the roof have major mechanical equipment sitting on Dunnage Steel less than 18" above the Roofing?	No
Does this roof instance have a Sustainable Roof System?	No
Do solar panels exist on these roofs?	No
Is/Are the roof(s) suitable for Solar Panel installation?	No
Installation Year	1981
Source of Installation	Custodial Staff
Deficiency	ASPHALT SHINGLE; ROOFING: MAJOR ACTIVE ROOF LEAKS IN INSTRUCTIONAL SPACE

Deficiency Quantity	100
Quantity Uom	S.F.
Potential Action	REPLACE ROOFING
Urgency of Action	PRIORITY 5
Purpose of Action	LEVEL 2

Roof 2 - Room 279
Violations	No violations recorded.
Instance on Modified Bitumen: Roof 3	Inspected
Instance Condition	4 - Between Fair and Poor
Instance Photo

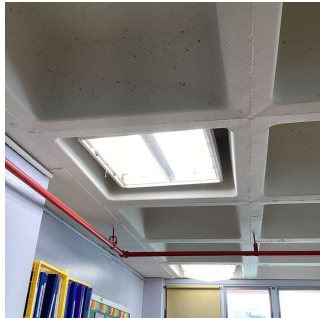
Roof 3
Instance Quantity	6,500
Instance Quantity Uom	S.F.
Does the roof have major mechanical equipment sitting on Dunnage Steel less than 18" above the Roofing?	No
Does this roof instance have a Sustainable Roof System?	No
Do solar panels exist on these roofs?	No
Is/Are the roof(s) suitable for Solar Panel installation?	No
Installation Year	1987
Source of Installation	Custodial Staff
Deficiency	MODIFIED BITUMEN: ROOFING: MAJOR ACTIVE ROOF LEAKS IN INSTRUCTIONAL SPACE
Roof Plan reference

Deficiency Quantity	200
Quantity Uom	S.F.
Potential Action	REPLACE ROOFING WITHOUT MAJOR EQUIPMENT REMOVAL
Urgency of Action	PRIORITY 5
Purpose of Action	LEVEL 2

Violations	Roof 3 - East Building - Room E (shown), Room F No violations recorded.
ROOFING DRAINS	Inspected
Condition	2 - Between Good and Fair
Deficiency	No deficiencies recorded
Specialties	Inspected
BULKHEAD/PENTHOUSE	Inspected
Condition	3 - Fair
Deficiency	BULKHEAD/PENTHOUSE WALLS/INTERIOR: GYPSUM BOARD DAMAGED/DETERIORATED
Roof Plan reference

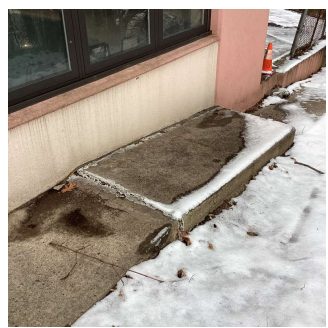
Question	Response
EXTERIOR	
ROOF	
Specialties	
DORMER	Does not Exist
DUNNAGE STEEL	Does not Exist
SKYLIGHT/ROOF VENT	Inspected
Material Type(s)	Plastic
Condition	2 - Between Good and Fair
Deficiency	No deficiencies recorded
ROOF/GRAVITY TANK	Does not Exist
STAIRS/RAMPS: EXTERIOR	Inspected
BUILDING CHEEK/FLANK WALLS	Inspected
Condition	2 - Between Good and Fair
Deficiency	No deficiencies recorded
RAILINGS	Inspected
Condition	2 - Between Good and Fair
Deficiency	No deficiencies recorded
STAIRS/RAMPS	Inspected
Condition	5 - Poor
Deficiency	CONCRETE: DETERIORATED SUBSTRATE
Roof Plan reference

Deficiency Quantity	70
Quantity Uom	S.F.
Potential Action	REPLACE SUBSTRATE AND RESET
Urgency of Action	PRIORITY 4
Purpose of Action	LEVEL 2
Deficiency Photo1

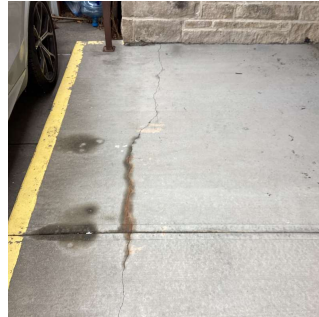
Violations	Facade F No violations recorded.
Deficiency	CONCRETE: CRACKS/SPALLING - MAJOR

Deficiency Quantity	70
Quantity Uom	S.F.
Potential Action	REPLACE
Urgency of Action	PRIORITY 4
Purpose of Action	LEVEL 2
Deficiency Photo1

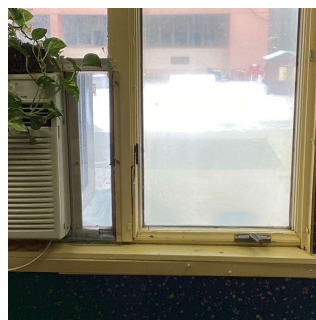
Question	Response
EXTERIOR	
WINDOWS	
WINDOWS	
Instance Quantity	500
Instance Quantity Uom	S.F.
Are these windows insulated	Yes
Installation Year	2012
Source of Installation	Custodial Staff
Deficiency	No deficiencies recorded
Instance on Wood: West Building	Inspected
Instance Condition	5 - Poor
Instance Quantity	900
Instance Quantity Uom	S.F.
Are these windows insulated	No
Installation Year	1986
Source of Installation	Custodial Staff
Deficiency	WOOD: DETERIORATED

400
S.F.
REPLACE WINDOW
PRIORITY 4
LEVEL 2

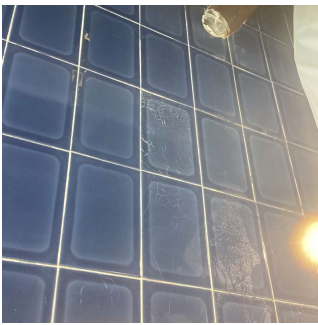
Instance on East Building - Basement	Inspected
Condition	3 - Fair
Deficiency	CERAMIC TILES: BROKEN/MISSING TILES
Deficiency Location/Instance	Pool Area
Deficiency Quantity	50
Quantity Uom	S.F.
Potential Action	REPLACE
Urgency of Action	PRIORITY 4
Purpose of Action	LEVEL 2

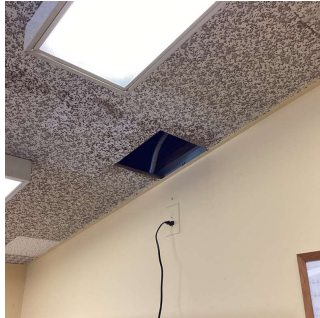
Facade A No violations recorded.
Vault/Ash Hoist Doors and Framing	
Condition	Inspected
Deficiency	2 - Between Good and Fair
AUDITORIUM	
Condition	Does not Exist
CAFETERIA	
Condition	Does not Exist
CLASSROOMS/CORRIDORS/ADMIN SPACES	
Ceiling	
Condition	Inspected
Deficiency	2 - Between Good and Fair
Deficiency Location/Instance	ACOUSTIC TILES: DAMAGED/MISSING - ACTIVE LEAK

Question	Response
INTERIOR	
CLASSROOMS/CORRIDORS/ADMIN SPACES	
Ceiling	
Deficiency Quantity	10
Quantity Uom	S.F.
Potential Action	REPLACE
Urgency of Action	PRIORITY 5
Purpose of Action	LEVEL 2
Deficiency Photo1

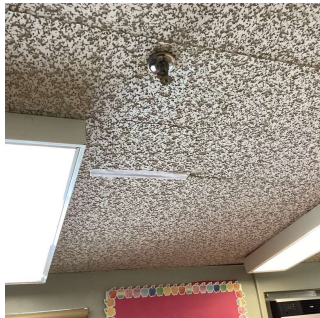
Room 279
Violations	No violations recorded.
Deficiency	ACOUSTIC TILES: DAMAGED/MISSING
Deficiency Location/Instance	Room 270, Main Entrance Lobby
Deficiency Quantity	20
Quantity Uom	S.F.
Potential Action	REPLACE
Urgency of Action	PRIORITY 3
Purpose of Action	LEVEL 2
Deficiency Photo1

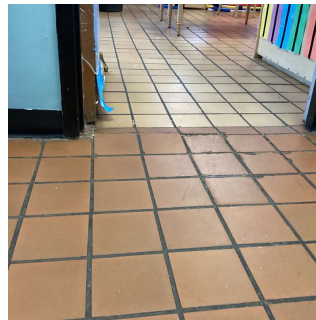
QUARRY TILE: DETERIORATED SUBSTRATE

REPLACE

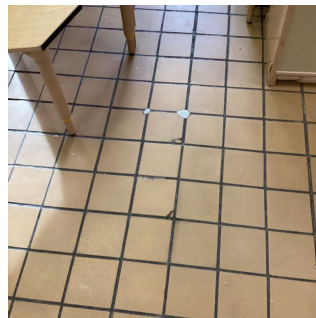
QUARRY TILE: BROKEN/MISSING TILES

REPLACE

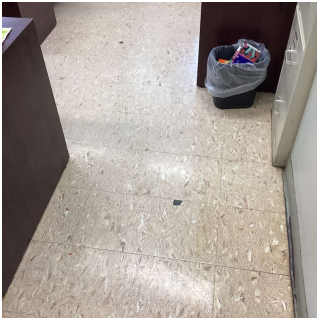
Question	Response
INTERIOR	
CLASSROOMS/CORRIDORS/ADMIN SPACES	
Floor Finish	
Violations	Room F No violations recorded.
Deficiency	VINYL TILES: BROKEN/DETERIORATED/MISSING TILES
Deficiency Location/Instance	Rooms 270, A
Deficiency Quantity	20
Quantity Uom	S.F.
Potential Action	REPLACE
Urgency of Action	PRIORITY 3
Purpose of Action	LEVEL 2
Deficiency Photo1

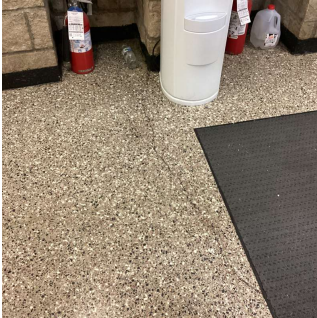
Violations	Room 270 No violations recorded.
Deficiency	TERRAZZO: CRACKS
Deficiency Location/Instance	Corridor near Room 270
Deficiency Quantity	40
Quantity Uom	S.F.
Potential Action	REPLACE
Urgency of Action	PRIORITY 3
Purpose of Action	LEVEL 2
Deficiency Photo1

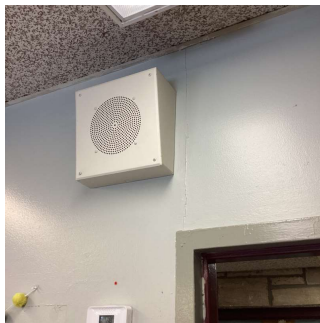
Violations	Corridor near Room 270 No violations recorded.
Walls	
Condition	Inspected 2 - Between Good and Fair
Deficiency	GYPSON BOARD: DETERIORATED
Deficiency Location/Instance	Corridor near Rooms 270
Deficiency Quantity	10
Quantity Uom	S.F.
Potential Action	REPLACE
Urgency of Action	PRIORITY 3
Purpose of Action	LEVEL 2

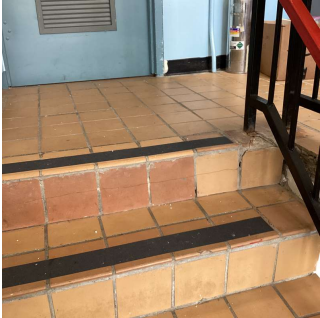
Question	Response
INTERIOR	
STAIRS/RAMPS: INTERIOR	
Stairs and Landings	
Condition	2 - Between Good and Fair
Deficiency	QUARRY TILE: BROKEN/MISSING
Deficiency Location/Instance	Stair A/1
Deficiency Quantity	10
Quantity Uom	S.F.
Potential Action	REPLACE
Urgency of Action	PRIORITY 3
Purpose of Action	LEVEL 2
Deficiency Photo1

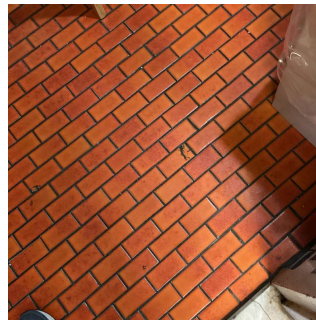
Inside Room A

CERAMIC TILE: BROKEN/MISSING TILES

REPLACE

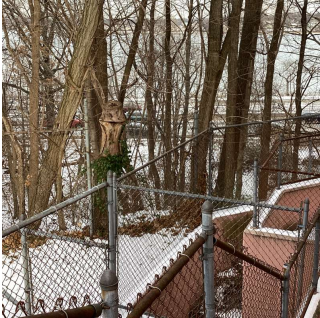
Question	Response
SITE	
FENCES	
Deficiency	CHAIN LINK: MISSING SECTIONS
Deficiency Location/Instance	Rear of Building
Deficiency Quantity	50
Quantity Uom	S.F.
Potential Action	REPLACE
Urgency of Action	PRIORITY 3
Purpose of Action	LEVEL 2
Deficiency Photo1

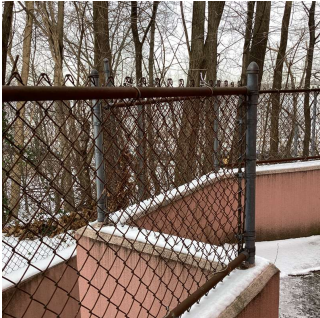
Violations	Rear of Building No violations recorded.
Deficiency	CHAIN LINK: RUST - MAJOR
Deficiency Location/Instance	Rear of Building
Deficiency Quantity	300
Quantity Uom	S.F.
Potential Action	REPLACE
Urgency of Action	PRIORITY 3
Purpose of Action	LEVEL 2
Deficiency Photo1

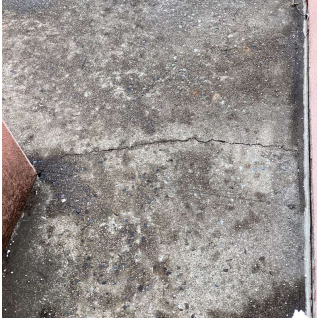
Question	Response
SITE	
PAVING	
Site Sidewalks & Walkways	
Concrete	
Condition	3 - Fair
Deficiency	CRACKS - MAJOR
Deficiency Location/Instance	Exits 12, 3
Deficiency Quantity	75
Quantity Uom	S.F.
Potential Action	REPLACE
Urgency of Action	PRIORITY 3
Purpose of Action	LEVEL 2
Deficiency Photo1

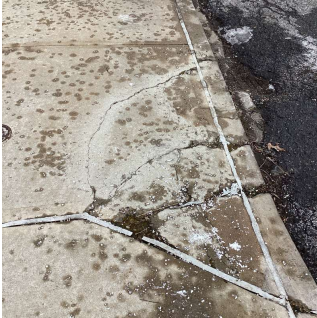
Exit 12
Violations	No violations recorded.
Pavers	Does not Exist
DOT Sidewalk	Inspected
Asphalt	Does not Exist
Concrete	Inspected
Condition	3 - Fair
Deficiency	DAMAGED/DETERIORATED/MISSING SECTIONS
Deficiency Location/Instance	Corbett Road
Deficiency Quantity	50
Quantity Uom	S.F.
Potential Action	REPLACE
Urgency of Action	PRIORITY 3
Purpose of Action	LEVEL 2
Deficiency Photo1
