**NYC Department of Education**  
**Building Condition Assessment Survey 2023 - 2024**

Architectural Inspection

Q822

**Asset:** P.S. 811 MINISCHOOL (OLD 136 MN)-Q, 114-36 202ND STREET, New York, 11412

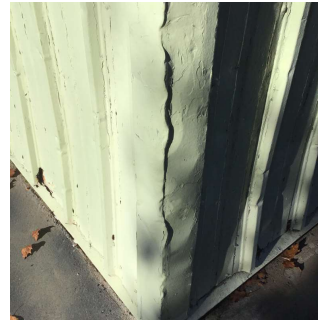
Facade A

METAL PANEL: SEVERE DENTS

REPLACE

PRIORITY 4

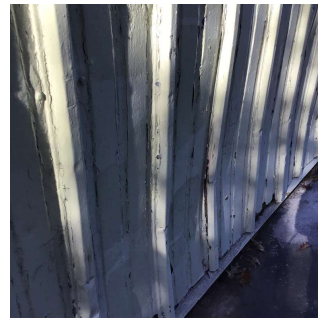
Facade D

METAL PANEL: MAJOR RUSTING

REPLACE

PRIORITY 4

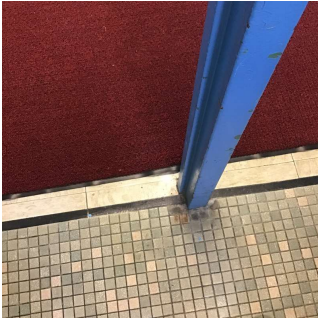
Question	Response
<b>INTERIOR</b>	
<b>CLASSROOMS/CORRIDORS/ADMIN SPACES</b>	Inspected
<b>Floor Finish</b>	
Deficiency	CERAMIC TILE: BROKEN/MISSING TILES
Deficiency Location/Instance	Exit 3 Vestibule
Deficiency Quantity	10
Quantity Uom	S.F.
Potential Action	REPLACE
Urgency of Action	PRIORITY 3
Purpose of Action	LEVEL 2
Deficiency Photo1

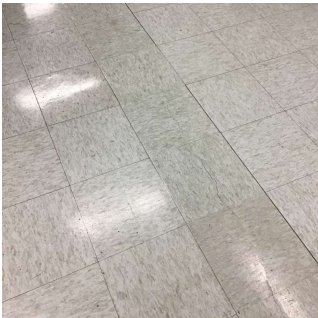
Violations	Exit 3 Vestibule No violations recorded.
Deficiency	VINYL TILES: DETERIORATED SUBSTRATE
Deficiency Location/Instance	Corridor near M-15, 13,12,
Deficiency Quantity	50
Quantity Uom	S.F.
Potential Action	REPLACE
Urgency of Action	PRIORITY 3
Purpose of Action	LEVEL 2
Deficiency Photo1
