NYC Department of Education
Building Condition Assessment Survey 2023 - 2024

Architectural Inspection

Q823

Asset: REGION 5 SUPERINTENDENT - QUEENS, 82-01 ROCKAWAY BLVD, New York, 11416

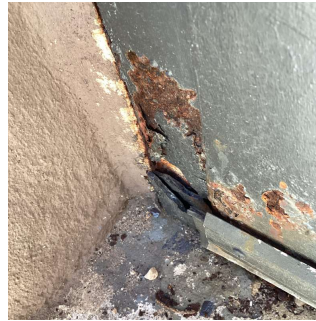
Facade A

Question	Response
Architectural	
EXTERIOR	Inspected
AREAWAY	Does not Exist
AWNINGS AND CANOPIES	Inspected
Condition	2 - Between Good and Fair
Deficiency	No deficiencies recorded
CHIMNEY	Inaccessible
COPING	Inaccessible
CORNICE	Does not Exist
DOORS	Inspected
DOORS AND FRAMES	Inspected
Condition	4 - Between Fair and Poor

Deficiency METAL: DETERIORATED DOOR AND FRAME - MAJOR DETERIORATION

Deficiency Quantity 1
Quantity Uom EACH
Potential Action REPLACE
Urgency of Action PRIORITY 4
Purpose of Action LEVEL 2

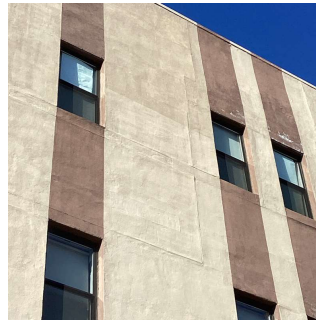
Facade E

5 - Poor

STUCCO CEMENT SURFACE: CRACKS, SPALLING

Deficiency Quantity

300

Quantity Uom

S.F.

Potential Action

REPLACE

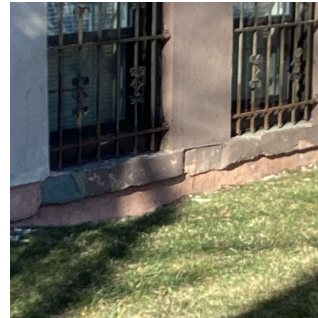
Facade E

BRICK: DETERIORATED MASONRY SILLS - MAJOR

Deficiency Quantity

50

Quantity Uom

L.F.

Potential Action

REMOVE AND REPLACE

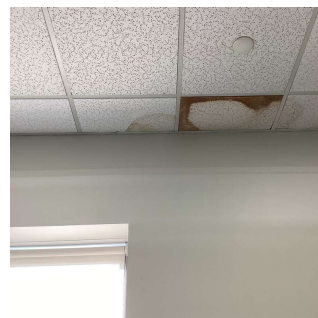
STUCCO CEMENT SURFACE: WATER INFILTRATION IN INSTRUCTIONAL SPACE

700
S.F.
REPAIR
PRIORITY 5
LEVEL 2

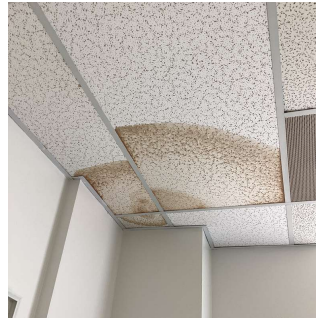
Roof 2 - Room 201, also Women's Toilet Room

Roof 2
Instance Quantity	2,500
Instance Quantity Uom	S.F.
Does the roof have major mechanical equipment sitting on Dunnage Steel less than 18" above the Roofing?	No
Does this roof instance have a Sustainable Roof System?	No
Do solar panels exist on these roofs?	No
Is/Are the roof(s) suitable for Solar Panel installation?	No
Installation Year	2015
Source of Installation	Custodial Staff
Deficiency	MODIFIED BITUMEN: ROOFING: MAJOR ACTIVE ROOF LEAKS IN INSTRUCTIONAL SPACE
Roof Plan reference	Q823

Deficiency Quantity	200
Quantity Uom	S.F.
Potential Action	REPLACE ROOFING WITHOUT MAJOR EQUIPMENT REMOVAL
Urgency of Action	PRIORITY 5
Purpose of Action	LEVEL 2

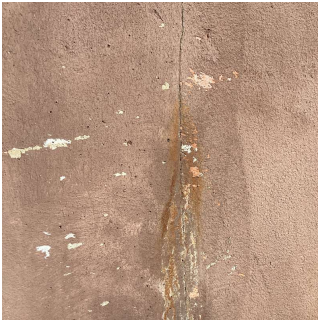
CAST IN PLACE CONCRETE: CRACKS/SPALLING - MINOR

Potential Action

REPAIR

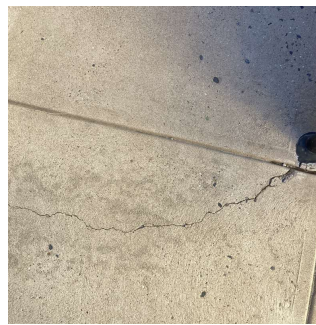
Violations	Facade A No violations recorded.
Deficiency	CONCRETE: CRACKS/SPALLING - MINOR

10
S.F.
REPAIR
PRIORITY 3
LEVEL 2

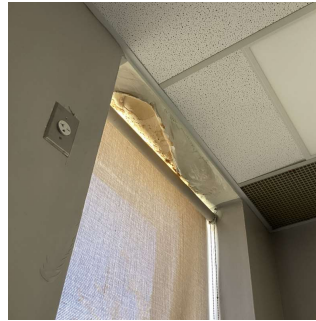
Room 315

Violations	Facade C No violations recorded.
ROOF STRUCTURE	Inspected
Condition	2 - Between Good and Fair
Deficiency	No deficiencies recorded
VAULTS-BUNKERS	Does not Exist
AUDITORIUM	Does not Exist
CAFETERIA	Does not Exist
CLASSROOMS/CORRIDORS/ADMIN SPACES	Inspected
Ceiling	Inspected
Condition	2 - Between Good and Fair
Deficiency	GYPSUM BOARD: DAMAGED/DETERIORATED - ACTIVE LEAK

Deficiency Location/Instance	Rooms 315, 420
Deficiency Quantity	30
Quantity Uom	S.F.
Potential Action	REPLACE
Urgency of Action	PRIORITY 5
Purpose of Action	LEVEL 2

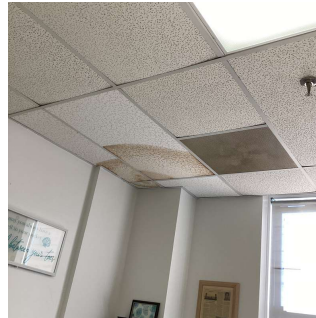
Room 201

ACOUSTIC TILES: DAMAGED/MISSING - ACTIVE LEAK

Rooms 201, 408, 460, 460A, Corridor near Elevator 4th Floor.

Potential Action

REPLACE

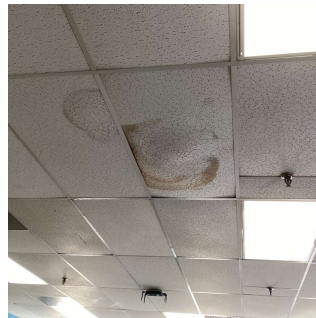
Room 460

ACOUSTIC TILES: DAMAGED/MISSING

Rooms 208, 304, 306, 460, Main Entrance Lobby, and others.

Potential Action

REPLACE

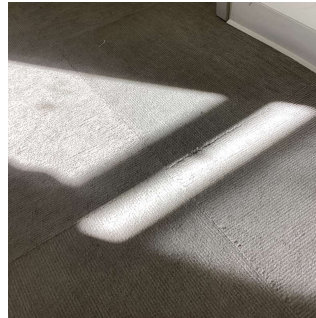
CARPET: WORN/DETERIORATED

Corridor near Room 408, Corridor near Elevator 4th Floor

Potential Action

REPLACE

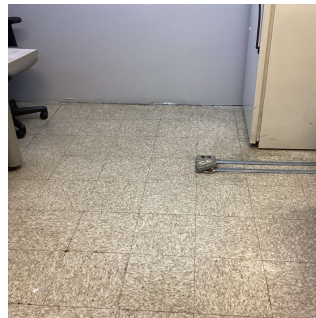
VINYL TILES: TRIPPING HAZARD - ELECTRICAL OUTLET

Room 101

Potential Action

REMOVE

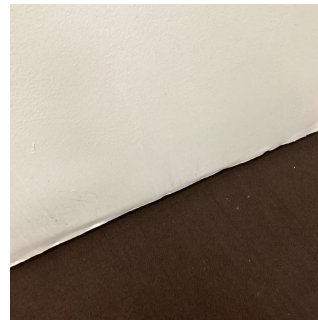
METAL: DETERIORATED DOOR

Room 204

MAINTENANCE
