NYC Department of Education
Building Condition Assessment Survey 2023 - 2024

Architectural Inspection

Q834

Asset: P.S. 34 MINISCHOOL - QUEENS, 104-12 SPRINGFIELD BLVD, New York, 11428

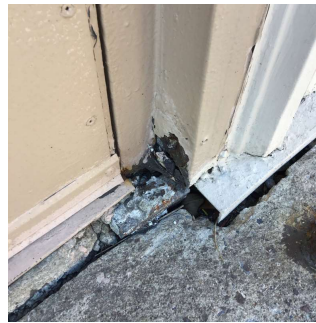
Facade A

Question	Response
Architectural	
EXTERIOR	Inspected
AREAWAY	Does not Exist
AWNINGS AND CANOPIES	Does not Exist
CHIMNEY	Does not Exist
COPING	Does not Exist
CORNICE	Does not Exist
DOORS	Inspected
DOORS AND FRAMES	Inspected
Condition	5 - Poor
Deficiency	METAL CLAD; DETERIORATED DOOR AND FRAME - MAJOR DETERIORATION

6
EACH
REPLACE
PRIORITY 4
LEVEL 2

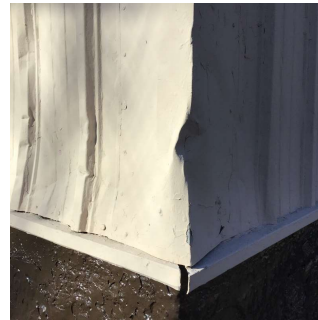
Facade B

METAL PANEL: DAMAGED TRIM

10

REPLACE

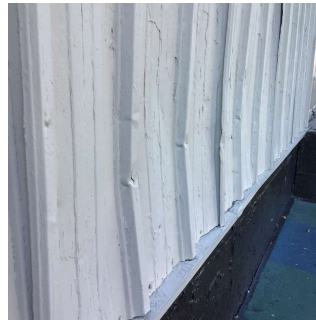
Facade A

METAL PANEL: SEVERE DENTS

2,000

REPLACE

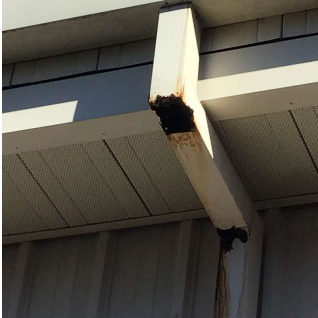
Question	Response
EXTERIOR	
LOUVER	
Elevation	 
Deficiency Quantity	10
Quantity Uom	S.F.
Potential Action	REPLACE
Urgency of Action	PRIORITY 4
Purpose of Action	LEVEL 2
Deficiency Photo1	 
Violations	Facade A No violations recorded.
PARAPETS	Does not Exist
PLAZA DECK	Does not Exist
ROOF	Inspected
Roofing	Inspected
Replacement Quantity	11,500
Replacement Uom	S.F.
ROOF HATCH/SMOKE HATCH	Does not Exist
LEADERS, GUTTERS, DOWNSPOUTS, SCUPPERS	Inspected
Condition	3 - Fair
Deficiency	DAMAGED/MISSING
Roof Plan reference	 
Deficiency Quantity	20
Quantity Uom	L.F.

Question	Response
EXTERIOR	
ROOF	
Roofing	
LEADERS, GUTTERS, DOWNSPOUTS, SCUPPERS	
Potential Action	REPLACE
Urgency of Action	PRIORITY 4
Purpose of Action	LEVEL 2
Deficiency Photo1

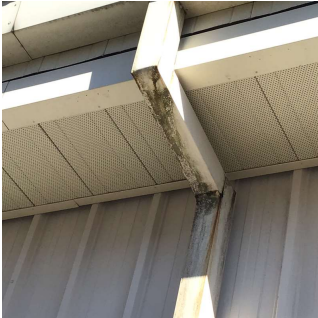
Violations	Facade C No violations recorded.
Deficiency	CLOGGED
Roof Plan reference

Deficiency Quantity	1
Quantity Uom	EACH
Potential Action	MAINTENANCE
Urgency of Action	PRIORITY 5
Purpose of Action	LEVEL 2
Deficiency Photo1

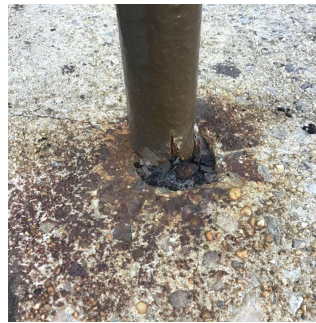
Facade A

Condition	3 - Fair
Deficiency	RUST - MAJOR

Deficiency Quantity	10
Quantity Uom	L.F.
Potential Action	REPLACE
Urgency of Action	PRIORITY 4
Purpose of Action	LEVEL 2

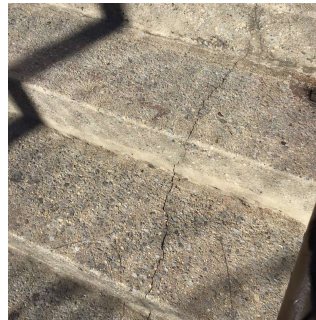
Facade B

CONCRETE: CRACKS/SPALLING - MINOR

10

REPAIR

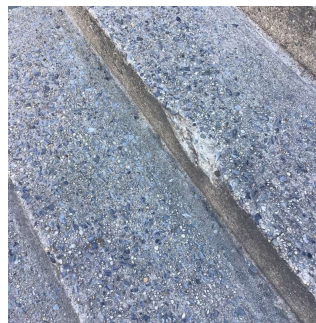
Facade A

CONCRETE: WORN-OUT TREAD/RISER/NOSING

10
 S.F.
 REPLACE
 PRIORITY 4
 LEVEL 2

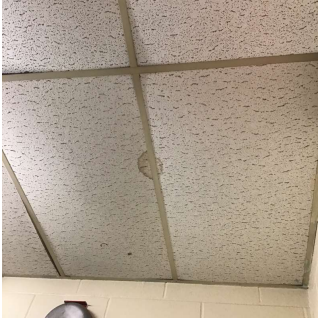
Near Vestibule Exit 3

Question	Response
INTERIOR	
STRUCTURAL	
FOUNDATION WALLS	
Material Type(s)	Concrete
Condition	3 - Fair
Deficiency	CONCRETE: CRACKED/SPALLED/REINFORCEMENT EXPOSED
Deficiency Location/Instance	Facade A
Deficiency Quantity	500
Quantity Uom	S.F.
Potential Action	REPAIR
Urgency of Action	PRIORITY 3
Purpose of Action	LEVEL 5
Deficiency Photo1	 
Violations	Facade A No violations recorded.
ROOF STRUCTURE	
Condition	Inspected
Deficiency	2 - Between Good and Fair
Deficiency	No deficiencies recorded
VAULTS-BUNKERS	
Does not Exist	
AUDITORIUM	
Does not Exist	
CAFETERIA	
Does not Exist	
CLASSROOMS/CORRIDORS/ADMIN SPACES	
Inspected	
Ceiling	
Condition	Inspected
Condition	2 - Between Good and Fair
Deficiency	ACOUSTIC TILES: DAMAGED/MISSING
Deficiency Location/Instance	Rooms M2, M5, M7, M11, Near Vestibule Exit 3, and others.
Deficiency Quantity	120
Quantity Uom	S.F.
Potential Action	REPLACE
Urgency of Action	PRIORITY 3
Purpose of Action	LEVEL 2

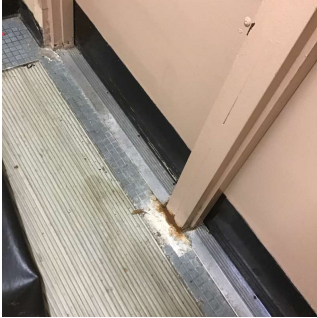
Violations	Room M1 No violations recorded.
Floor Finish	Inspected
Condition	2 - Between Good and Fair
Deficiency	CERAMIC TILE: BROKEN/MISSING TILES
Deficiency Location/Instance	Main Entrance, Exit 1 - Vestibule
Deficiency Quantity	20
Quantity Uom	S.F.
Potential Action	REPLACE
Urgency of Action	PRIORITY 3
Purpose of Action	LEVEL 2
Deficiency Photo1

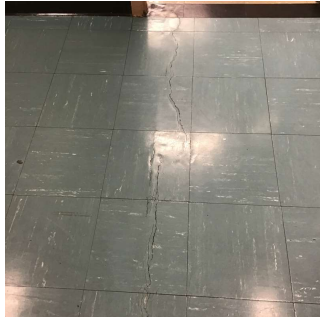
Violations	Exit 1 - Vestibule No violations recorded.
Deficiency	VINYL TILES: DETERIORATED SUBSTRATE
Deficiency Location/Instance	Room M9, Corridor near Room M9, Main Entrance.
Deficiency Quantity	30

Quantity Uom	S.F.
Potential Action	REPLACE
Urgency of Action	PRIORITY 3

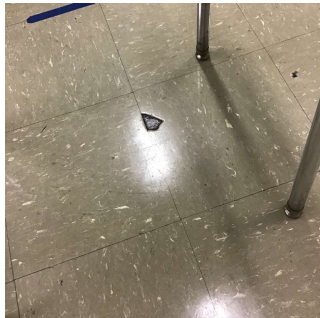
Violations	Corridor near Room M9 No violations recorded.
Deficiency	VINYL TILES: BROKEN/DETERIORATED/MISSING TILES
Deficiency Location/Instance	Rooms M5, M7, M8, M11, Corridor near Room M10,and others.
Deficiency Quantity	70
Quantity Uom	S.F.
Potential Action	REPLACE
Urgency of Action	PRIORITY 3
Purpose of Action	LEVEL 2
Deficiency Photo1

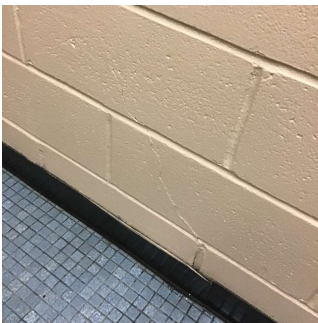
Violations	Room M 11 No violations recorded.
Walls	Inspected
Condition	2 - Between Good and Fair
Deficiency	MASONRY: CRACKS/SPALLING
Deficiency Location/Instance	Vestibule Exit 3, Corridor near Room M5, M10
Deficiency Quantity	30
Quantity Uom	S.F.
Potential Action	REPLACE
Urgency of Action	PRIORITY 3
Purpose of Action	LEVEL 2

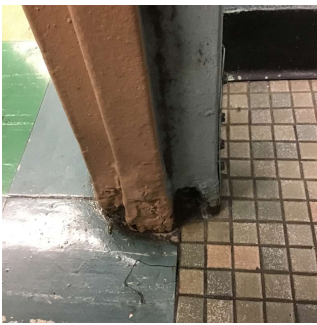
Violations	Vestibule Exit 3 No violations recorded.
Specialties	Does not Exist
GYMNASIUM	Does not Exist
INTERIOR DOOR HARDWARE	Inspected
Condition	2 - Between Good and Fair
Deficiency	No deficiencies recorded
INTERIOR GUARDS	Inspected
Condition	2 - Between Good and Fair
Deficiency	No deficiencies recorded
KITCHEN	Does not Exist
LIBRARY	Does not Exist
LOCKER ROOM	Does not Exist
MULTI-PURPOSE ROOM	Does not Exist
SCIENCE DEMO ROOM	Does not Exist
SCIENCE LAB	Does not Exist
SCIENCE PREP ROOM	Does not Exist
SHOWER ROOM	Does not Exist
STAIRS/RAMPS: INTERIOR	Does not Exist
TOILET ROOMS - STAFF	Inspected
Ceiling	Inspected
Condition	2 - Between Good and Fair
Deficiency	No deficiencies recorded
Door(s)	Inspected
Condition	5 - Poor
Deficiency	METAL: DETERIORATED DOOR AND FRAME
Deficiency Location/Instance	Staff - Main Entrance
Deficiency Quantity	1

Quantity Uom	EACH
Potential Action	MAINTENANCE
Urgency of Action	PRIORITY 3
Purpose of Action	LEVEL 2

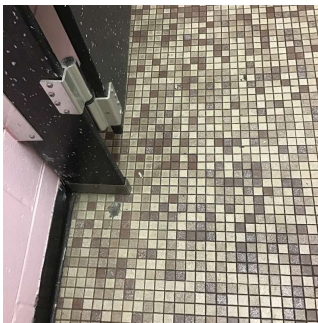
Question	Response
INTERIOR	
TOILET ROOMS - STUDENTS	
Door(s)	
Potential Action	MAINTENANCE
Urgency of Action	PRIORITY 3
Purpose of Action	LEVEL 2
Deficiency Photo1	 
	Boys
Violations	No violations recorded.
Deficiency	METAL: DETERIORATED DOOR
Deficiency Location/Instance	Girls
Deficiency Quantity	1
Quantity Uom	EACH
Potential Action	MAINTENANCE
Urgency of Action	PRIORITY 3
Purpose of Action	LEVEL 2
Deficiency Photo1	 
	Girls
Violations	No violations recorded.
Floor Finish	Inspected
Condition	2 - Between Good and Fair
Deficiency	CERAMIC TILE: BROKEN/MISSING TILES
Deficiency Location/Instance	Boys, Girls
Deficiency Quantity	10
Quantity Uom	S.F.
Potential Action	REPLACE
Urgency of Action	PRIORITY 3
Purpose of Action	LEVEL 2
