NYC Department of Education
Building Condition Assessment Survey 2023 - 2024

Architectural Inspection

Q836

Asset: P.S. 36 MINISCHOOL - QUEENS, 187-01 FOCH BLVD, New York, 11412

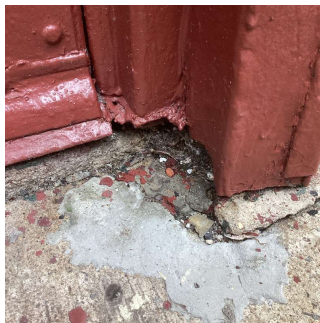
Question	Response
Architectural	
EXTERIOR	Inspected
AREAWAY	Does not Exist
AWNINGS AND CANOPIES	Does not Exist
CHIMNEY	Does not Exist
COPING	Does not Exist
CORNICE	Does not Exist
DOORS	Inspected
DOORS AND FRAMES	Inspected
Condition	5 - Poor
Deficiency	METAL: DETERIORATED DOOR AND FRAME - MAJOR DETERIORATION
Roof Plan reference	
Deficiency Quantity	6
Quantity Uom	EACH
Potential Action	REPLACE
Urgency of Action	PRIORITY 4
Purpose of Action	LEVEL 2

Question	Response
EXTERIOR	
DOORS	
DOORS AND FRAMES	
Deficiency Photo1

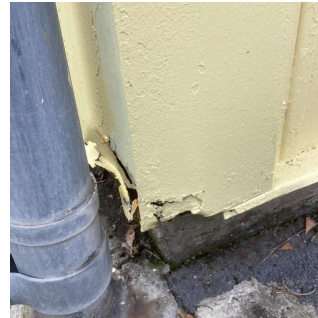
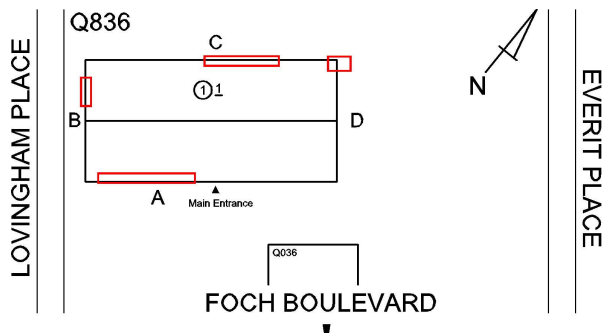
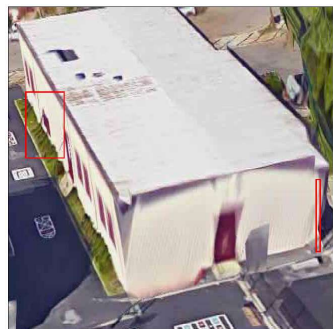
Facade D

Violations	Facade A No violations recorded.
DOOR HARDWARE	Inspected
Condition	3 - Fair
Deficiency	No deficiencies recorded
LINTELS	Does not Exist
TRANSOM/SIDE LIGHT	Does not Exist
EXTERIOR WALLS	Inspected
Material Type(s)	Steel
Replacement Quantity	6,000
Replacement Uom	S.F.
Instance on All Facades	Inspected
Instance Condition	5 - Poor
Instance Quantity	6,000
Instance Quantity Uom	S.F.
Deficiency	METAL PANEL: DAMAGED TRIM
Roof Plan reference

Deficiency Quantity	50
Quantity Uom	L.F.
Potential Action	REPLACE

Urgency of Action
 Purpose of Action
 Deficiency Photo1

PRIORITY 4
 LEVEL 2

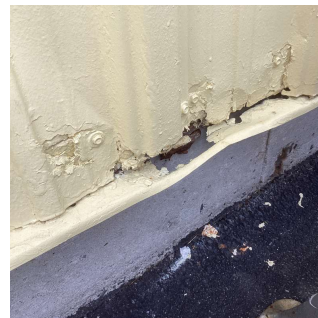
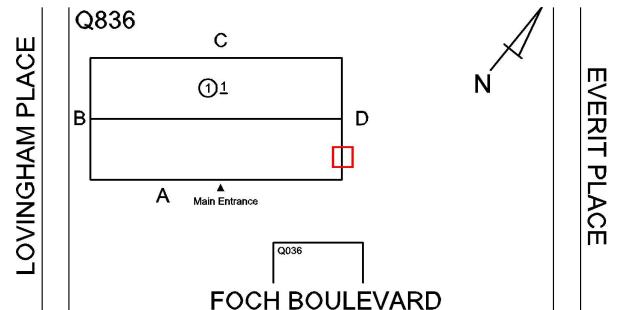
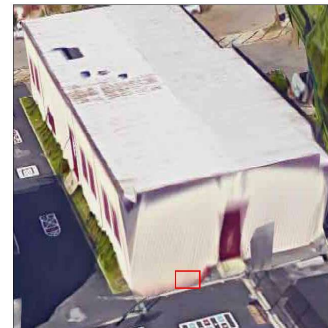
Facade D

METAL PANEL: MAJOR RUSTING

Deficiency Quantity

10

Potential Action

REPLACE

Urgency of Action

PRIORITY 4

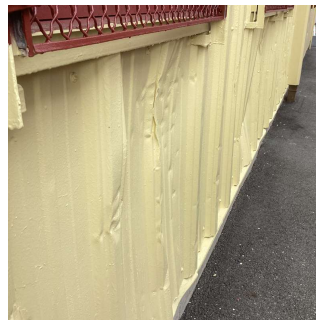
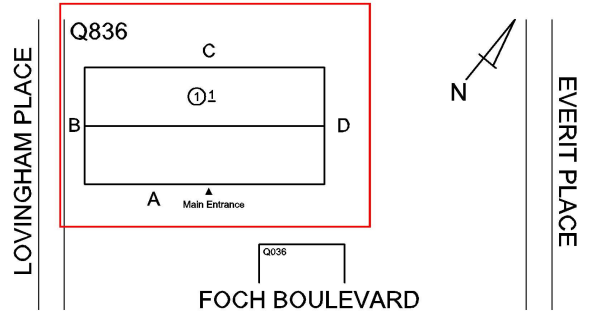
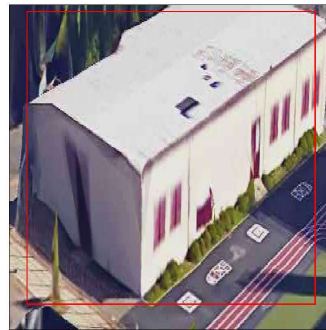
Facade A

Deficiency METAL PANEL: SEVERE DENTS

Deficiency Quantity 500
 Quantity Uom S.F.
 Potential Action REPLACE
 Urgency of Action PRIORITY 4
 Purpose of Action LEVEL 2
 Deficiency Photo1

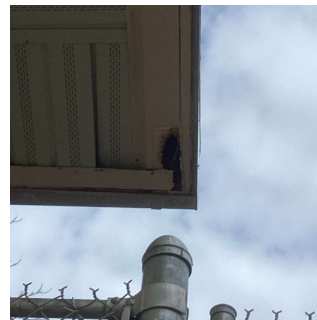
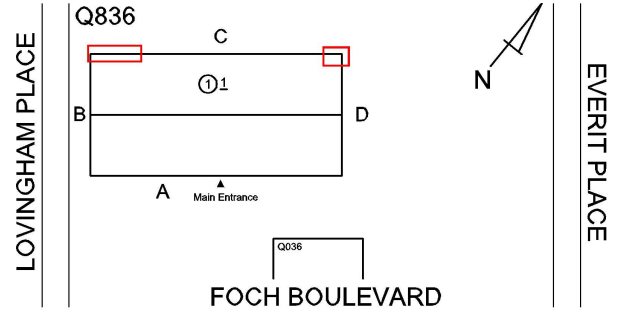
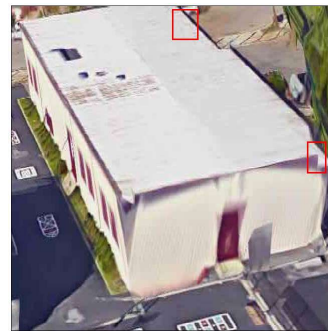
Facade D

Deficiency METAL: DETERIORATION/DAMAGED/MISSING PIECES

Deficiency Quantity

20

Potential Action

REPLACE

Urgency of Action

PRIORITY 4

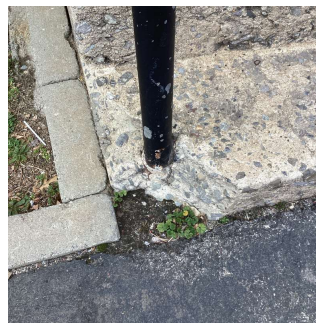
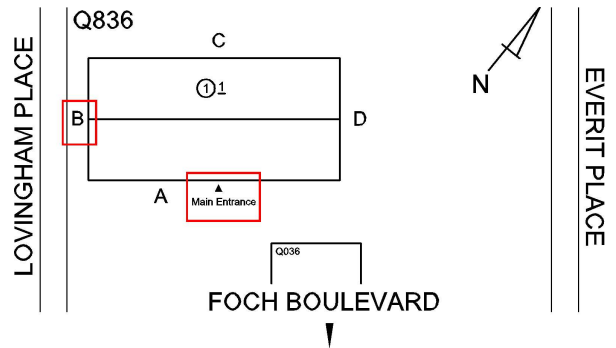
Purpose of Action	LEVEL 2
Deficiency Photo1	
Violations	Facade A No violations recorded.
Deficiency	CONCRETE: CRACKS/SPALLING - MAJOR

Deficiency Quantity
 Quantity Uom
 Potential Action
 Urgency of Action
 Purpose of Action
 Deficiency Photo1

20
 S.F.
 REPLACE
 PRIORITY 4
 LEVEL 2

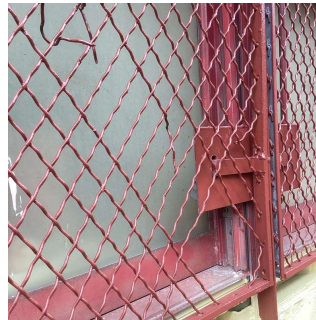
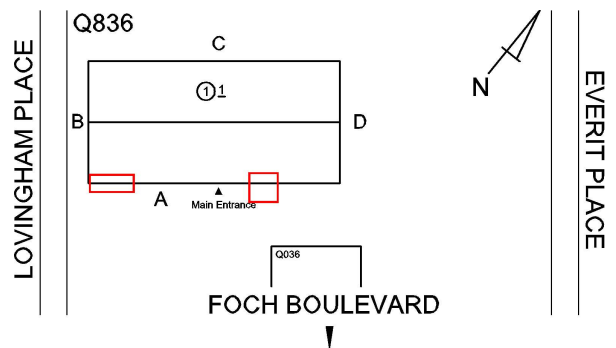
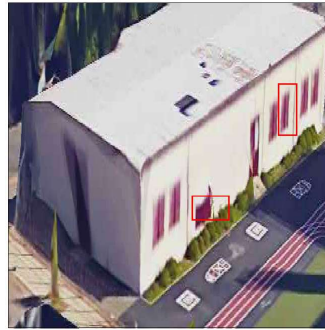
Facade A

DETERIORATED/TORN-OUT/MISSING

Deficiency Quantity
Quantity Uom
Potential Action
Urgency of Action
Purpose of Action
Deficiency Photo1

30
S.F.
REPLACE
PRIORITY 4
LEVEL 2

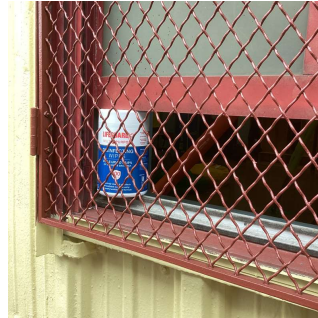
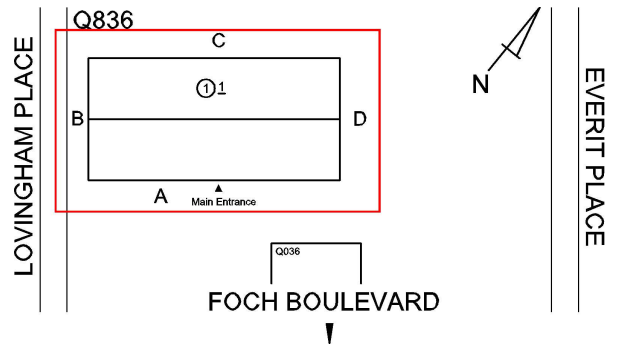
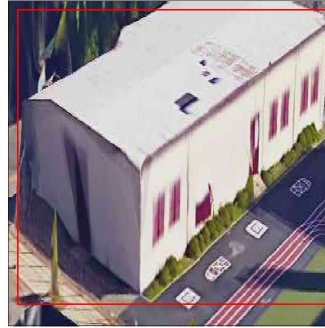
Facade A

ALUMINUM - DOUBLE HUNG: INOPERABLE

Deficiency Quantity
Quantity Uom
Potential Action
Urgency of Action
Purpose of Action
Deficiency Photo1

300
S.F.
REPLACE WINDOW
PRIORITY 4
LEVEL 2

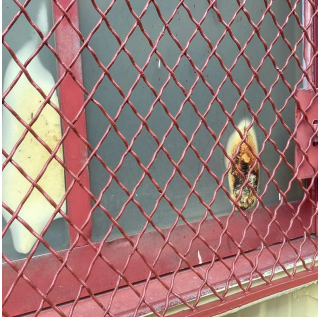
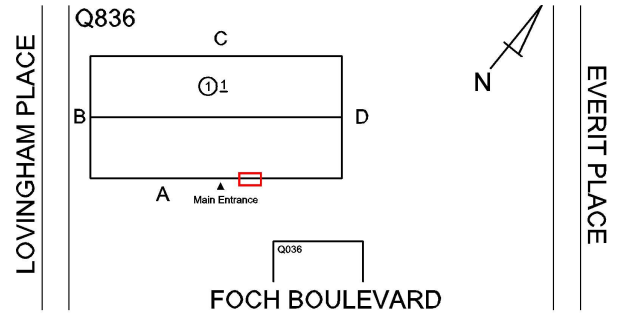
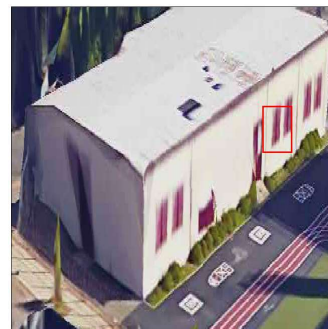
ALUMINUM - DOUBLE HUNG: BROKEN PANE

Deficiency Quantity
Quantity Uom

30
S.F.

Question	Response
EXTERIOR	
WINDOWS	
WINDOWS	
Potential Action	MAINTENANCE
Urgency of Action	PRIORITY 3
Purpose of Action	LEVEL 2
Deficiency Photo1

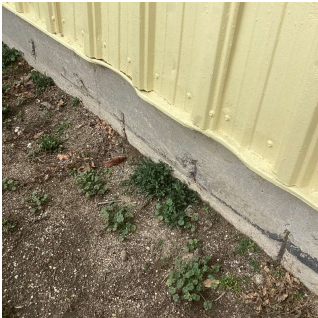
Violations	Facade A No violations recorded.
INTERIOR	Inspected
POOLS	Does not Exist
STRUCTURAL	Inspected
COLUMNS/BEAMS/BEARING WALLS	Inspected
Condition	2 - Between Good and Fair
Deficiency	No deficiencies recorded
FLOOR STRUCTURE	Inspected
Condition	2 - Between Good and Fair
Deficiency	No deficiencies recorded
FOUNDATION WALLS	Inspected
Material Type(s)	Concrete
Condition	3 - Fair
Deficiency	CONCRETE: CRACKED/SPALLED/REINFORCEMENT EXPOSED
Deficiency Location/Instance	Facade A
Deficiency Quantity	50
Quantity Uom	S.F.
Potential Action	REPAIR
Urgency of Action	PRIORITY 3
Purpose of Action	LEVEL 5
Deficiency Photo1

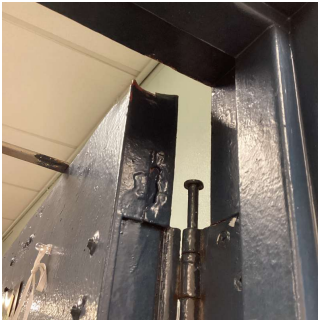
Question	Response
INTERIOR	
STRUCTURAL	Inspected
ROOF STRUCTURE	Inspected
Deficiency	No deficiencies recorded
VAULTS-BUNKERS	Does not Exist
AUDITORIUM	Does not Exist
CAFETERIA	Does not Exist
CLASSROOMS/CORRIDORS/ADMIN SPACES	Inspected
Ceiling	Inspected
Condition	2 - Between Good and Fair
Deficiency	No deficiencies recorded
Door(s)	Inspected
Condition	5 - Poor
Deficiency	METAL: DETERIORATED DOOR
Deficiency Location/Instance	Rooms M3, M7
Deficiency Quantity	2
Quantity Uom	EACH
Potential Action	MAINTENANCE
Urgency of Action	PRIORITY 3
Purpose of Action	LEVEL 2
Deficiency Photo1

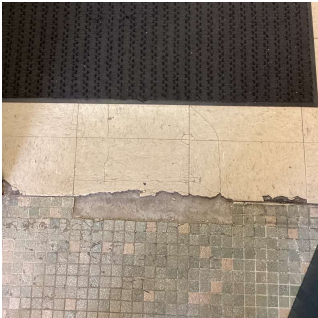
Question	Response
INTERIOR	
CLASSROOMS/CORRIDORS/ADMIN SPACES	
Floor Finish	
Violations	No violations recorded.
Deficiency	CERAMIC TILE: BROKEN/MISSING TILES
Deficiency Location/Instance	Near Main Entrance
Deficiency Quantity	10
Quantity Uom	S.F.
Potential Action	REPLACE
Urgency of Action	PRIORITY 3
Purpose of Action	LEVEL 2
Deficiency Photo1

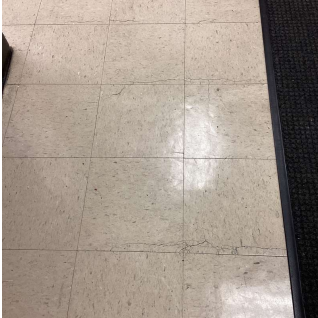
Violations	No violations recorded.
Deficiency	VINYL TILES: BROKEN/DETERIORATED/MISSING TILES
Deficiency Location/Instance	Rooms M1, M2, Corridor near Rooms M6, M10, M12, and others
Deficiency Quantity	150
Quantity Uom	S.F.
Potential Action	REPLACE
Urgency of Action	PRIORITY 3
Purpose of Action	LEVEL 2
Deficiency Photo1

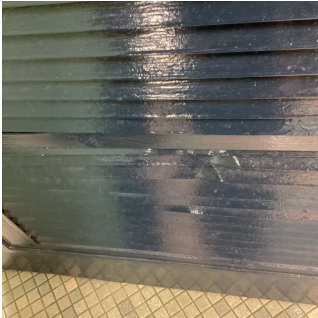
Question	Response
INTERIOR	
KITCHEN	Does not Exist
LIBRARY	Does not Exist
LOCKER ROOM	Does not Exist
MULTI-PURPOSE ROOM	Does not Exist
SCIENCE DEMO ROOM	Does not Exist
SCIENCE LAB	Does not Exist
SCIENCE PREP ROOM	Does not Exist
SHOWER ROOM	Does not Exist
STAIRS/RAMPS: INTERIOR	Does not Exist
TOILET ROOMS - STAFF	Inspected
Ceiling	Inspected
Condition	2 - Between Good and Fair
Deficiency	No deficiencies recorded
Door(s)	Inspected
Condition	5 - Poor
Deficiency	METAL: DAMAGED LOUVER
Deficiency Location/Instance	Room M10
Deficiency Quantity	1
Quantity Uom	EACH
Potential Action	MAINTENANCE
Urgency of Action	PRIORITY 3
Purpose of Action	LEVEL 2
Deficiency Photo1
