**NYC Department of Education**  
**Building Condition Assessment Survey 2023 - 2024**

Architectural Inspection

**Asset:** P.S. 841- QUEENS, 48-25 37TH STREET, New York, 11104

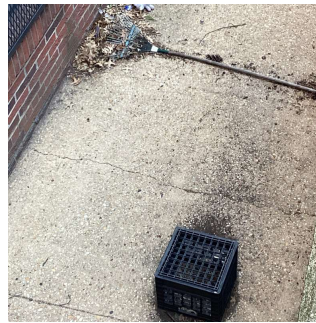
AW1  
No violations recorded.

Question	Response
<b>Architectural</b>	
<b>EXTERIOR</b>	Inspected
<b>AREAWAY</b>	Inspected
Instance on AW1 - AW4	Inspected
Instance Condition	3 - Fair
Instance Quantity	4
Instance Quantity Uom	EACH
Deficiency	AREAWAY SLAB: CRACKS AND SPALLING
Roof Plan reference	Q841

Deficiency Quantity	20
Quantity Uom	S.F.
Potential Action	REPAIR
Urgency of Action	PRIORITY 3

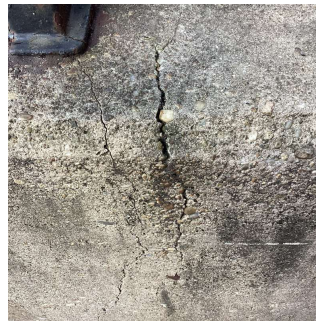
AW1  
No violations recorded.

AREAWAY WALLS: CRACKS AND SPALLING  
Q841

40  
S.F.  
REPAIR  
PRIORITY 3  
LEVEL 2

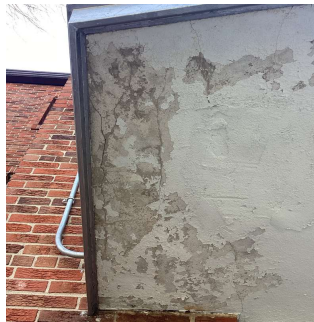
Facade A

CONCRETE: MAJOR CRACKS/SPALLING

10  
 S.F.  
 REPAIR  
 PRIORITY 4  
 LEVEL 2

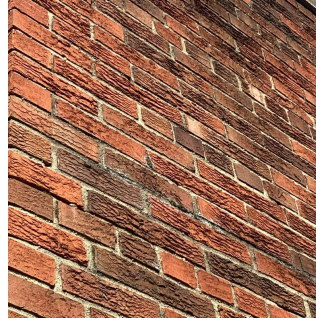
CH

BRICK: DETERIORATED JOINTS

50  
 S.F.  
 REPOINT  
 PRIORITY 3  
 LEVEL 2

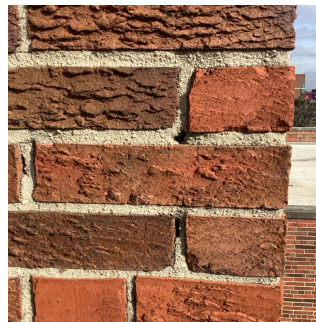
CH

BRICK: DETERIORATED JOINTS

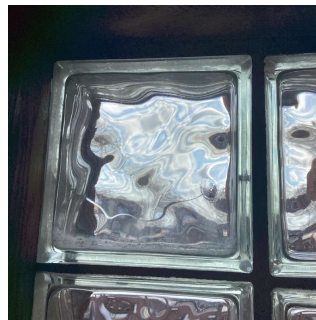
Facade F - 2nd Floor Girls Toilet Room

GLASS BLOCK: CHIPPED/ BROKEN PIECES

REPLACE-IN-KIND

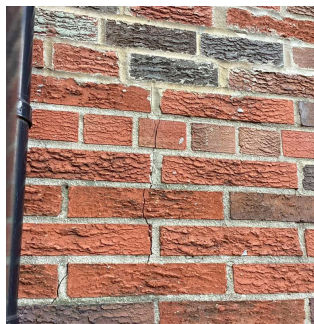
Facade F

BRICK: MINOR CRACKS AND SPALLING

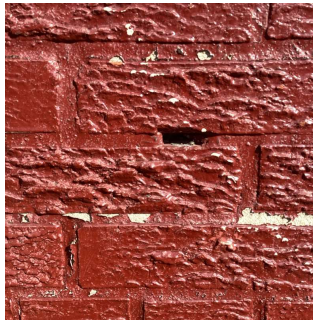
Facade G

BRICK: DETERIORATED JOINTS

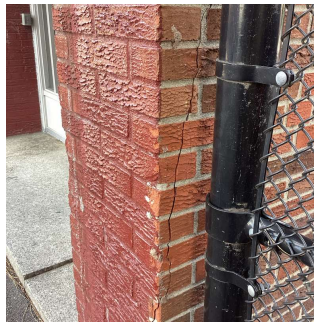
Facade F  
No violations recorded.

BRICK: CRACKS/DISPLACED/SPALLED BRICK AT BUILDING CORNERS

50  
S.F.  
REMOVE AND REBUILD  
PRIORITY 4  
LEVEL 2

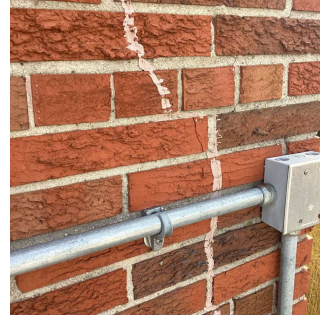
BH1

**BULKHEAD/PENTHOUSE WALLS/INTERIOR: BRICK  
CRACKS/SPALLING**

20  
S.F.  
REPLACE  
PRIORITY 3  
LEVEL 2

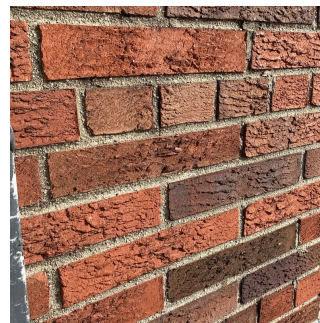
BH2

**BULKHEAD/PENTHOUSE WALLS/EXTERIOR: DETERIORATED JOINTS**

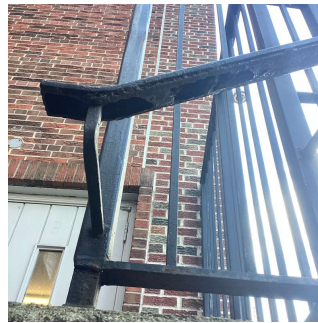
Facade A

RUST - MAJOR

10  
 L.F.  
 REPLACE  
 PRIORITY 4  
 LEVEL 2

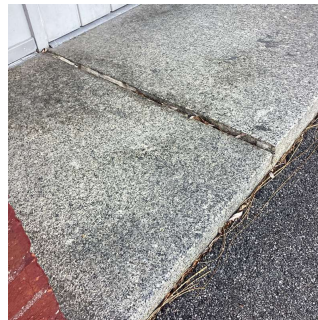
Facade G

STONE: DETERIORATED SUBSTRATE

REPLACE SUBSTRATE AND RESET

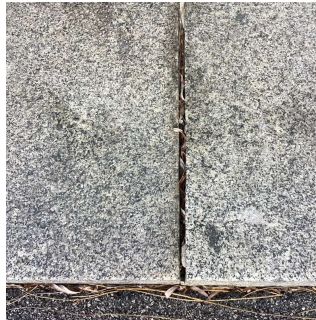
Facade G

STONE: DETERIORATED JOINTS

20  
 L.F.  
 REPOINT  
 PRIORITY 4  
 LEVEL 2

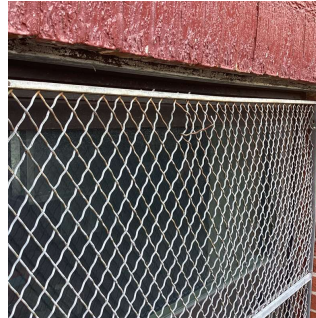
Facade G

DETERIORATED/TORN-OUT/MISSING

60  
S.F.  
REPLACE  
PRIORITY 4  
LEVEL 2

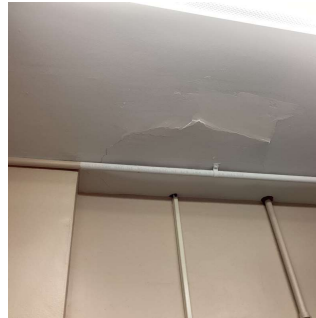
Room 202

PLASTER: CRACKS/SPALLING

REPLACE

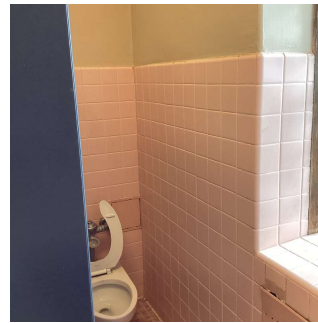
Violations	Room B12 No violations recorded.
<b>Stalls</b>	Inspected
Condition	5 - Poor
Deficiency	BROKEN/MISSING
Deficiency Location/Instance	Room 212
Deficiency Quantity	1
Quantity Uom	EACH
Potential Action	REPLACE
Urgency of Action	PRIORITY 3
