NYC Department of Education
Building Condition Assessment Survey 2023 - 2024

Architectural Inspection

Q848

Asset: P.S. 81 ANNEX (OLD 75) - QUEENS, 511 SENECA AVENUE, New York, 11385

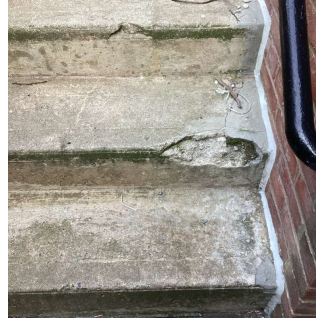
Facade C - AW3

AREAWAY STAIRS: DETERIORATED TREADS/RISERS/NOSINGS

Potential Action

REPAIR

PRIORITY 3

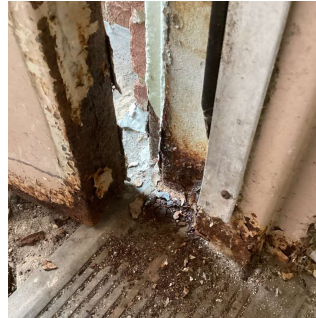
Facade D

METAL: DETERIORATED DOOR AND FRAME - MAJOR DETERIORATION

Quantity Uom	EACH
Potential Action	REPLACE
Urgency of Action	PRIORITY 4
Purpose of Action	LEVEL 2
Deficiency Photo1

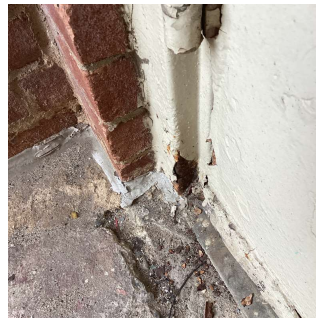
Facade D

Deficiency	METAL: DETERIORATED DOOR AND FRAME - MINOR DETERIORATION
------------	--

Deficiency Quantity	1
Quantity Uom	EACH
Potential Action	MAINTENANCE
Urgency of Action	PRIORITY 3
Purpose of Action	LEVEL 2
Deficiency Photo1

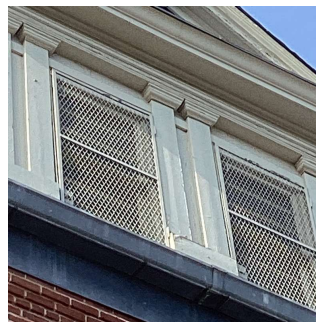
Facade A
No violations recorded.

Deficiency	No deficiencies recorded
ROOFING DRAINS	Does not Exist
Specialties	Inspected
BULKHEAD/PENTHOUSE	Does not Exist
CUPOLA/ SPIRES/ TOWERS	Does not Exist
DORMER	Inspected
Condition	3 - Fair
Deficiency	DAMAGED COVERING

20
S.F.
REPAIR COVERING
PRIORITY 4
LEVEL 2

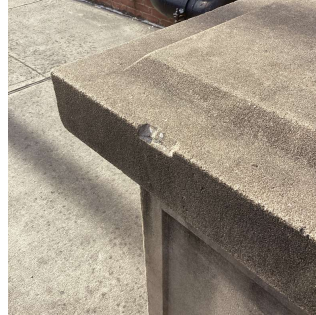
Facade A

STONE: CRACKS/SPALLING - MINOR

10
S.F.
REPAIR

PRIORITY 3
 LEVEL 2

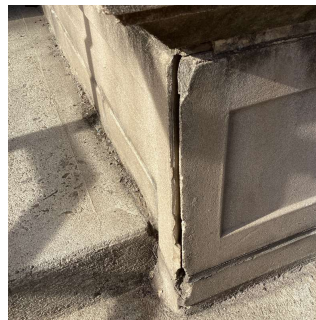
Facade A

STONE: DETERIORATED JOINTS

REPOINT

PRIORITY 4

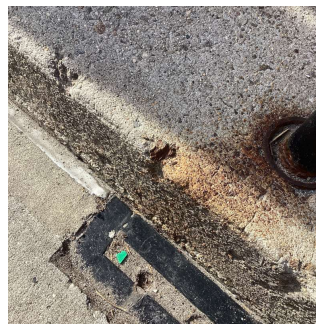
Facade A

CONCRETE: WORN-OUT TREAD/RISER/NOSING

10
S.F.
REPLACE
PRIORITY 4
LEVEL 2

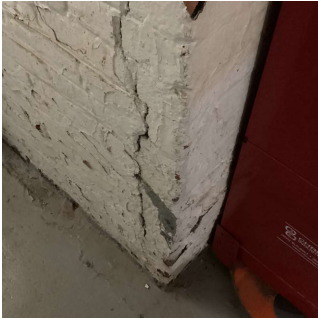
Basement - By exit stait
Violations	No violations recorded.
Deficiency	MASONRY BEARING WALL: CRACKED/SPALLED

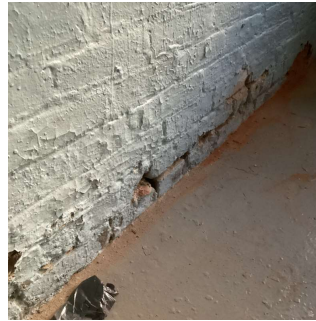
Deficiency Location/Instance	Basement - Electrical Panel Room
Deficiency Quantity	10
Quantity Uom	S.F.
Potential Action	RESTITCH
Urgency of Action	PRIORITY 4
Purpose of Action	LEVEL 5

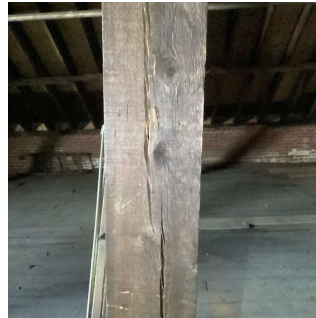
Attic

WOOD COLUMNS/BEAMS: DETERIORATED

REPLACE

PRIORITY 4

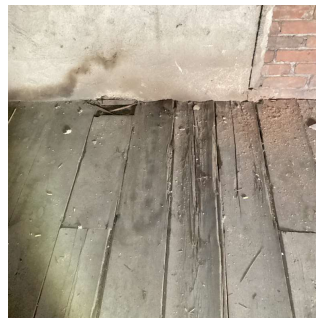
WOOD: DETERIORATED/DAMAGED

REPLACE

PRIORITY 3

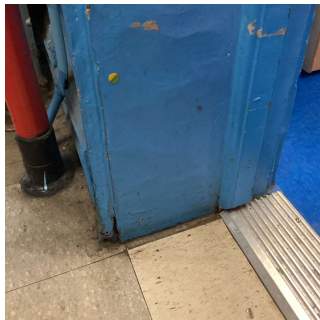
Question	Response
INTERIOR	
CAFETERIA	
Instance on Basement	Inspected
Ceiling	
Instance on Basement	Inspected
Condition	2 - Between Good and Fair
Deficiency	No deficiencies recorded
Door(s)	
Instance on Basement	Not Required
Fixed Equipment	
Instance on Basement	Does not Exist
Floor Finish	
Instance on Basement	Inspected
Condition	1 - Good
Deficiency	No deficiencies recorded
Sliding-folding Partition	
Instance on Basement	Does not Exist
Stage	
Instance on Basement	Does not Exist
Walls	
Instance on Basement	Inspected
Condition	2 - Between Good and Fair
Deficiency	No deficiencies recorded
Window Curtains/Shades/Blinds	
Instance on Basement	Does not Exist
CLASSROOMS/CORRIDORS/ADMIN SPACES	
Instance on Basement	Inspected
Ceiling	
Instance on Basement	Inspected
Condition	2 - Between Good and Fair
Deficiency	No deficiencies recorded
Door(s)	
Instance on Basement	Inspected
Condition	5 - Poor
Deficiency	METAL CLAD WOOD: DETERIORATED DOOR AND FRAME

Deficiency Location/Instance	Rooms 101A, 102A
Deficiency Quantity	2
Quantity Uom	EACH
Potential Action	MAINTENANCE
Urgency of Action	PRIORITY 3
Purpose of Action	LEVEL 2
Deficiency Photo1

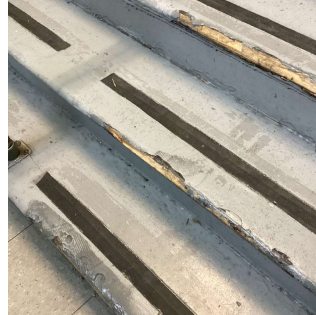
Stairs and Landings	Inspected
Condition	5 - Poor
Deficiency	WOOD: BROKEN/DETERIORATED
Deficiency Location/Instance	Main Entrance
Deficiency Quantity	20
Quantity Uom	S.F.
Potential Action	REPLACE

PRIORITY 3
LEVEL 2

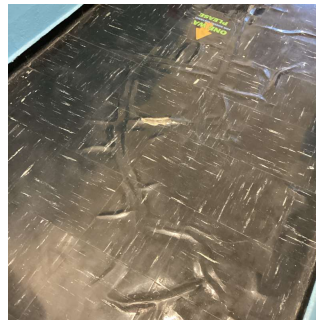
Stair B/2

VINYL TILES: DETERIORATED SUBSTRATE
Stair B/1, 2
100
S.F.
REPLACE
PRIORITY 3
LEVEL 2

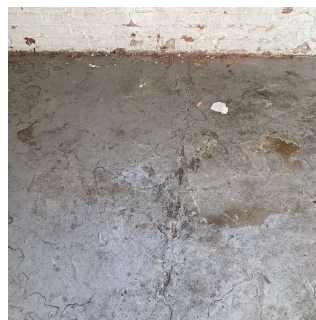
CONCRETE: CRACKS/SPALLING - MAJOR
Stair B/Basement
10
S.F.
REPLACE
PRIORITY 3
LEVEL 2

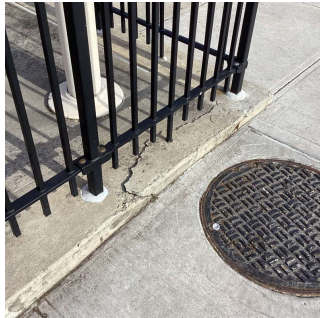
Question	Response
SITE	
Drainage System for Concrete	Inspected
Catch Basins/Manhole - Surrounded by concrete	Inspected
Deficiency	No deficiencies recorded
Culverts - Concrete Covering	Does not Exist
Drainage System for Soil	Does not Exist
DRINKING FOUNTAINS	Does not Exist
FENCES	Inspected
Condition	2 - Between Good and Fair
Deficiency	CONCRETE CURB: DAMAGED/DETERIORATED
Deficiency Location/Instance	Seneca Avenue
Deficiency Quantity	20
Quantity Uom	S.F.
Potential Action	REPLACE
Urgency of Action	PRIORITY 3
Purpose of Action	LEVEL 2
Deficiency Photo1
