**NYC Department of Education**  
**Building Condition Assessment Survey 2023 - 2024**

Architectural Inspection

**Asset:** I.S. 77 - QUEENS, 976 SENECA AVENUE, New York, 11385

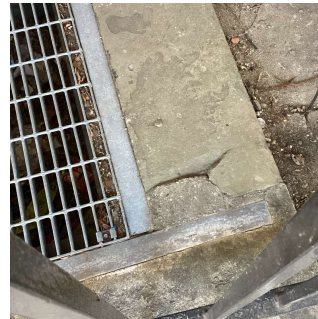
AW3

AREAWAY WALLS: CRACKS AND SPALLING

REPLACE

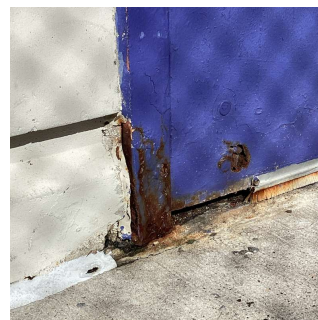
METAL: DETERIORATED DOOR AND FRAME - MAJOR DETERIORATION

11  
EACH  
REPLACE  
PRIORITY 4  
LEVEL 2

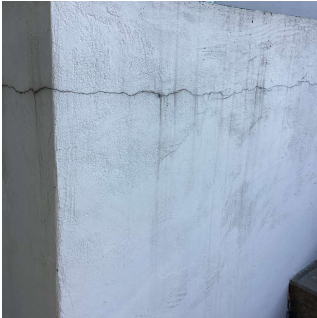
**CHEEK WALL/CRACKS, SPALLING - MINOR**

20  
S.F.  
REPAIR  
PRIORITY 3  
LEVEL 2

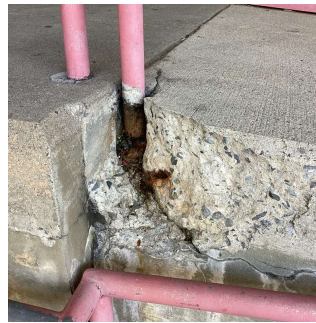
Facade D

Deficiency	CAST IN PLACE CONCRETE: CRACKS/SPALLING - MAJOR
------------	---

Deficiency Quantity	30
Quantity Uom	S.F.
Potential Action	REPLACE
Urgency of Action	PRIORITY 4
Purpose of Action	LEVEL 2

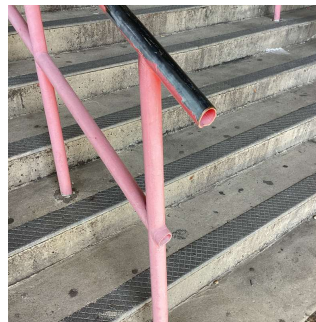
Facade D

DAMAGED

REPLACE

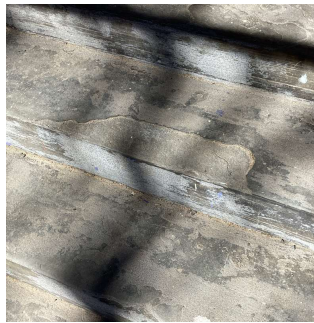
Facade B

STONE: CRACKS/SPALLING - MINOR

10  
 S.F.  
 REPAIR  
 PRIORITY 3  
 LEVEL 2

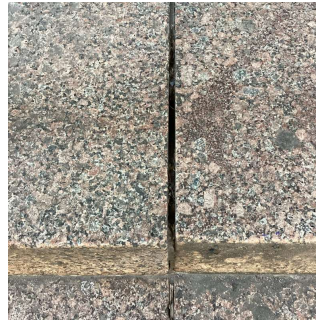
Facade A

**STONE: DETERIORATED JOINTS**

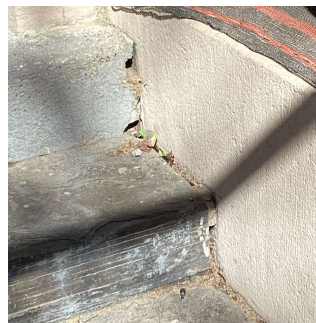
Facade B

**STONE: DETERIORATED JOINTS**

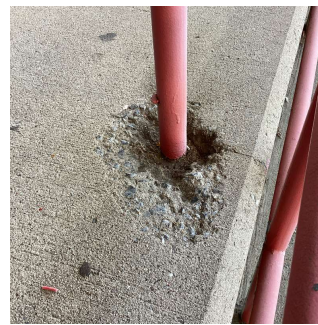
Facade D

**CONCRETE: CRACKS/SPALLING - MAJOR**

80  
 S.F.  
 REPLACE  
 PRIORITY 4  
 LEVEL 2

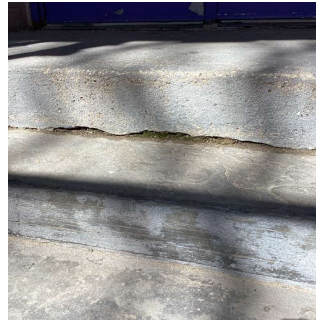
Facade B

**STONE: CRACKS/SPALLING - MAJOR**

10  
 S.F.  
 REPLACE  
 PRIORITY 4  
 LEVEL 2

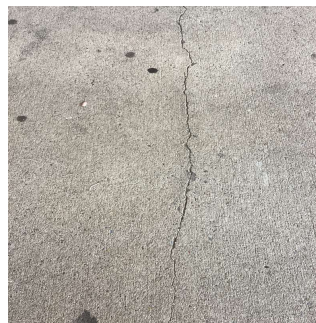
Facade D

**CONCRETE: CRACKS/SPALLING - MINOR**

REPAIR

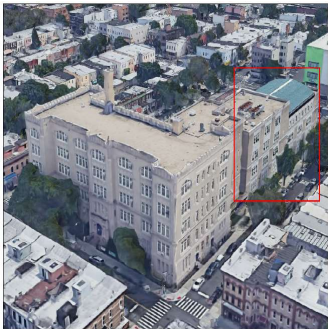
Question	Response
<b>EXTERIOR</b>	
<b>WINDOWS</b>	
<b>WINDOWS</b>	Inspected
Material Type(s)	Aluminum
Instance on Aluminum - Double Hung: 2003 Addition	Inspected
Instance Condition	3 - Fair
Instance Quantity	4,000
Instance Quantity Uom	S.F.
Are these windows insulated	No
Installation Year	2003
Source of Installation	Custodial Staff
Deficiency	ALUMINUM - DOUBLE HUNG: INOPERABLE BALANCE
Roof Plan reference

Deficiency Quantity	20
Quantity Uom	EACH
Potential Action	REPLACE BALANCES
Urgency of Action	PRIORITY 3
Purpose of Action	LEVEL 2
Deficiency Photo1

Violations	Facade E - Cafeteria (similar throughout) No violations recorded.
Instance on Aluminum - Double Hung: Original Building	Inspected
Instance Condition	3 - Fair
Instance Quantity	14,000

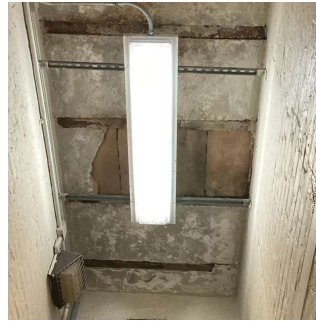
Basement - Stairs to Exit 17

Yes	Potential Falling Debris	Deteriorated concrete floor slab is a potential falling debris hazard.	INTERIOR   STRUCTURAL   FLOOR STRUCTURE	Basement - Stairs to Exit 17, Storage Room B08, Electrical Panel Room near Ash Hoist Vault	Joseph Mateo	Custodian

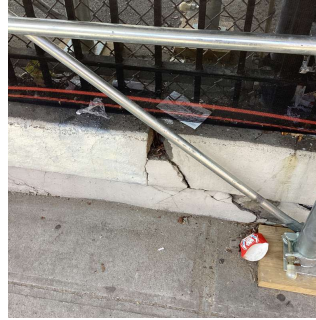
Priority Condition Exist Last Year?	Priority Category	Condition Description	Component Affected	Location Description	Person(s) Notified	Person(s) Title	PhotoImage
No	Potential Falling Debris	Severely damaged retaining wall is a potential safety hazard.	SITE   RETAINING WALLS	George Street	Mario Madrid	Stationary Engineer
