NYC Department of Education
Building Condition Assessment Survey 2023 - 2024

Architectural Inspection

Q858

Asset: P.S. 188 ANNEX - QUEENS, 216-15 PECK AVENUE, New York, 11364

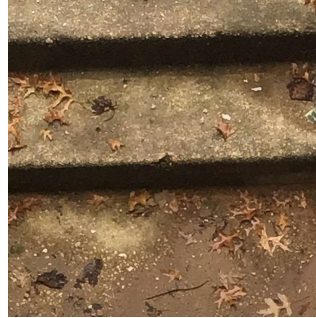
AW1

AREAWAY

Potential Action
 Urgency of Action
 Purpose of Action
 Deficiency Photo1

REPAIR
 PRIORITY 3
 LEVEL 2

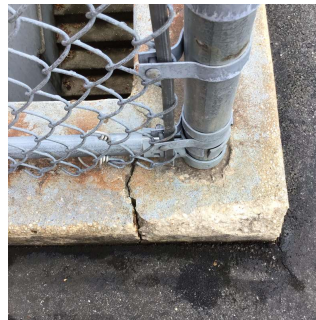
AW1

AREAWAY WALLS: CRACKS AND SPALLING

50
 S.F.
 REPLACE
 PRIORITY 4
 LEVEL 2

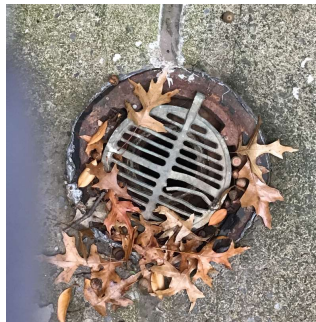
AW3
 No violations recorded.

AREAWAY DRAINS: DETERIORATED

1
 EACH
 REPLACE
 PRIORITY 4
 LEVEL 2

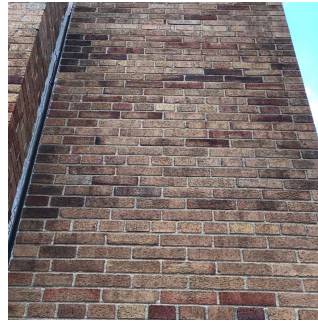
CH

BRICK: DETERIORATED JOINTS

40
 S.F.
 REPOINT
 PRIORITY 3
 LEVEL 2

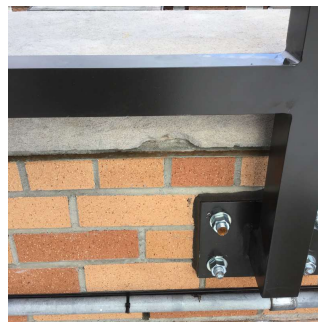
Roof 1

CAST STONE: CRACKED/BROKEN PIECES

REPLACE-IN-KIND

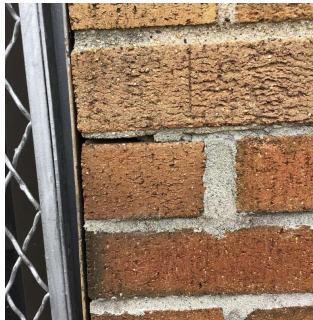
Facade E

BRICK: DETERIORATED JOINTS

REPOINT

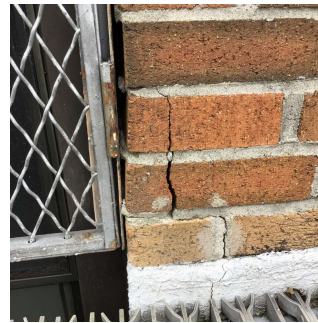
Facade E

BRICK: MAJOR / THRU CRACKS

REMOVE AND REBUILD

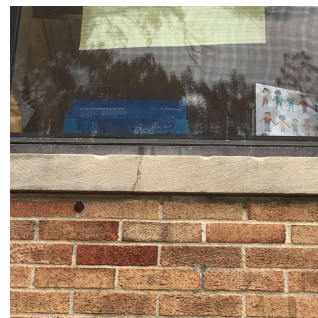
Facade E

BRICK: DETERIORATED MASONRY SILLS - MINOR

REPAIR

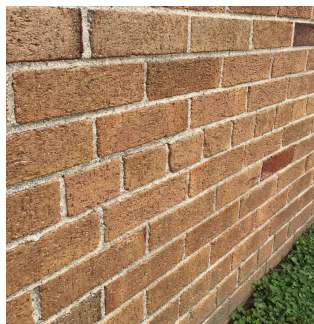
Facade A

BRICK: DETERIORATED JOINTS

600
S.F.
REPOINT
PRIORITY 3
LEVEL 2

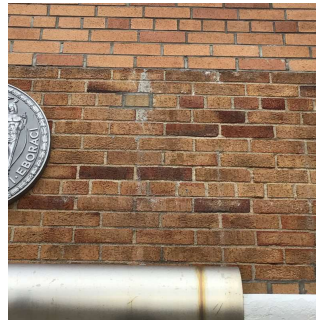
Facade A

BRICK: EFFLORESCENCE

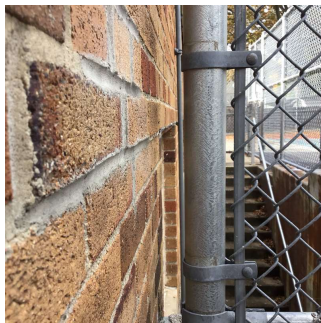
BRICK: MINOR BULGING

Question	Response
EXTERIOR	
EXTERIOR WALLS	
Purpose of Action	LEVEL 2
Deficiency Photo1

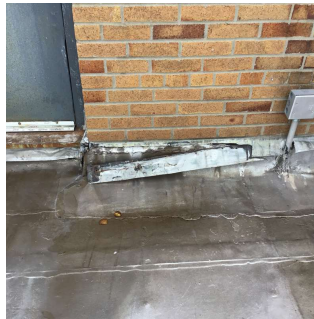
Roof 1
No violations recorded.

Deficiency SINGLE PLY, FULLY ADHERED ROOF: FLASHING: CAP FLASHING MISSING

Deficiency Quantity	10
Quantity Uom	L.F.
Potential Action	INSTALL NEW
Urgency of Action	PRIORITY 4
Purpose of Action	LEVEL 2
Deficiency Photo1

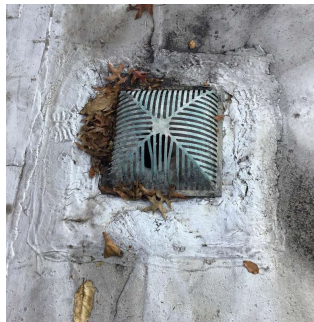
Roof 1
 No violations recorded.

Condition	Inspected
Deficiency	3 - Fair DETERIORATED

1
 EACH
 REPLACE
 PRIORITY 4
 LEVEL 2

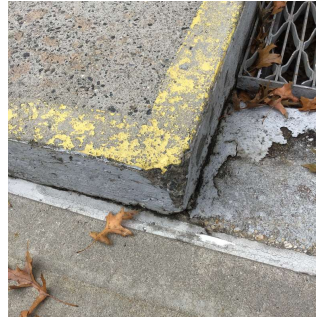
Facade G - Exit 1

CONCRETE: WORN-OUT TREAD/RISER/NOSING

10
 S.F.
 REPLACE
 PRIORITY 4
 LEVEL 2

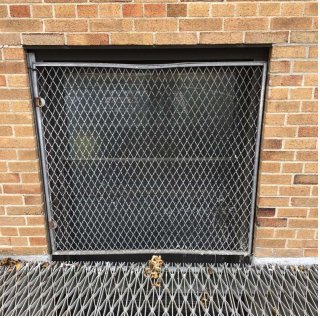
DETERIORATED/TORN-OUT/MISSING

Deficiency Quantity	20
Quantity Uom	S.F.
Potential Action	REPLACE
Urgency of Action	PRIORITY 4
Purpose of Action	LEVEL 2
Deficiency Photo1

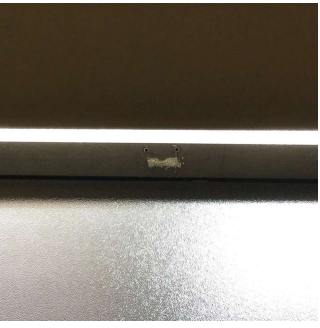
Violations	Facade E No violations recorded.
LINTELS	Inspected
Condition	2 - Between Good and Fair
Deficiency	No deficiencies recorded
WINDOWS	Inspected
Material Type(s)	Aluminum
Instance on Aluminum - Double Hung: All Facades	Inspected
Instance Condition	3 - Fair
Instance Quantity	2,000
Instance Quantity Uom	S.F.
Are these windows insulated	Yes
Installation Year	1992
Source of Installation	Custodial Staff
Deficiency	ALUMINUM - DOUBLE HUNG: HARDWARE POOR CONDITION/MISSING

Deficiency Quantity	20
Quantity Uom	EACH
Potential Action	MAINTENANCE
Urgency of Action	PRIORITY 3
Purpose of Action	LEVEL 2
Deficiency Photo1

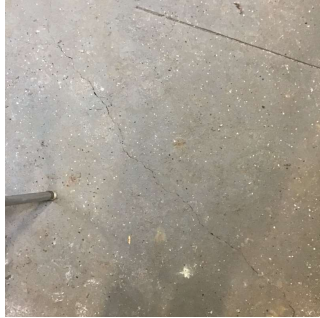
Violations	<p>Facade E - Cafeteria</p> <p>No violations recorded.</p>
INTERIOR	Inspected
POOLS	Does not Exist
STRUCTURAL	Inspected
COLUMNS/BEAMS/BEARING WALLS	Inspected
Condition	2 - Between Good and Fair
Deficiency	No deficiencies recorded
FLOOR STRUCTURE	Inspected
Condition	3 - Fair
Deficiency	CONCRETE SLAB ON GRADE: THRU CRACKS
Deficiency Location/Instance	Boiler Room
Deficiency Quantity	60
Quantity Uom	S.F.
Potential Action	REPAIR

Question	Response
INTERIOR	
STRUCTURAL	
FLOOR STRUCTURE	
Urgency of Action	PRIORITY 3
Purpose of Action	LEVEL 5
Deficiency Photo1

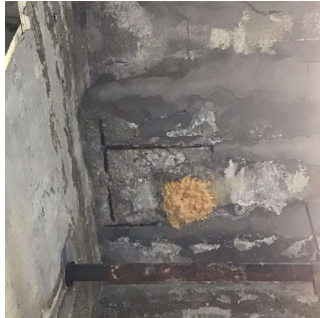
Boiler Room
Violations	No violations recorded.
Deficiency	CONCRETE: CRACKS/SPALLED/REINFORCEMENT EXPOSED
Deficiency Location/Instance	Boiler Room
Deficiency Quantity	20
Quantity Uom	S.F.
Potential Action	REPAIR
Urgency of Action	PRIORITY 4
Purpose of Action	LEVEL 5
Deficiency Photo1

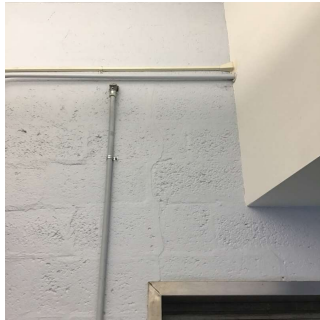
Question	Response
INTERIOR	
CAFETERIA	
Walls	
Instance on Basement	Inspected
Condition	2 - Between Good and Fair
Deficiency	MASONRY: CRACKS/SPALLING
Deficiency Location/Instance	Near Serving area
Deficiency Quantity	10
Quantity Uom	S.F.
Potential Action	REPLACE
Urgency of Action	PRIORITY 3
Purpose of Action	LEVEL 2
Deficiency Photo1

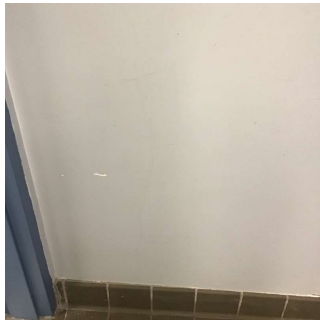
Violations	Near Serving area No violations recorded.
Deficiency	PLASTER: CRACKS/SPALLING
Deficiency Location/Instance	Near Room B3
Deficiency Quantity	10
Quantity Uom	S.F.
Potential Action	REPLACE
Urgency of Action	PRIORITY 3
Purpose of Action	LEVEL 2
Deficiency Photo1

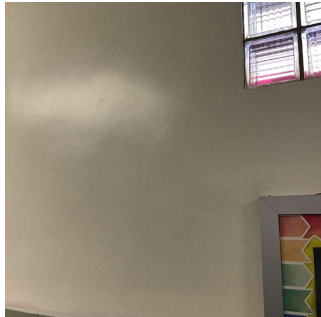
Question	Response
INTERIOR	
CLASSROOMS/CORRIDORS/ADMIN SPACES	
Door(s)	
Condition	5 - Poor
Deficiency	WOOD: DETERIORATED DOOR
Deficiency Location/Instance	Rooms 105, 102
Deficiency Quantity	2
Quantity Uom	EACH
Potential Action	MAINTENANCE
Urgency of Action	PRIORITY 3
Purpose of Action	LEVEL 2
Deficiency Photo1	 
Violations	Room 105 No violations recorded.
Floor Finish	
Condition	Inspected 2 - Between Good and Fair
Deficiency	VINYL TILES: DETERIORATED SUBSTRATE
Deficiency Location/Instance	Rooms B9, B8, 110, 102
Deficiency Quantity	60
Quantity Uom	S.F.
Potential Action	REPLACE
Urgency of Action	PRIORITY 3
Purpose of Action	LEVEL 2
Deficiency Photo1	 
Violations	Room B9 No violations recorded.
Walls	
Condition	Inspected 2 - Between Good and Fair
Deficiency	PLASTER: CRACKS/SPALLING
Deficiency Location/Instance	Corridor near Rooms 111, 103, 101
Deficiency Quantity	30
Quantity Uom	S.F.
Potential Action	REPLACE
Urgency of Action	PRIORITY 3

Question	Response
INTERIOR	
CLASSROOMS/CORRIDORS/ADMIN SPACES	
Walls	
Purpose of Action	LEVEL 2
Deficiency Photo1

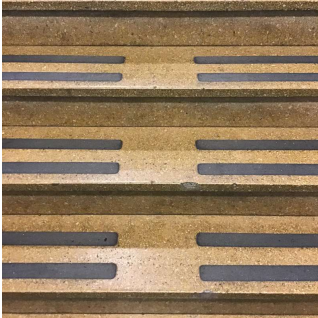
Question	Response
INTERIOR	
SCIENCE PREP ROOM	Does not Exist
SHOWER ROOM	Does not Exist
STAIRS/RAMPS: INTERIOR	Inspected
Do Letter Stair Signs Exist?	Yes
Ceiling	Inspected
Condition	2 - Between Good and Fair
Deficiency	No deficiencies recorded
Door(s)	Inspected
Condition	2 - Between Good and Fair
Deficiency	No deficiencies recorded
Partition	Does not Exist
Railings	Inspected
Condition	2 - Between Good and Fair
Deficiency	No deficiencies recorded
Stairs and Landings	Inspected
Condition	3 - Fair
Deficiency	TERRAZZO: CRACKS
Deficiency Location/Instance	Stairs A/Basement, 1, B/1, C/Basement, 1
Deficiency Quantity	60
Quantity Uom	S.F.
Potential Action	REPLACE
Urgency of Action	PRIORITY 3
Purpose of Action	LEVEL 2
Deficiency Photo1

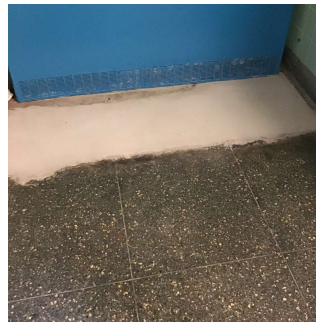
Violations	Stair A/Basement No violations recorded.
Deficiency	CERAMIC TILE: BROKEN/MISSING
Deficiency Location/Instance	Stair A/Basement, C/1
Deficiency Quantity	40
Quantity Uom	S.F.
Potential Action	REPLACE

Urgency of Action	PRIORITY 3
Purpose of Action	LEVEL 2

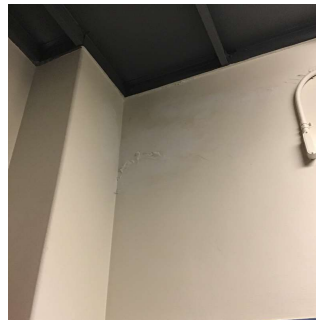
Stair B/1

PLASTER: CRACKS/SPALLING

REPLACE

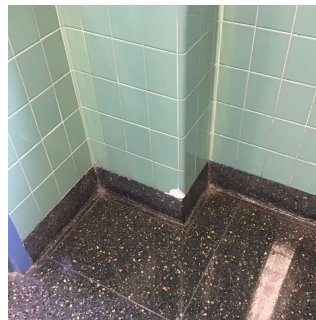
CERAMIC TILE: BROKEN/ MISSING

REPLACE

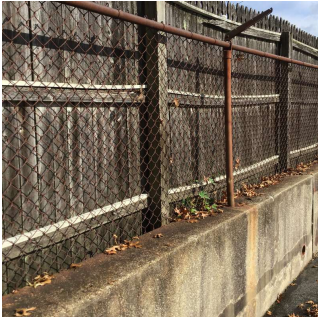
Question	Response
SITE	
Drainage System for Concrete	Inspected
Catch Basins/Manhole - Surrounded by concrete	Inspected
Condition	2 - Between Good and Fair
Deficiency	No deficiencies recorded
Culverts - Concrete Covering	Does not Exist
Drainage System for Soil	Does not Exist
DRINKING FOUNTAINS	Does not Exist
FENCES	Inspected
Condition	4 - Between Fair and Poor
Deficiency	CHAIN LINK: RUST - MAJOR
Deficiency Location/Instance	Schoolyard
Deficiency Quantity	900
Quantity Uom	S.F.
Potential Action	REPLACE
Urgency of Action	PRIORITY 3
Purpose of Action	LEVEL 2
Deficiency Photo1

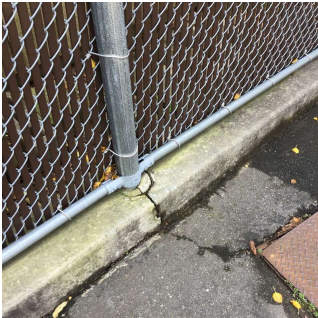
Violations	Schoolyard No violations recorded.
Deficiency	CONCRETE CURB: DAMAGED/DETERIORATED
Deficiency Location/Instance	Schoolyard
Deficiency Quantity	40
Quantity Uom	S.F.
Potential Action	REPLACE
Urgency of Action	PRIORITY 3
Purpose of Action	LEVEL 2
Deficiency Photo1

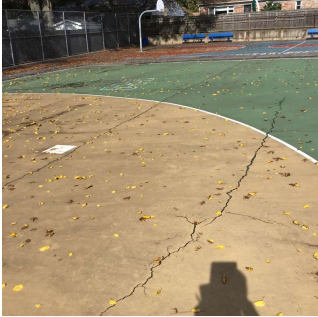
Question	Response
SITE	
PAVING	
Student Use	Inspected
Gravel Exists?	No
Asphalt	Inspected
Condition	4 - Between Fair and Poor
Deficiency	CRACKS - MAJOR
Deficiency Location/Instance	Schoolyard
Deficiency Quantity	1,600
Quantity Uom	S.F.
Potential Action	REPLACE
Urgency of Action	PRIORITY 3
Purpose of Action	LEVEL 2
Deficiency Photo1

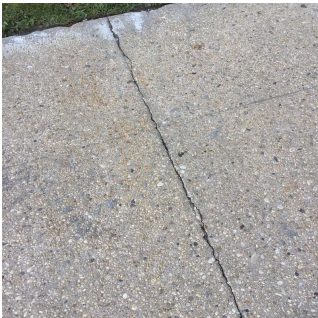
Violations	Schoolyard No violations recorded.
Concrete	Does not Exist
Pavers	Does not Exist
Site Sidewalks & Walkways	Inspected
Asphalt	Inspected
Condition	1 - Good
Deficiency	No deficiencies recorded
Concrete	Inspected
Condition	3 - Fair
Deficiency	CRACKS - MAJOR
Deficiency Location/Instance	Schoolyard Main Entrance, Exit 2
Deficiency Quantity	75
Quantity Uom	S.F.
Potential Action	REPLACE
Urgency of Action	PRIORITY 3
Purpose of Action	LEVEL 2
Deficiency Photo1

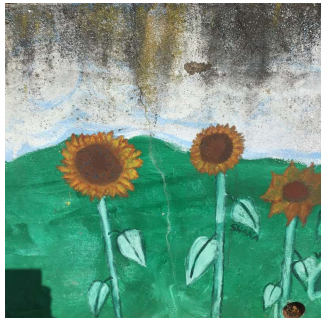
Question	Response
SITE	
PAVING	Inspected
Site Sidewalks & Walkways	Inspected
Pavers	Does not Exist
DOT Sidewalk	Does not Exist
PLAYGROUNDS	Inspected
Instance on Schoolyard	Inspected
Benches	
Instance on Schoolyard	Does not Exist
Fence	
Instance on Schoolyard	Does not Exist
Pavement	
Instance on Schoolyard	Does not Exist
Play Equipment	
Instance on Schoolyard	Inspected
Condition	2 - Between Good and Fair
Deficiency	No deficiencies recorded
Safety Surfacing	
Instance on Schoolyard	Inspected
Condition	2 - Between Good and Fair
Deficiency	No deficiencies recorded
Unpaved Area	
Instance on Schoolyard	Does not Exist
PLAYING SURFACE	Does not Exist
RETAINING WALLS	Inspected
Are there any Retaining Walls 6' OR higher facing public street/sidewalk?	No
Condition	3 - Fair
Deficiency	CAST IN PLACE CONCRETE: CRACKS/SPALLING - MAJOR
Deficiency Location/Instance	Schoolyard
Deficiency Quantity	60
Quantity Uom	S.F.
Potential Action	REPLACE

Urgency of Action	PRIORITY 3
Purpose of Action	LEVEL 2
Deficiency Photo1

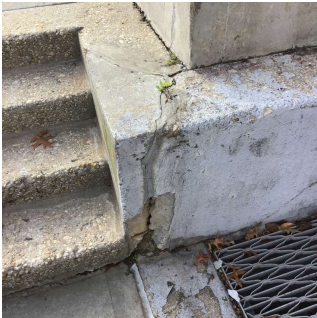
Question	Response
SITE	
SEATING	
Benches	
Metal/Wood/Plastic	
Condition	5 - Poor
Deficiency	DAMAGED/DETERIORATED
Deficiency Location/Instance	Schoolyard
Deficiency Quantity	5
Quantity Uom	EACH
Potential Action	REPLACE
Urgency of Action	PRIORITY 3
Purpose of Action	LEVEL 2
Deficiency Photo1	 
Violations	Schoolyard No violations recorded.
Bleachers	Does not Exist
SITE WALLS (NOT RETAINING WALLS)	Does not Exist
STAIRS/RAMPS: EXTERIOR	Inspected
Railings	Inspected
Condition	3 - Fair
Deficiency	MISSING
Deficiency Location/Instance	Schoolyard Main Entrance
Deficiency Quantity	10
Quantity Uom	L.F.
Potential Action	REPLACE
Urgency of Action	PRIORITY 5
Purpose of Action	LEVEL 6
Deficiency Photo1	 
Violations	Schoolyard Main Entrance No violations recorded.
Site Cheek/flank Walls	Inspected
Condition	2 - Between Good and Fair
Deficiency	CAST IN PLACE CONCRETE: CRACKS/SPALLING - MAJOR
Deficiency Location/Instance	Schoolyard Main Entrance

Question	Response
SITE	
STAIRS/RAMPS: EXTERIOR	
Site Cheek/flank Walls	
Deficiency Quantity	20
Quantity Uom	S.F.
Potential Action	REPLACE
Urgency of Action	PRIORITY 3
Purpose of Action	LEVEL 2
Deficiency Photo1
