NYC Department of Education
Building Condition Assessment Survey 2023 - 2024

Architectural Inspection

Asset: P.S. 60 MINISCHOOL - QUEENS, 91-02 88TH AVENUE, New York, 11421

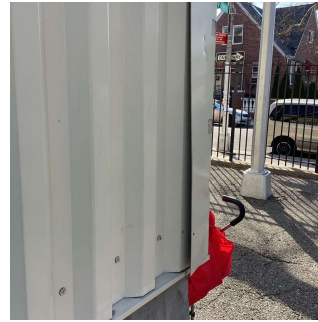
Facade C

METAL PANEL: SEVERE DENTS

REPLACE

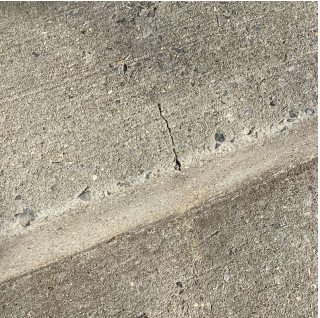
Do solar panels exist on these roofs?	No
Is/Are the roof(s) suitable for Solar Panel installation?	No
Installation Year	1987
Source of Installation	Custodial Staff
Deficiency	No deficiencies recorded
ROOFING DRAINS	Does not Exist
Specialties	Does not Exist
STAIRS/RAMPS: EXTERIOR	Inspected
BUILDING CHEEK/FLANK WALLS	Does not Exist
RAILINGS	Inspected
Condition	2 - Between Good and Fair
Deficiency	No deficiencies recorded
STAIRS/RAMPS	Inspected
Condition	3 - Fair
Deficiency	CONCRETE: CRACKS/SPALLING - MINOR

Deficiency Quantity	15
Quantity Uom	S.F.
Potential Action	REPAIR
Urgency of Action	PRIORITY 3
Purpose of Action	LEVEL 2
Deficiency Photo1

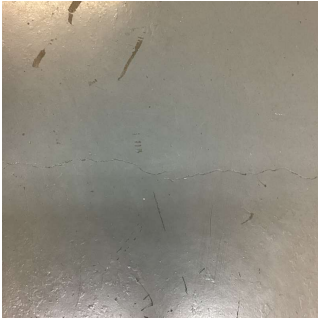
Question	Response
INTERIOR	
STRUCTURAL	
COLUMNS/BEAMS/BEARING WALLS	Inspected
Condition	2 - Between Good and Fair
Deficiency	No deficiencies recorded
FLOOR STRUCTURE	Inspected
Condition	3 - Fair
Deficiency	CONCRETE SLAB ON GRADE: THRU CRACKS
Deficiency Location/Instance	Mechanical Equipment Room
Deficiency Quantity	40
Quantity Uom	S.F.
Potential Action	REPAIR
Urgency of Action	PRIORITY 3
Purpose of Action	LEVEL 5
Deficiency Photo1

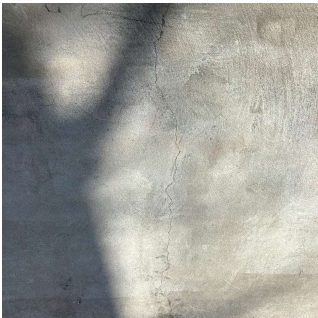
Violations	Mechanical Equipment Room No violations recorded.
FOUNDATION WALLS	Inspected
Material Type(s)	Concrete
Condition	3 - Fair
Deficiency	CONCRETE: CRACKED/SPALLED/REINFORCEMENT EXPOSED
Deficiency Location/Instance	Facades B, C, D, E
Deficiency Quantity	100
Quantity Uom	S.F.
Potential Action	REPAIR
Urgency of Action	PRIORITY 3
Purpose of Action	LEVEL 5
Deficiency Photo1

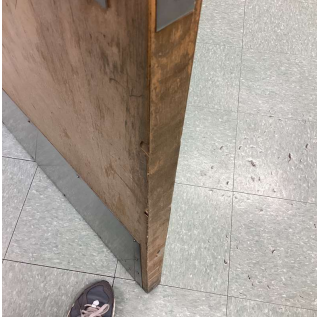
Question	Response
INTERIOR	
STRUCTURAL	
FOUNDATION WALLS	
Quantity Uom	S.F.
Potential Action	REPAIR
Urgency of Action	PRIORITY 4
Purpose of Action	LEVEL 5
Deficiency Photo1	 
Violations	Facade D No violations recorded.
ROOF STRUCTURE	
Condition	Inspected
Deficiency	2 - Between Good and Fair
VAULTS-BUNKERS	
Condition	No deficiencies recorded
AUDITORIUM	
Condition	Does not Exist
CAFETERIA	
Condition	Does not Exist
CLASSROOMS/CORRIDORS/ADMIN SPACES	
Ceiling	
Condition	Inspected
Deficiency	2 - Between Good and Fair
Deficiency	ACOUSTIC TILES ON PLASTER: DAMAGED/MISSING
Deficiency Location/Instance	Corridor near Rooms 2, 6, Rooms 8, 10, 17 and others
Deficiency Quantity	60
Quantity Uom	S.F.
Potential Action	REPLACE
Urgency of Action	PRIORITY 3
Purpose of Action	LEVEL 2
Deficiency Photo1	 
Violations	Corridor near Room 6 No violations recorded.
Door(s)	
Condition	Inspected
Deficiency	5 - Poor
Deficiency Location/Instance	WOOD: DETERIORATED DOOR

Question	Response
INTERIOR	
CLASSROOMS/CORRIDORS/ADMIN SPACES	
Door(s)	
Quantity Uom	EACH
Potential Action	MAINTENANCE
Urgency of Action	PRIORITY 3
Purpose of Action	LEVEL 2
Deficiency Photo1

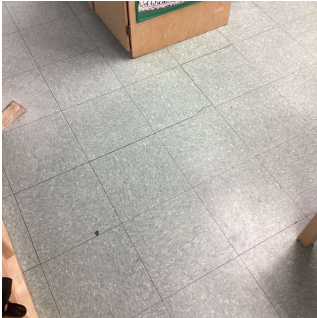
Room 2
Violations	No violations recorded.
Floor Finish	Inspected
Condition	2 - Between Good and Fair
Deficiency	VINYL TILES: BROKEN/DETERIORATED/MISSING TILES
Deficiency Location/Instance	Rooms 2, 17, Corridor near Rooms 2, 8
Deficiency Quantity	40
Quantity Uom	S.F.
Potential Action	REPLACE
Urgency of Action	PRIORITY 3
Purpose of Action	LEVEL 2
Deficiency Photo1

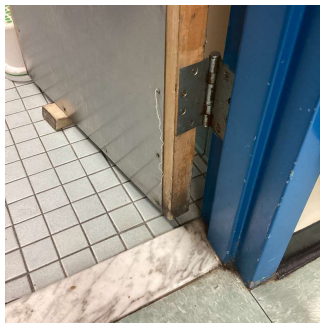
Question	Response
INTERIOR	
TOILET ROOMS - STAFF	
Ceiling	Inspected
Violations	No violations recorded.
Door(s)	Inspected
Condition	2 - Between Good and Fair
Deficiency	No deficiencies recorded
Floor Finish	Inspected
Condition	2 - Between Good and Fair
Deficiency	No deficiencies recorded
Stalls	Does not Exist
Walls	Inspected
Condition	4 - Between Fair and Poor
Deficiency	GYPSUM BOARD: DETERIORATED
Deficiency Location/Instance	1st Floor - Staff
Deficiency Quantity	20
Quantity Uom	S.F.
Potential Action	REPLACE
Urgency of Action	PRIORITY 3
Purpose of Action	LEVEL 2
Deficiency Photo1	 
Violations	1st Floor - Staff No violations recorded.
TOILET ROOMS - STUDENTS	
Ceiling	Inspected
Condition	2 - Between Good and Fair
Deficiency	No deficiencies recorded
Door(s)	Inspected
Condition	5 - Poor
Deficiency	WOOD: DETERIORATED DOOR
Deficiency Location/Instance	Rooms 3A, 8A, 4A (2)
Deficiency Quantity	4
Quantity Uom	EACH
Potential Action	MAINTENANCE

Question	Response
INTERIOR	
TOILET ROOMS - STUDENTS	
Door(s)	
Deficiency Photo1

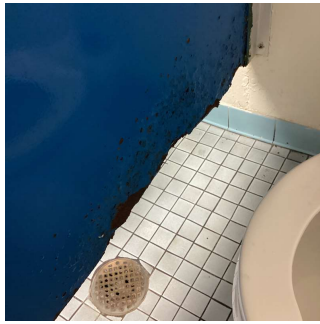
No	Protruding Elements	Severely damaged metal partitions is a potential safety hazard.	INTERIOR TOILET ROOMS - STUDENTS Stalls	Room 4A	Edwin Malave	Fireman

Violations	Room 8A No violations recorded.
Floor Finish	Inspected
Condition	2 - Between Good and Fair
Deficiency	No deficiencies recorded
Stalls	Inspected
Condition	5 - Poor
Deficiency	RUST - MAJOR
Deficiency Location/Instance	Room 4A
Deficiency Quantity	4
Quantity Uom	EACH
Potential Action	REPLACE
Urgency of Action	PRIORITY 5
Purpose of Action	LEVEL 6
Deficiency Photo1

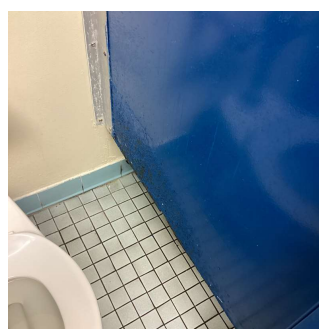
Violations	Room 4A No violations recorded.
Deficiency	RUST - MAJOR
Deficiency Location/Instance	Rooms 3A, 8A, 15A
Deficiency Quantity	12
Quantity Uom	EACH
Potential Action	REPLACE
Urgency of Action	PRIORITY 3
Purpose of Action	LEVEL 2
