**NYC Department of Education**  
**Building Condition Assessment Survey 2023 - 2024**

Architectural Inspection

Q864

**Asset:** P.S. 54 MINISCHOOL - QUEENS, 86-02 127TH STREET, New York, 11418

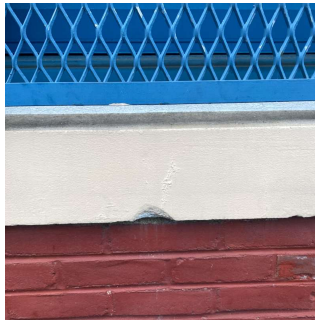
Facade F

BRICK: DETERIORATED MASONRY SILLS - MINOR

10

L.F.

REPAIR

PRIORITY 3

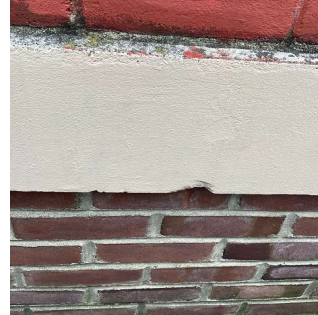
Facade F

CAST IN PLACE / PRE-CAST CONCRETE: MINOR CRACKS/SPALLING

50

S.F.

REPAIR  
PRIORITY 3  
LEVEL 2

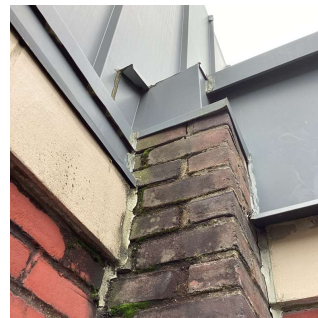
**BRICK: DETERIORATED JOINTS**

50  
S.F.  
REPOINT  
PRIORITY 3  
LEVEL 2

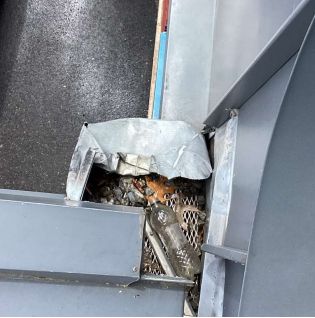
Question	Response
<b>EXTERIOR</b>	
<b>ROOF</b>	
<b>Roofing</b>	
<b>LEADERS, GUTTERS, DOWNSPOUTS, SCUPPERS</b>	
Deficiency	DETERIORATED SCUPPER
Roof Plan reference

Deficiency Quantity	4
Quantity Uom	EACH
Potential Action	REPLACE
Urgency of Action	PRIORITY 4
Purpose of Action	LEVEL 2
Deficiency Photo1

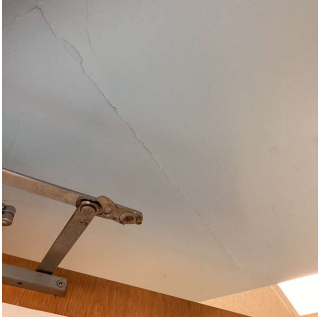
Question	Response
<b>INTERIOR</b>	
<b>STRUCTURAL</b>	Inspected
<b>COLUMNS/BEAMS/BEARING WALLS</b>	Inspected
Condition	2 - Between Good and Fair
Deficiency	No deficiencies recorded
<b>FLOOR STRUCTURE</b>	Inspected
Condition	2 - Between Good and Fair
Deficiency	No deficiencies recorded
<b>FOUNDATION WALLS</b>	Inspected
Material Type(s)	Concrete
Condition	2 - Between Good and Fair
Deficiency	No deficiencies recorded
<b>ROOF STRUCTURE</b>	Inspected
Condition	2 - Between Good and Fair
Deficiency	No deficiencies recorded
<b>VAULTS-BUNKERS</b>	Does not Exist
<b>AUDITORIUM</b>	Does not Exist
<b>CAFETERIA</b>	Does not Exist
<b>CLASSROOMS/CORRIDORS/ADMIN SPACES</b>	Inspected
<b>Ceiling</b>	Inspected
Condition	3 - Fair
Deficiency	GYPSUM BOARD: DAMAGED/DETERIORATED
Deficiency Location/Instance	Room 109
Deficiency Quantity	20
Quantity Uom	S.F.
Potential Action	REPLACE
Urgency of Action	PRIORITY 3
Purpose of Action	LEVEL 2
Deficiency Photo1

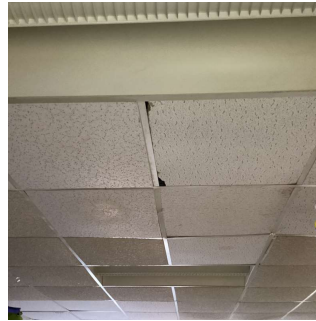
Violations	Room 109 No violations recorded.
Deficiency	ACOUSTIC TILES: DAMAGED/MISSING
Deficiency Location/Instance	Rooms 109, 122, 123, Corridor near Room 122
Deficiency Quantity	60
Quantity Uom	S.F.
Potential Action	REPLACE
Urgency of Action	PRIORITY 3
Purpose of Action	LEVEL 2

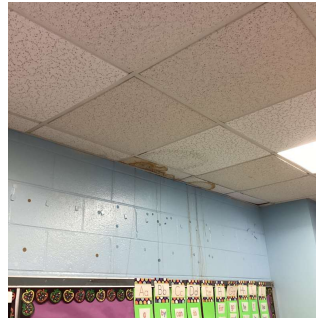
Room 107

ACOUSTIC TILES: DAMAGED/MISSING - ACTIVE LEAK

Rooms 107, 108, 109, 110, 111, 112, 114

REPLACE

PRIORITY 5

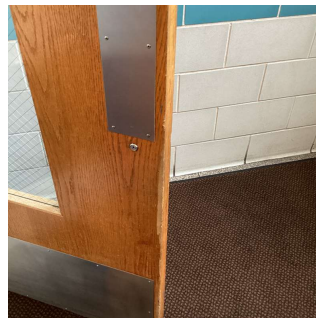
5 - Poor

WOOD: DETERIORATED DOOR

Exits 11, 12 Vestibules, Rooms 108, 110, 111 and others

MAINTENANCE

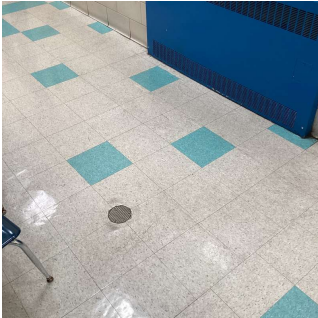
Question	Response
<b>INTERIOR</b>	
<b>CLASSROOMS/CORRIDORS/ADMIN SPACES</b>	
<b>Door(s)</b>	Inspected
	Exit 12 Vestibule
Violations	No violations recorded.
<b>Floor Finish</b>	Inspected
Condition	2 - Between Good and Fair
Deficiency	VINYL TILES: BROKEN/DETERIORATED/MISSING TILES
Deficiency Location/Instance	Corridor near Room 122, 121, 112, 111, 106 and others
Deficiency Quantity	150
Quantity Uom	S.F.
Potential Action	REPLACE
Urgency of Action	PRIORITY 3
Purpose of Action	LEVEL 2
Deficiency Photo1

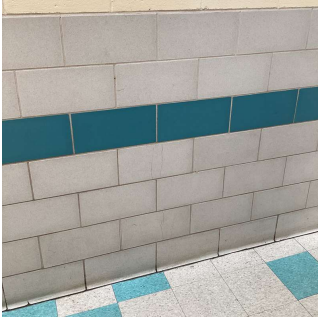
Corridor near Room 122
Violations	No violations recorded.
Deficiency	MASONRY: CRACKS/SPALLING

Corridor near Room 111
Violations	No violations recorded.
<b>Walls</b>	Inspected
Condition	2 - Between Good and Fair
Deficiency	GLAZED BLOCK: CRACKS/SPALLING
Deficiency Location/Instance	Corridor near Room 122
Deficiency Quantity	20
Quantity Uom	S.F.
Potential Action	REPLACE
Urgency of Action	PRIORITY 3
Purpose of Action	LEVEL 2
Deficiency Photo1

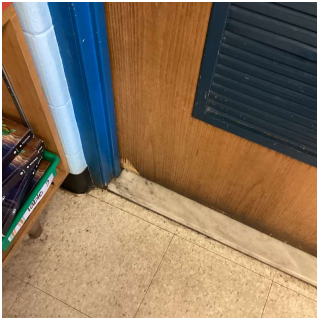
Question	Response
<b>INTERIOR</b>	
<b>TOILET ROOMS - STAFF</b>	
<b>Door(s)</b>	
Deficiency Photo1	 
Violations	Room 120 No violations recorded.
<b>Floor Finish</b>	Inspected
Condition	2 - Between Good and Fair
Deficiency	No deficiencies recorded
<b>Stalls</b>	Does not Exist
<b>Walls</b>	Inspected
Condition	2 - Between Good and Fair
Deficiency	No deficiencies recorded
<b>TOILET ROOMS - STUDENTS</b>	Inspected
<b>Ceiling</b>	Inspected
Condition	2 - Between Good and Fair
Deficiency	GYPSUM BOARD: DAMAGED/DETERIORATED
Deficiency Location/Instance	1st Floor - Boys, 1st Floor - Girls
Deficiency Quantity	20
Quantity Uom	S.F.
Potential Action	REPLACE
Urgency of Action	PRIORITY 3
Purpose of Action	LEVEL 2
Deficiency Photo1	 
Violations	1st Floor - Boys No violations recorded.
<b>Door(s)</b>	Inspected
Condition	5 - Poor
Deficiency	WOOD: DETERIORATED DOOR
Deficiency Location/Instance	Room 108A, 121, 107A (2)
Deficiency Quantity	4

Quantity Uom	EACH
Potential Action	MAINTENANCE
Urgency of Action	PRIORITY 3
