**NYC Department of Education**  
**Building Condition Assessment Survey 2023 - 2024**

Architectural Inspection

Q865

**Asset:** P.S. 55 MINISCHOOL - QUEENS, 131-10 97TH AVENUE, New York, 11419

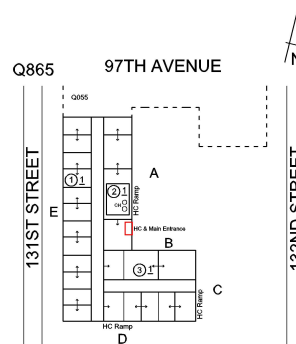
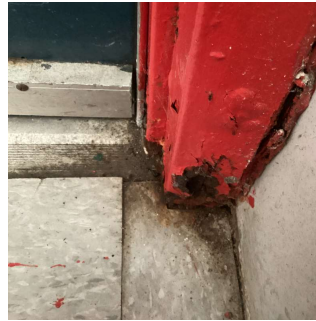
Facade A

Question	Response
<b>Architectural</b>	
<b>EXTERIOR</b>	Inspected
<b>AREAWAY</b>	Does not Exist
<b>AWNINGS AND CANOPIES</b>	Does not Exist
<b>CHIMNEY</b>	Inspected
Material Type(s)	Metal
Condition	2 - Between Good and Fair
Deficiency	No deficiencies recorded
<b>COPING</b>	Does not Exist
<b>CORNICE</b>	Does not Exist
<b>DOORS</b>	Inspected
<b>DOORS AND FRAMES</b>	Inspected
Condition	5 - Poor
Deficiency	METAL: DETERIORATED DOOR AND FRAME - MAJOR DETERIORATION
Roof Plan reference

Deficiency Quantity	2
Quantity Uom	EACH
Potential Action	REPLACE
Urgency of Action	PRIORITY 4
Purpose of Action	LEVEL 2

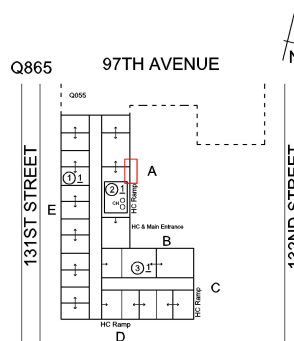
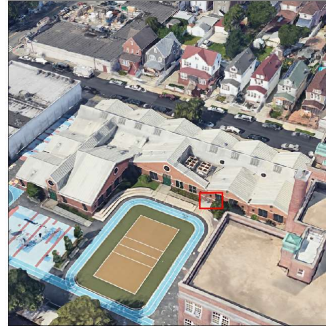
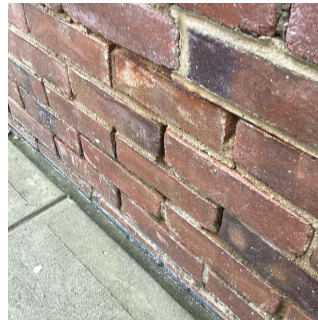
Facade A

BRICK: DETERIORATED JOINTS

Deficiency Quantity

30

Quantity Uom

S.F.

REPOINT

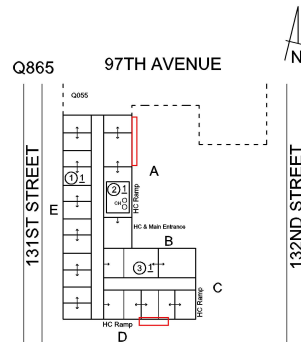
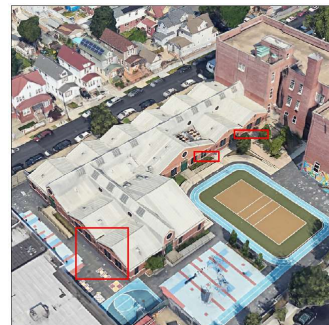
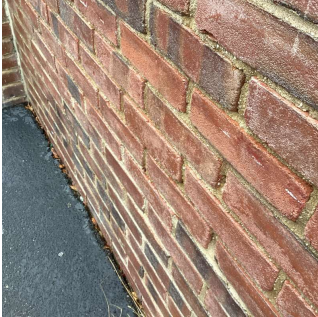
BRICK: DETERIORATED JOINTS

Deficiency Quantity

200

Quantity Uom

S.F.

Question	Response
<b>EXTERIOR</b>	
<b>EXTERIOR WALLS</b>	
Urgency of Action	PRIORITY 3
Purpose of Action	LEVEL 2
Deficiency Photo1

REPOINT

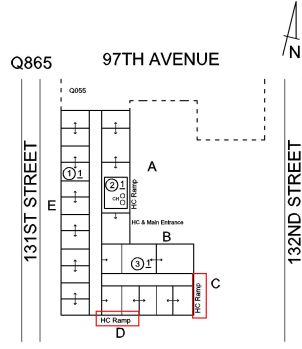
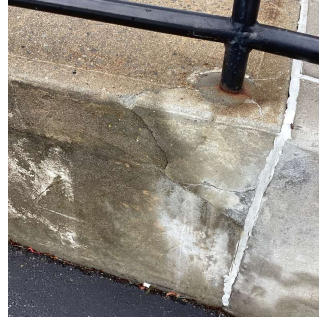
Question	Response
<b>EXTERIOR</b>	
<b>ROOF</b>	Inspected
<b>Specialties</b>	
<b>SKYLIGHT/ROOF VENT</b>	Inspected
Condition	2 - Between Good and Fair
Deficiency	No deficiencies recorded
<b>ROOF/GRAVITY TANK</b>	Does not Exist
<b>STAIRS/RAMPS: EXTERIOR</b>	Inspected
<b>BUILDING CHEEK/FLANK WALLS</b>	Inspected
Condition	3 - Fair
Deficiency	CAST IN PLACE CONCRETE: CRACKS/SPALLING - MINOR
Roof Plan reference

Deficiency Quantity	20
Quantity Uom	S.F.
Potential Action	REPAIR
Urgency of Action	PRIORITY 3
Purpose of Action	LEVEL 2
Deficiency Photo1

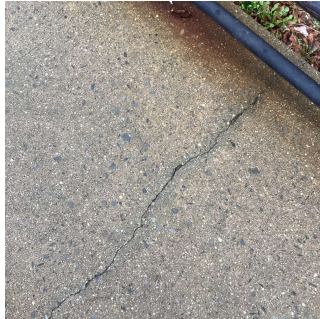
Violations	Facade C No violations recorded.
<b>RAILINGS</b>	Inspected
Condition	2 - Between Good and Fair
Deficiency	No deficiencies recorded
<b>STAIRS/RAMPS</b>	Inspected
Condition	3 - Fair
Deficiency	CONCRETE: CRACKS/SPALLING - MINOR

Question	Response
<b>EXTERIOR</b>	
<b>STAIRS/RAMPS: EXTERIOR</b>	Inspected
<b>STAIRS/RAMPS</b>	
Roof Plan reference	
Deficiency Quantity	30
Quantity Uom	S.F.
Potential Action	REPAIR
Urgency of Action	PRIORITY 3
Purpose of Action	LEVEL 2
Deficiency Photo1

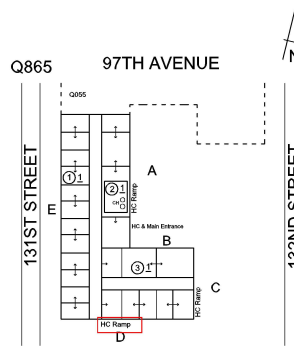
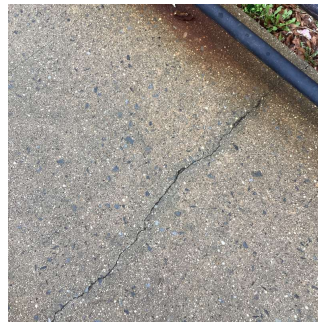
Facade C  
No violations recorded.

30  
S.F.  
REPAIR  
PRIORITY 3  
LEVEL 2

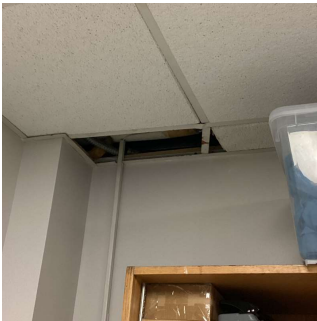
Deficiency Photo1	 
Violations	Room 150 No violations recorded.
Deficiency	ACOUSTIC TILES: DAMAGED/MISSING
Deficiency Location/Instance	Rooms 127, 131, 138
Deficiency Quantity	20
Quantity Uom	S.F.
Potential Action	REPLACE
Urgency of Action	PRIORITY 3
Purpose of Action	LEVEL 2

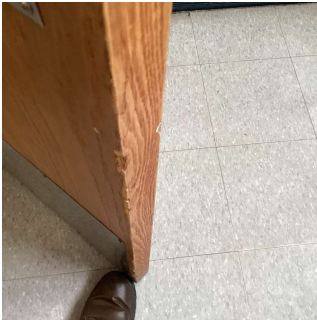
Violations	Room 138 No violations recorded.
<b>Door(s)</b>	
Condition	Inspected 5 - Poor
Deficiency	WOOD: DETERIORATED DOOR
Deficiency Location/Instance	Exit Vestibule near Room 138, Room147, 131, 126 , Exit 10 and others.
Deficiency Quantity	12
Quantity Uom	EACH
Potential Action	MAINTENANCE
Urgency of Action	PRIORITY 3
Purpose of Action	LEVEL 2
Deficiency Photo1

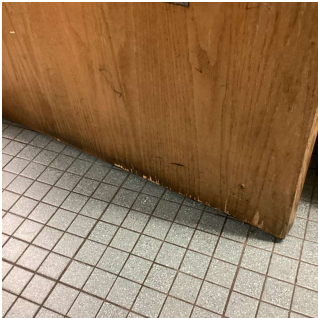
Question	Response
<b>INTERIOR</b>	
<b>TOILET ROOMS - STAFF</b>	
<b>Door(s)</b>	Inspected
Condition	2 - Between Good and Fair
Deficiency	No deficiencies recorded
<b>Floor Finish</b>	Inspected
Condition	2 - Between Good and Fair
Deficiency	No deficiencies recorded
<b>Stalls</b>	Does not Exist
<b>Walls</b>	Inspected
Condition	2 - Between Good and Fair
Deficiency	No deficiencies recorded
<b>TOILET ROOMS - STUDENTS</b>	
<b>Ceiling</b>	Inspected
Condition	2 - Between Good and Fair
Deficiency	No deficiencies recorded
<b>Door(s)</b>	Inspected
Condition	5 - Poor
Deficiency	WOOD: DETERIORATED DOOR
Deficiency Location/Instance	In Room 127/131
Deficiency Quantity	1
Quantity Uom	EACH
Potential Action	MAINTENANCE
Urgency of Action	PRIORITY 3
Purpose of Action	LEVEL 2
Deficiency Photo1

Violations	In Room 127/131 No violations recorded.
<b>Floor Finish</b>	Inspected
Condition	2 - Between Good and Fair
Deficiency	No deficiencies recorded
