NYC Department of Education
Building Condition Assessment Survey 2023 - 2024

Architectural Inspection

Asset: P.S. 99 ANNEX - QUEENS, 83-34 KEW GARDEN ROAD, New York, 11415

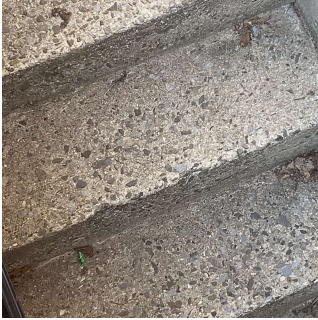
Question	Response
Architectural	
EXTERIOR	Inspected
AREAWAY	Inspected
Instance on AW1	Inspected
Instance Condition	2 - Between Good and Fair
Instance Quantity	1
Instance Quantity Uom	EACH
Deficiency	AREAWAY STAIRS: DETERIORATED TREADS/RISERS/NOSINGS
Roof Plan reference	
Deficiency Quantity	10
Quantity Uom	S.F.
Potential Action	REPAIR
Urgency of Action	PRIORITY 3
Purpose of Action	LEVEL 2

Violations	Facade D - AW1 No violations recorded.
AWNINGS AND CANOPIES	
Condition	Inspected 2 - Between Good and Fair
Deficiency	No deficiencies recorded
CHIMNEY	
Material Type(s)	Inspected Masonry
Condition	3 - Fair
Deficiency	BRICK: MINOR CRACKS AND SPALLING
Roof Plan reference

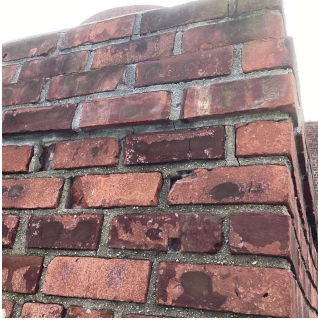
Deficiency Quantity	10
Quantity Uom	S.F.
Potential Action	RESTITCH
Urgency of Action	PRIORITY 3
Purpose of Action	LEVEL 2
Deficiency Photo1

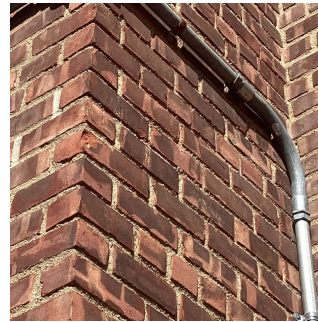
Facade D

Violations	Roof 1 No violations recorded.
Deficiency	BRICK: DETERIORATED JOINTS

200
S.F.
REPOINT
PRIORITY 4
LEVEL 2

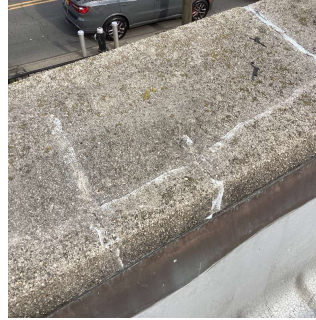
Roof 1

CAST STONE: CRACKED/BROKEN PIECES

10
L.F.
REPLACE-IN-KIND
PRIORITY 4
LEVEL 2

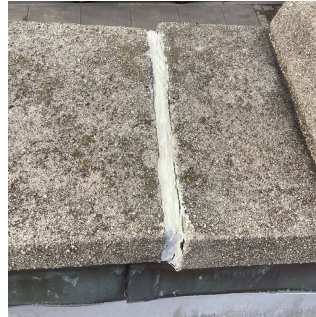
Roof 1

CAST STONE: DETERIORATED TRANSVERSE JOINTS

30

MAINTENANCE

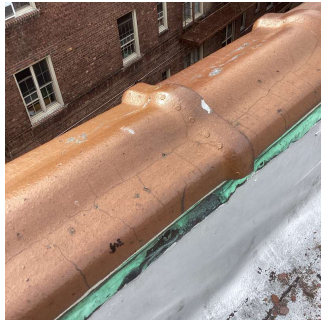
TERRA COTTA: CRACKED/BROKEN PIECES

Question	Response
EXTERIOR	
COPING	
Roof Plan reference	
Deficiency Quantity	50
Quantity Uom	L.F.
Potential Action	REPLACE-IN-KIND
Urgency of Action	PRIORITY 4
Purpose of Action	LEVEL 2
Deficiency Photo1

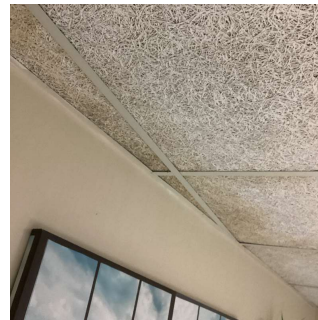
Facade B - Room 112 Assistant Principal

BRICK: WATER INFILTRATION IN INSTRUCTIONAL SPACE

100

REPAIR

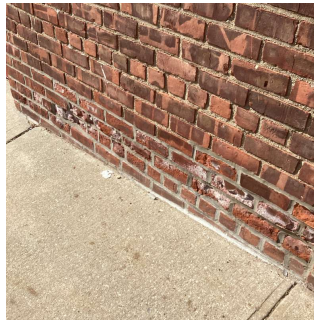
Facade D

BRICK: MINOR CRACKS AND SPALLING

30

RESTITCH

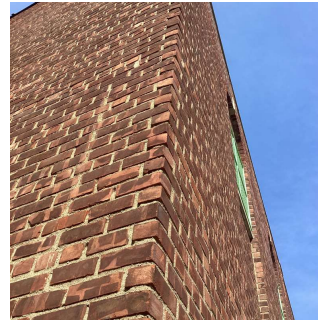
Facade D

BRICK: DETERIORATED JOINTS

300

REPOINT

PRIORITY 4
LEVEL 2

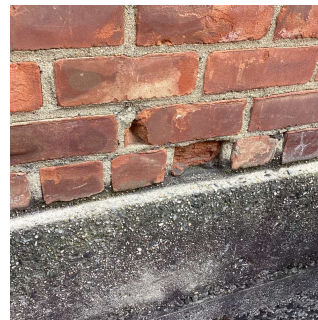
Facade D

BRICK: MAJOR / THRU CRACKS

20

REMOVE AND REBUILD

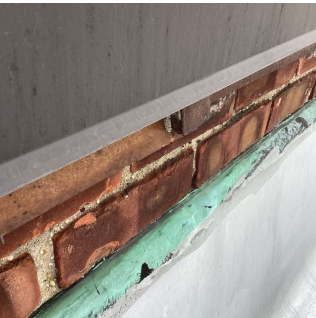
Question	Response
EXTERIOR	
PARAPETS	
Instance Condition	3 - Fair
Instance Quantity	3,500
Instance Quantity Uom	C.F.
Deficiency	BRICK: DETERIORATED JOINTS
Roof Plan reference

Deficiency Quantity	100
Quantity Uom	S.F.
Potential Action	REPOINT
Urgency of Action	PRIORITY 3
Purpose of Action	LEVEL 2
Deficiency Photo1

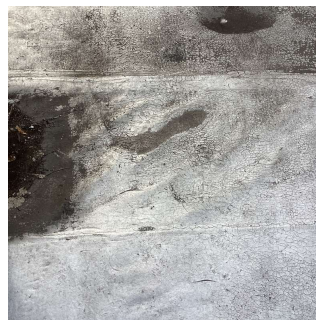
Roof 1

Deficiency	MODIFIED BITUMEN: ROOFING: DELAMINATION
------------	---

Deficiency Quantity	30
---------------------	----

Potential Action	REPLACE ROOFING WITHOUT MAJOR EQUIPMENT REMOVAL
------------------	---

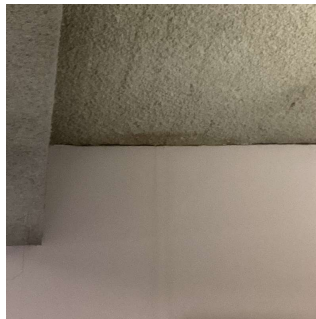
Roof 1 - Room 211
 No violations recorded.

Deficiency	MODIFIED BITUMEN: ROOFING: MAJOR ACTIVE ROOF LEAKS IN INSTRUCTIONAL SPACE
------------	---

100
 S.F.
 REPLACE ROOFING WITHOUT MAJOR EQUIPMENT
 REMOVAL
 PRIORITY 5
 LEVEL 2

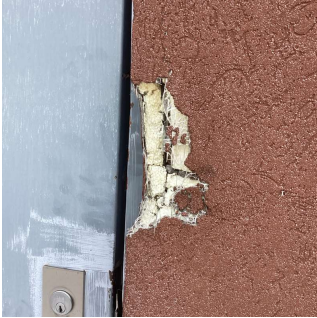
BULKHEAD/PENTHOUSE WALLS/EXTERIOR:
 CRACKS/SPALLING - MAJOR

10
 S.F.

Question	Response
EXTERIOR	
ROOF	
Specialties	
BULKHEAD/PENTHOUSE	
Potential Action	REPLACE
Urgency of Action	PRIORITY 4
Purpose of Action	LEVEL 2
Deficiency Photo1

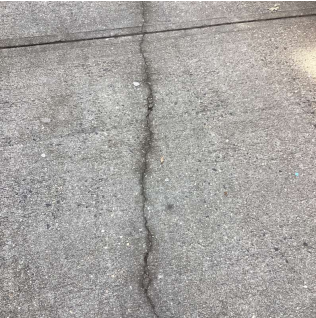
Question	Response
EXTERIOR	
STAIRS/RAMPS: EXTERIOR	
STAIRS/RAMPS	
Condition	3 - Fair
Deficiency	CONCRETE: CRACKS/SPALLING - MINOR
Roof Plan reference	<p>Q866</p>

Deficiency Quantity	30
Quantity Uom	S.F.
Potential Action	REPAIR
Urgency of Action	PRIORITY 3
Purpose of Action	LEVEL 2
Deficiency Photo1

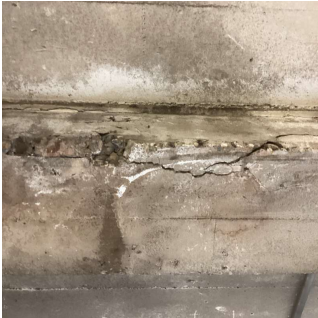
Question	Response
INTERIOR	Inspected
POOLS	Does not Exist
STRUCTURAL	Inspected
COLUMNS/BEAMS/BEARING WALLS	Inspected
Condition	3 - Fair
Deficiency	CONCRETE COLUMNS/BEAMS: CRACKED/SPALLED/REINFORCEMENT EXPOSED
Deficiency Location/Instance	Basement - Electrical Panel Room
Deficiency Quantity	10
Quantity Uom	S.F.
Potential Action	REPAIR
Urgency of Action	PRIORITY 3
Purpose of Action	LEVEL 5
Deficiency Photo1

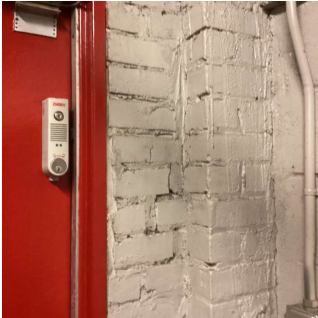
Violations	Basement - Electrical Panel Room No violations recorded.
Deficiency	MASONRY BEARING WALL: DETERIORATED JOINTS
Deficiency Location/Instance	1st Floor - Ground Equipment Room
Deficiency Quantity	20
Quantity Uom	S.F.
Potential Action	REPOINT
Urgency of Action	PRIORITY 3
Purpose of Action	LEVEL 5
Deficiency Photo1

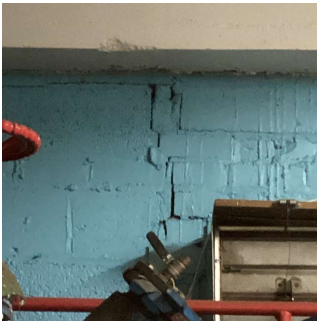
Violations	1st Floor- Ground Equipment Room No violations recorded.
Deficiency	MASONRY BEARING WALL: CRACKED/SPALLED
Deficiency Location/Instance	1st Floor - Mechanical Room
Deficiency Quantity	10

Quantity Uom	S.F.
Potential Action	RESTITCH
Urgency of Action	PRIORITY 3
Purpose of Action	LEVEL 5

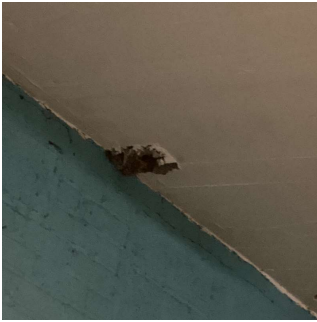
Violations	1st Floor - Mechanical Room No violations recorded.
FLOOR STRUCTURE	Inspected
Condition	2 - Between Good and Fair
Deficiency	CONCRETE: CRACKS/SPALLED/REINFORCEMENT EXPOSED
Deficiency Location/Instance	1st Floor - Mechanical Room, Storage
Deficiency Quantity	20
Quantity Uom	S.F.
Potential Action	REPAIR
Urgency of Action	PRIORITY 3
Purpose of Action	LEVEL 5
Deficiency Photo1

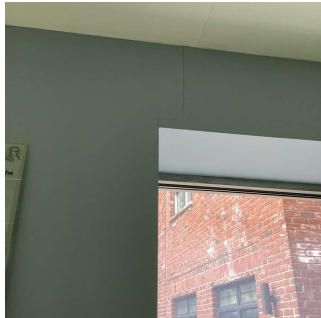
Question	Response
INTERIOR	
CAFETERIA	
Floor Finish	
Condition	2 - Between Good and Fair
Deficiency	No deficiencies recorded
Sliding-folding Partition	
Instance on 1st Floor	Inspected
Condition	2 - Between Good and Fair
Deficiency	No deficiencies recorded
Stage	
Instance on 1st Floor	Does not Exist
Walls	
Instance on 1st Floor	Inspected
Condition	2 - Between Good and Fair
Deficiency	GYPSUM BOARD: DETERIORATED
Deficiency Location/Instance	Near Windows
Deficiency Quantity	10
Quantity Uom	S.F.
Potential Action	REPLACE
Urgency of Action	PRIORITY 3
Purpose of Action	LEVEL 2
Deficiency Photo1

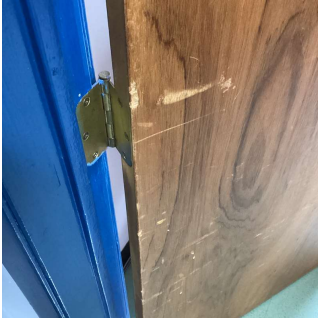
Question	Response
INTERIOR	
CLASSROOMS/CORRIDORS/ADMIN SPACES	
Door(s)	Inspected
Condition	3 - Fair
Deficiency	WOOD: DETERIORATED DOOR
Deficiency Location/Instance	Room 215
Deficiency Quantity	1
Quantity Uom	EACH
Potential Action	MAINTENANCE
Urgency of Action	PRIORITY 3
Purpose of Action	LEVEL 2
Deficiency Photo1

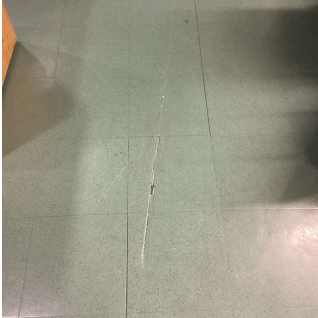
Room 215
Violations	No violations recorded.
Floor Finish	Inspected
Condition	2 - Between Good and Fair
Deficiency	VINYL TILES: BROKEN/DETERIORATED/MISSING TILES
Deficiency Location/Instance	Rooms 200, 210, 214, Corridor near Room 209
Deficiency Quantity	80
Quantity Uom	S.F.
Potential Action	REPLACE
Urgency of Action	PRIORITY 3
Purpose of Action	LEVEL 2
Deficiency Photo1

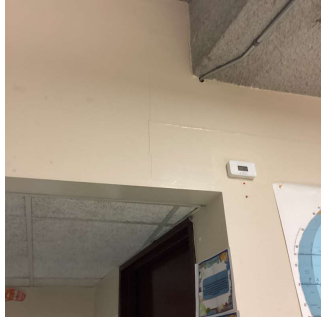
Room 210
Violations	No violations recorded.
Walls	Inspected
Condition	2 - Between Good and Fair
Deficiency	GYPSUM BOARD: DETERIORATED
Deficiency Location/Instance	Rooms 111, 211, Corridor near Cafeteria, Rooms 206, 208, and others.

Deficiency Quantity	300
Quantity Uom	S.F.
Potential Action	REPLACE
Urgency of Action	PRIORITY 3

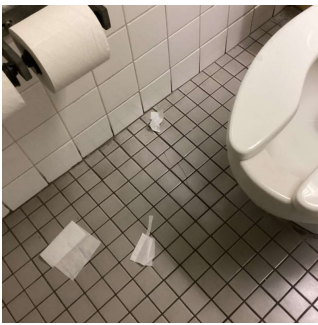
Question	Response
INTERIOR	
TOILET ROOMS - STAFF	
Ceiling	Inspected
Deficiency	No deficiencies recorded
Door(s)	Inspected
Condition	2 - Between Good and Fair
Deficiency	No deficiencies recorded
Floor Finish	Inspected
Condition	2 - Between Good and Fair
Deficiency	No deficiencies recorded
Stalls	Does not Exist
Walls	Inspected
Condition	2 - Between Good and Fair
Deficiency	No deficiencies recorded
TOILET ROOMS - STUDENTS	
Ceiling	Inspected
Condition	2 - Between Good and Fair
Deficiency	No deficiencies recorded
Door(s)	Inspected
Condition	2 - Between Good and Fair
Deficiency	No deficiencies recorded
Floor Finish	Inspected
Condition	2 - Between Good and Fair
Deficiency	CERAMIC TILE: BROKEN/MISSING TILES
Deficiency Location/Instance	Room 211
Deficiency Quantity	10
Quantity Uom	S.F.
Potential Action	REPLACE
Urgency of Action	PRIORITY 3
Purpose of Action	LEVEL 2
Deficiency Photo1

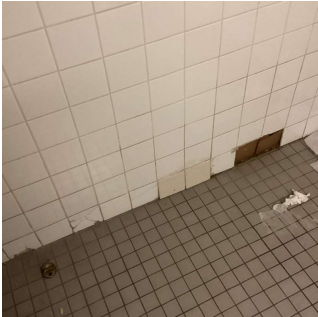
Stalls	Does not Exist
Walls	Inspected
Condition	2 - Between Good and Fair
Deficiency	CERAMIC TILE: BROKEN/ MISSING
Deficiency Location/Instance	Room 109A
Deficiency Quantity	10
Quantity Uom	S.F.
Potential Action	REPLACE
Urgency of Action	PRIORITY 3

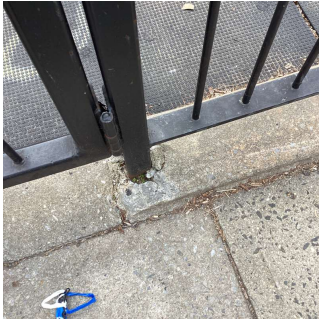
Violations	Room 109A No violations recorded.
LIFE SAFETY	Inspected
F.D. HOLDING AREA	Does not Exist
STEEL STAIRS	Does not Exist
SITE	Inspected
CONTAINERIZATION	Does not Exist
Drainage System for Asphalt	Does not Exist
Drainage System for Concrete	Inspected
Catch Basins/Manhole - Surrounded by concrete	Inspected
Condition	2 - Between Good and Fair
Deficiency	No deficiencies recorded
Culverts - Concrete Covering	Does not Exist
Drainage System for Soil	Inspected
Catch Basins/Manhole - Surrounded by Soil	Inspected
Condition	2 - Between Good and Fair
Deficiency	No deficiencies recorded
Culverts - Soil Covering	Does not Exist
DRINKING FOUNTAINS	Does not Exist
FENCES	Inspected
Condition	2 - Between Good and Fair
Deficiency	CONCRETE CURB: DAMAGED/DETERIORATED
Deficiency Location/Instance	Kew Gardens Road, Lefferts Boulevard

Deficiency Quantity	20
Quantity Uom	S.F.
Potential Action	REPLACE
Urgency of Action	PRIORITY 3
Purpose of Action	LEVEL 2

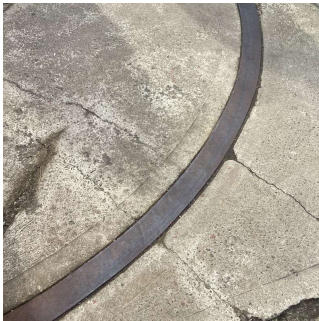
Violations	Kew Gardens Road No violations recorded.
IRRIGATION SYSTEM	Does not Exist
PAVING	Inspected
Student Non-Use	Does not Exist
Student Use	Does not Exist
Site Sidewalks & Walkways	Inspected
Asphalt	Does not Exist
Concrete	Inspected
Condition	3 - Fair
Deficiency	DAMAGED/DETERIORATED/MISSING SECTIONS
Deficiency Location/Instance	Near Stairs Main Entrance
Deficiency Quantity	125
Quantity Uom	S.F.
Potential Action	REPLACE
Urgency of Action	PRIORITY 3
Purpose of Action	LEVEL 2
Deficiency Photo1

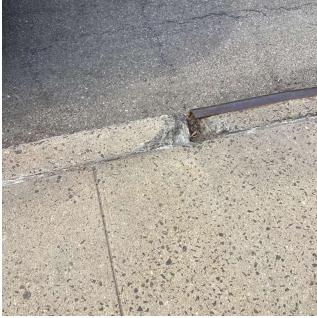
Violations	Near Stairs Main Entrance No violations recorded.
Pavers	Does not Exist
DOT Sidewalk	Inspected
Asphalt	Does not Exist
Concrete	Inspected
Condition	4 - Between Fair and Poor
Deficiency	DAMAGED CURBS
Deficiency Location/Instance	Lefferts Boulevard, Kew Gardens Road, 83rd Drive
Deficiency Quantity	150
Quantity Uom	L.F.
Potential Action	REPLACE

Question	Response
SITE	
PAVING	
DOT Sidewalk	
Concrete	
Urgency of Action	PRIORITY 3
Purpose of Action	LEVEL 2
Deficiency Photo1

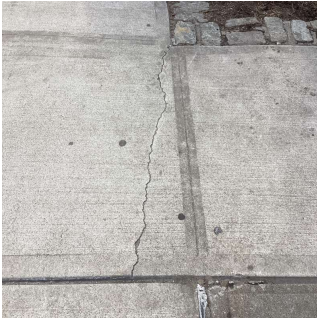
Lefferts Boulevard
Violations	No violations recorded.
Deficiency	DAMAGED/DETERIORATED/MISSING SECTIONS
Deficiency Location/Instance	Lefferts Boulevard, Kew Gardens Road, 83rd Drive
Deficiency Quantity	400
Quantity Uom	S.F.
Potential Action	REPLACE
Urgency of Action	PRIORITY 3
Purpose of Action	LEVEL 2
Deficiency Photo1

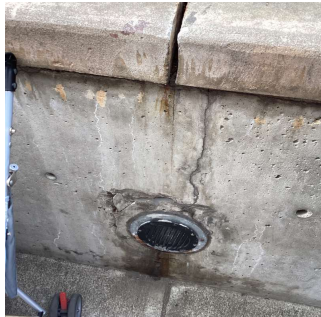
Question	Response
SITE	
PLAYGROUNDS	
Play Equipment	
Condition	2 - Between Good and Fair
Deficiency	No deficiencies recorded
Safety Surfacing	
Instance on Along Kew Gardens Road	Inspected
Condition	2 - Between Good and Fair
Deficiency	No deficiencies recorded
Unpaved Area	
Instance on Along Kew Gardens Road	Does not Exist
PLAYING SURFACE	Does not Exist
RETAINING WALLS	Inspected
Are there any Retaining Walls 6' OR higher facing public street/sidewalk?	No
Condition	2 - Between Good and Fair
Deficiency	CAST IN PLACE CONCRETE: CRACKS/SPALLING - MAJOR
Deficiency Location/Instance	Near Main Entrance
Deficiency Quantity	10
Quantity Uom	S.F.
Potential Action	REPLACE
Urgency of Action	PRIORITY 3
Purpose of Action	LEVEL 2
Deficiency Photo1
