**NYC Department of Education**  
**Building Condition Assessment Survey 2023 - 2024**

Architectural Inspection

Q868

**Asset:** P.S. 78 - QUEENS, 48-09 CENTER BLVD., New York, 11109

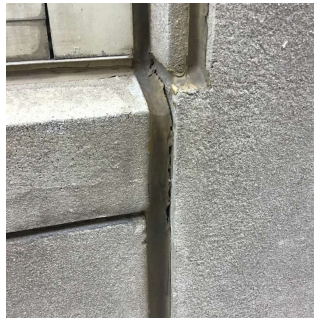
Facade C

Question	Response
<b>Architectural</b>	
<b>EXTERIOR</b>	Inspected
<b>AREAWAY</b>	Does not Exist
<b>AWNINGS AND CANOPIES</b>	Does not Exist
<b>CHIMNEY</b>	Not Required
<b>COPING</b>	Not Required
<b>CORNICE</b>	Does not Exist
<b>DOORS</b>	Inspected
<b>DOORS AND FRAMES</b>	Inspected
Condition	2 - Between Good and Fair
Deficiency	No deficiencies recorded
<b>DOOR HARDWARE</b>	Inspected
Condition	3 - Fair
Deficiency	No deficiencies recorded
<b>LINTELS</b>	Inspected
Condition	2 - Between Good and Fair
Deficiency	No deficiencies recorded
<b>TRANSOM/SIDE LIGHT</b>	Inspected
Condition	2 - Between Good and Fair
Deficiency	No deficiencies recorded
<b>EXTERIOR WALLS</b>	Inspected
Material Type(s)	Concrete, Masonry
Replacement Quantity	10,000
Replacement Uom	S.F.
Instance on All Facades	Inspected
Instance Condition	3 - Fair
Instance Quantity	10,000
Instance Quantity Uom	S.F.
Deficiency	CAST IN PLACE / PRE-CAST CONCRETE: DETERIORATED CONTROL/EXPANSION JOINTS

Deficiency Quantity

100

L.F.

MAINTENANCE

PRIORITY 3

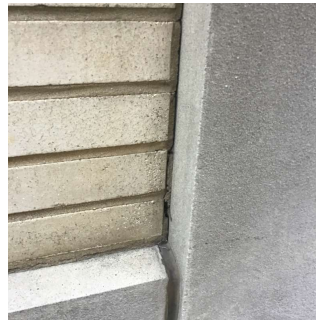
Facade C

CAST IN PLACE / PRE-CAST CONCRETE: DETERIORATED JOINTS

20

L.F.

REPOINT

PRIORITY 3

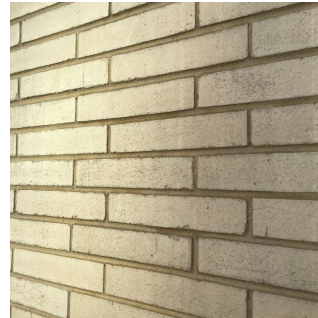
Facade B

BRICK: DETERIORATED JOINTS

80

S.F.

REPOINT

PRIORITY 3  
LEVEL 2

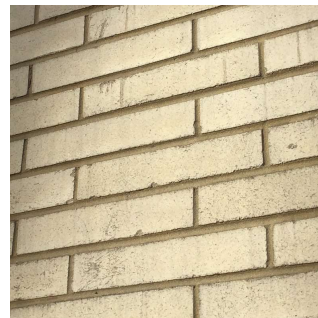
Facade B

**BRICK: MINOR CRACKS AND SPALLING**

40

S.F.

RESTITCH

PRIORITY 3

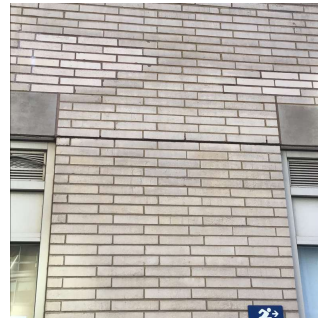
Facade B

BRICK: RELIEVING ANGLES - MINOR DETERIORATION

40

L.F.

MAINTENANCE

PRIORITY 3

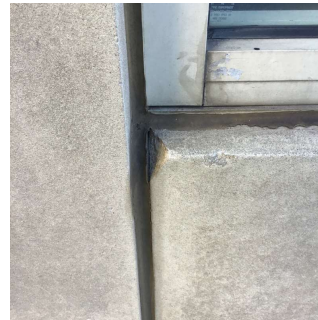
Facade B

CAST IN PLACE / PRE-CAST CONCRETE: MINOR  
CRACKS/SPALLING

20

S.F.

REPAIR

PRIORITY 3

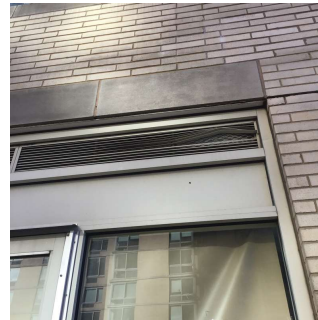
BROKEN/ DENTED BLADES

Facade B  
 No violations recorded.

20  
 S.F.  
 REPLACE  
 PRIORITY 4  
 LEVEL 2

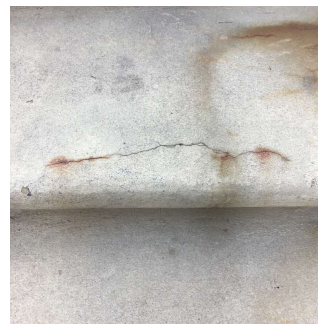
Facade A

<b>PARAPETS</b>	Not Required
<b>PLAZA DECK</b>	Not Required
<b>ROOF</b>	Not Required
<b>STAIRS/RAMPS: EXTERIOR</b>	Inspected
<b>BUILDING CHEEK/FLANK WALLS</b>	Inspected
Condition	2 - Between Good and Fair
Deficiency	No deficiencies recorded
<b>RAILINGS</b>	Inspected
Condition	2 - Between Good and Fair
Deficiency	No deficiencies recorded
<b>STAIRS/RAMPS</b>	Inspected
Condition	4 - Between Fair and Poor
Deficiency	STONE: CRACKS/SPALLING - MINOR

30  
S.F.  
REPAIR  
PRIORITY 3  
LEVEL 2

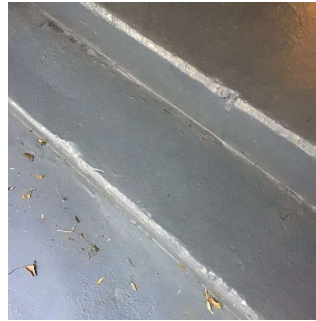
Facade C

CONCRETE: WORN-OUT TREAD/RISER/NOSING

10  
S.F.  
REPLACE  
PRIORITY 4  
LEVEL 2

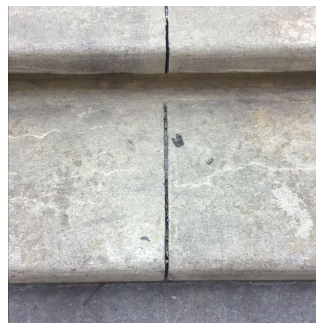
Facade A

**STONE: DETERIORATED JOINTS**

10

L.F.

REPOINT

PRIORITY 4

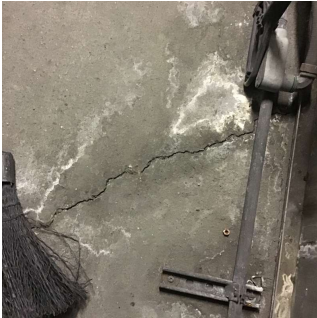
Question	Response
<b>EXTERIOR</b>	
<b>WINDOWS</b>	
<b>WINDOWS</b>	
Instance on Aluminum - Other: All Facades	Inspected
Instance Condition	3 - Fair
Instance Quantity	3,400
Instance Quantity Uom	S.F.
Are these windows insulated	Yes
Installation Year	1996
Source of Installation	Custodial Staff
Deficiency	No deficiencies recorded
<b>INTERIOR</b>	Inspected
<b>POOLS</b>	Does not Exist
<b>STRUCTURAL</b>	Inspected
<b>COLUMNS/BEAMS/BEARING WALLS</b>	Inspected
Condition	2 - Between Good and Fair
Deficiency	No deficiencies recorded
<b>FLOOR STRUCTURE</b>	Inspected
Condition	3 - Fair
Deficiency	CONCRETE: CRACKS/SPALLED/REINFORCEMENT EXPOSED
Deficiency Location/Instance	Rooms 118, 129A, 216-A, Garage Mechanical Equipment Room
Deficiency Quantity	120
Quantity Uom	S.F.
Potential Action	REPAIR
Urgency of Action	PRIORITY 3
Purpose of Action	LEVEL 5
Deficiency Photo1

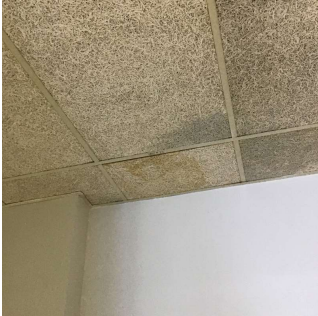
Question	Response
<b>INTERIOR</b>	
<b>CAFETERIA</b>	
<b>Walls</b>	
Deficiency	GYP SUM BOARD: DETERIORATED
Deficiency Location/Instance	Near Entrance
Deficiency Quantity	10
Quantity Uom	S.F.
Potential Action	REPLACE
Urgency of Action	PRIORITY 3
Purpose of Action	LEVEL 2
Deficiency Photo1	 
	Near Entrance
Violations	No violations recorded.
Deficiency	WALL PADDING: DETERIORATED
Deficiency Location/Instance	Near Kitchen, Left and Right Side, Rear, Columns
Deficiency Quantity	240
Quantity Uom	S.F.
Potential Action	REPLACE
Urgency of Action	PRIORITY 3
Purpose of Action	LEVEL 2
Deficiency Photo1	 
	Near Kitchen
Violations	No violations recorded.
<b>Window Curtains/Shades/Blinds</b>	
Instance on 2nd Floor - Staff (500 SF)	Does not Exist
Instance on 2nd Floor - Students (1200 SF)	Does not Exist
<b>CLASSROOMS/CORRIDORS/ADMIN SPACES</b>	
<b>Ceiling</b>	Inspected
Condition	2 - Between Good and Fair
Deficiency	TECTUM: DAMAGED/MISSING

Deficiency Location/Instance	Room 115, Corridor near Rooms 209, 129, 118, 113 and others
Deficiency Quantity	80
Quantity Uom	S.F.
Potential Action	REPLACE

Room 115
Violations	No violations recorded.
<b>Door(s)</b>	Inspected
Condition	2 - Between Good and Fair
Deficiency	No deficiencies recorded
<b>Floor Finish</b>	Inspected
Condition	2 - Between Good and Fair
Deficiency	VINYL TILES: BROKEN/DETERIORATED/MISSING TILES
Deficiency Location/Instance	Main Entrance Lobby, Corridor near Room 223
Deficiency Quantity	20
Quantity Uom	S.F.
Potential Action	REPLACE
Urgency of Action	PRIORITY 3
Purpose of Action	LEVEL 2
Deficiency Photo1

Question	Response
<b>INTERIOR</b>	
<b>CLASSROOMS/CORRIDORS/ADMIN SPACES</b>	
<b>Ceiling</b>	
Urgency of Action	PRIORITY 3
Purpose of Action	LEVEL 2
Deficiency Photo1

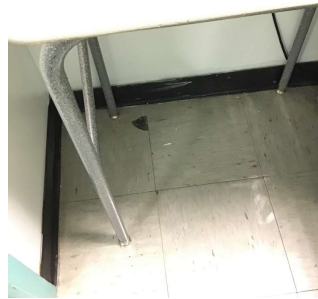
Room 218B  
No violations recorded.

Instance on 2nd Floor	Inspected
Condition	2 - Between Good and Fair
Deficiency	VINYL TILES: BROKEN/DETERIORATED/MISSING TILES
Deficiency Location/Instance	Room 218B
Deficiency Quantity	10
Quantity Uom	S.F.
Potential Action	REPLACE
Urgency of Action	PRIORITY 3
Purpose of Action	LEVEL 2
Deficiency Photo1

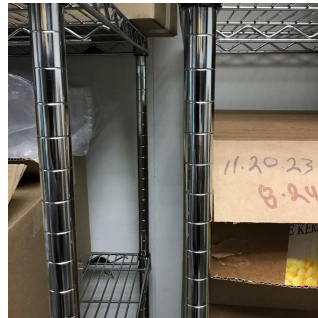
Room 218C  
No violations recorded.

Instance on 2nd Floor	Inspected
Condition	2 - Between Good and Fair
Deficiency	GYPSUM BOARD: DETERIORATED
Deficiency Location/Instance	Room 218C
Deficiency Quantity	10
Quantity Uom	S.F.
Potential Action	REPLACE
Urgency of Action	PRIORITY 3
Purpose of Action	LEVEL 2
Deficiency Photo1

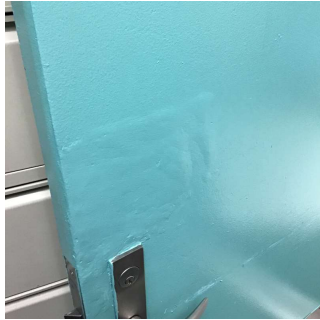
Question	Response
<b>INTERIOR</b>	
<b>LIBRARY</b>	
<b>Ceiling</b>	
Condition	2 - Between Good and Fair
Deficiency	No deficiencies recorded
<b>Door(s)</b>	
Instance on Room 210 (600 SF)	Inspected
Condition	3 - Fair
Deficiency	METAL: DETERIORATED DOOR
Deficiency Location/Instance	Main Entrance
Deficiency Quantity	1
Quantity Uom	EACH
Potential Action	MAINTENANCE
Urgency of Action	PRIORITY 3
Purpose of Action	LEVEL 2
Deficiency Photo1

Violations	Main Entrance No violations recorded.
<b>Floor Finish</b>	
Instance on Room 210 (600 SF)	Inspected
Condition	3 - Fair
Deficiency	CARPET: WORN/DETERIORATED
Deficiency Location/Instance	Center, Right Side
Deficiency Quantity	40
Quantity Uom	S.F.
Potential Action	REPLACE
Urgency of Action	PRIORITY 3
Purpose of Action	LEVEL 2
Deficiency Photo1

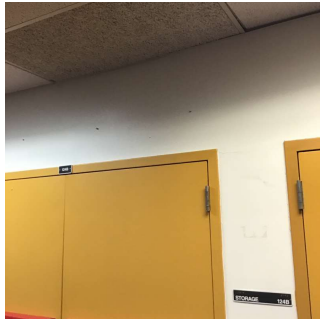
Question	Response
<b>INTERIOR</b>	
<b>MULTI-PURPOSE ROOM</b>	
<b>Fixed Equipment</b>	
Instance on 1st Floor (1200 SF)	Does not Exist
<b>Floor Finish</b>	
Instance on 1st Floor (1200 SF)	Inspected
Condition	2 - Between Good and Fair
Deficiency	No deficiencies recorded
<b>Sliding-folding Partition</b>	
Instance on 1st Floor (1200 SF)	Does not Exist
<b>Stage</b>	
Instance on 1st Floor (1200 SF)	Does not Exist
<b>Walls</b>	
Instance on 1st Floor (1200 SF)	Inspected
Condition	2 - Between Good and Fair
Deficiency	GYPSUM BOARD: DETERIORATED
Deficiency Location/Instance	Near Closets
Deficiency Quantity	10
Quantity Uom	S.F.
Potential Action	REPLACE
Urgency of Action	PRIORITY 3
Purpose of Action	LEVEL 2
Deficiency Photo1

Violations	Near Closets No violations recorded.
<b>Window Curtains/Shades/Blinds</b>	
Instance on 1st Floor (1200 SF)	Does not Exist
<b>SCIENCE DEMO ROOM</b>	Does not Exist
<b>SCIENCE LAB</b>	Does not Exist

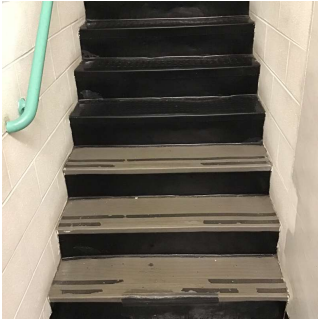
Question	Response
<b>INTERIOR</b>	
<b>STAIRS/RAMPS: INTERIOR</b>	
<b>Railings</b>	Inspected
Condition	2 - Between Good and Fair
Deficiency	No deficiencies recorded
<b>Stairs and Landings</b>	Inspected
Condition	3 - Fair
Deficiency	SHEET VINYL: WORN-OUT TREAD/NOSINGS
Deficiency Location/Instance	Stair D/1
Deficiency Quantity	20
Quantity Uom	S.F.
Potential Action	REPLACE
Urgency of Action	PRIORITY 3
Purpose of Action	LEVEL 2
Deficiency Photo1

Violations	Stair D/1 No violations recorded.
Deficiency	VINYL TILES: BROKEN/DETERIORATED/MISSING TILES
Deficiency Location/Instance	Stair D/2
Deficiency Quantity	10
Quantity Uom	S.F.
Potential Action	REPLACE
Urgency of Action	PRIORITY 3
Purpose of Action	LEVEL 2
Deficiency Photo1

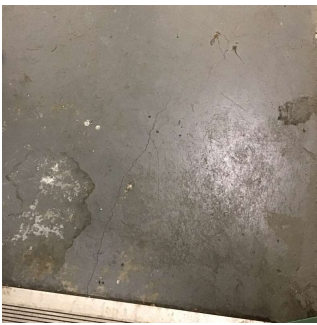
Violations	Stair D/2 No violations recorded.
Deficiency	CONCRETE: CRACKS/SPALLING - MAJOR
Deficiency Location/Instance	Stair A/2, 1
Deficiency Quantity	50
Quantity Uom	S.F.
Potential Action	REPLACE

Question	Response
<b>INTERIOR</b>	
<b>STAIRS/RAMPS: INTERIOR</b>	
<b>Stairs and Landings</b>	Inspected
Deficiency Photo1

Violations	Stair A/2 No violations recorded.
<b>Walls</b>	Inspected
Condition	2 - Between Good and Fair
Deficiency	No deficiencies recorded
<b>TOILET ROOMS - STAFF</b>	
<b>Ceiling</b>	Inspected
Condition	2 - Between Good and Fair
Deficiency	No deficiencies recorded
<b>Door(s)</b>	Inspected
Condition	2 - Between Good and Fair
Deficiency	No deficiencies recorded
<b>Floor Finish</b>	Inspected
Condition	3 - Fair
Deficiency	CERAMIC TILE: BROKEN/MISSING TILES
Deficiency Location/Instance	Room 119
Deficiency Quantity	10
Quantity Uom	S.F.
Potential Action	REPLACE
Urgency of Action	PRIORITY 3
Purpose of Action	LEVEL 2
Deficiency Photo1	 
Violations	Room 119 No violations recorded.
<b>Stalls</b>	Does not Exist
<b>Walls</b>	Inspected
Condition	2 - Between Good and Fair
Deficiency	No deficiencies recorded
<b>TOILET ROOMS - STUDENTS</b>

Urgency of Action	PRIORITY 3
Purpose of Action	LEVEL 2

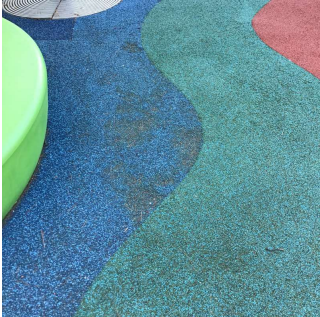
Question	Response
<b>SITE</b>	
<b>PLAYGROUNDS</b>	
<b>Pavement</b>	
Instance on Along Center Boulevard	Does not Exist
<b>Play Equipment</b>	
Instance on Along Center Boulevard	Inspected
Condition	2 - Between Good and Fair
Deficiency	No deficiencies recorded
<b>Safety Surfacing</b>	
Instance on Along Center Boulevard	Inspected
Condition	3 - Fair
Deficiency	DETERIORATED/MISSING
Deficiency Location/Instance	Near Benches, Right Side, Near Entrance
Deficiency Quantity	30
Quantity Uom	S.F.
Potential Action	REPLACE
Urgency of Action	PRIORITY 3
Purpose of Action	LEVEL 2
Deficiency Photo1

Violations	Near Benches No violations recorded.
Deficiency	DETERIORATED/MISSING
Deficiency Location/Instance	Left Side Near tree pits, tree pit near Bench
Deficiency Quantity	20
Quantity Uom	S.F.
Potential Action	REPLACE
Urgency of Action	PRIORITY 5
Purpose of Action	LEVEL 6
Deficiency Photo1

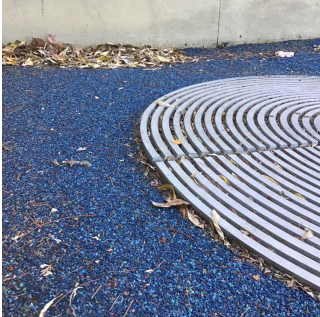
Violations	Left Side Near tree pits No violations recorded.

Priority Condition Exist Last Year?	Priority Category	Condition Description	Component Affected	Location Description	Person(s) Notified	Person(s) Title	PhotoImage
Yes	Protruding Elements	Severely sinking safety surfacing with protruding elements around tree pits is a potential tripping hazard.	SITE   PLAYGROUNDS   Safety Surfacing	Left Side Near tree pits, Near Bench	Kevin Golero	Handyman

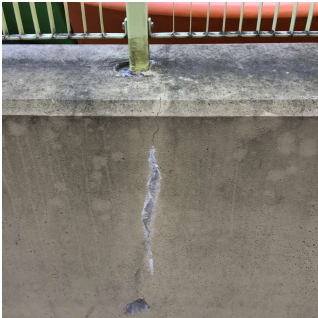
Question	Response
<b>SITE</b>	
<b>RETAINING WALLS</b>	Inspected
Are there any Retaining Walls 6' OR higher facing public street/sidewalk?	No
Condition	2 - Between Good and Fair
Deficiency	CAST IN PLACE CONCRETE: CRACKS/SPALLING - MAJOR
Deficiency Location/Instance	49th Avenue, Schoolyard
Deficiency Quantity	20
Quantity Uom	S.F.
Potential Action	REPLACE
Urgency of Action	PRIORITY 3
Purpose of Action	LEVEL 2
Deficiency Photo1

49th Avenue
Violations	No violations recorded.
<b>SEATING</b>	Does not Exist
<b>SITE WALLS (NOT RETAINING WALLS)</b>	Does not Exist
<b>STAIRS/RAMPS: EXTERIOR</b>	Inspected
<b>Railings</b>	Inspected
Condition	2 - Between Good and Fair
Deficiency	No deficiencies recorded
<b>Site Cheek/flank Walls</b>	Inspected
Condition	2 - Between Good and Fair
Deficiency	No deficiencies recorded
<b>Stairs/ramps</b>	Inspected
Condition	2 - Between Good and Fair
Deficiency	No deficiencies recorded
<b>ARTWORK</b>	Does not Exist
