**NYC Department of Education**  
**Building Condition Assessment Survey 2023 - 2024**

Architectural Inspection

**Asset:** P.S. 69 PORTABLE - QUEENS, 77-02 37TH AVENUE, New York, 11372

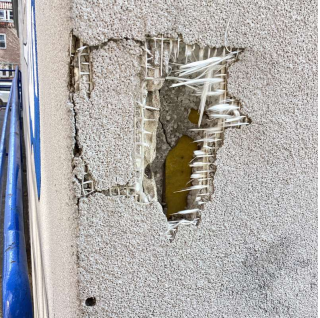
Question	Response
<b>EXTERIOR</b>	
<b>EXTERIOR WALLS</b>	
Replacement Quantity	3,000
Replacement Uom	S.F.
Instance on All Facades	Inspected
Instance Condition	4 - Between Fair and Poor
Instance Quantity	3,000
Instance Quantity Uom	S.F.
Deficiency	STUCCO CEMENT SURFACE: CRACKS, SPALLING
Roof Plan reference	<p><b>Q869</b></p>

Deficiency Quantity	60
Quantity Uom	S.F.
Potential Action	REPLACE
Urgency of Action	PRIORITY 4
Purpose of Action	LEVEL 2
Deficiency Photo1

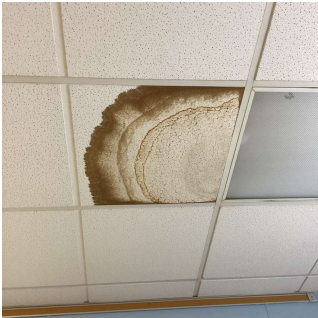
Deficiency	SINGLE PLY, FULLY ADHERED ROOF: ROOFING: MAJOR ACTIVE ROOF LEAKS IN INSTRUCTIONAL SPACE
Roof Plan reference	<b>Q869</b>

Deficiency Quantity	900
Quantity Uom	S.F.
Potential Action	REPLACE ROOFING WITHOUT MAJOR EQUIPMENT REMOVAL
Urgency of Action	PRIORITY 5
Purpose of Action	LEVEL 2

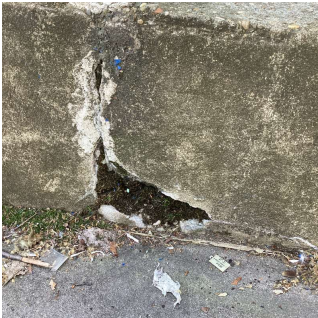
Violations	Facade A No violations recorded.

Violations	No violations recorded.
<b>ROOFING DRAINS</b>	Inspected
Condition	2 - Between Good and Fair
Deficiency	No deficiencies recorded
<b>Specialties</b>	Does not Exist
<b>STAIRS/RAMPS: EXTERIOR</b>	Inspected
<b>BUILDING CHEEK/FLANK WALLS</b>	Inspected
Condition	3 - Fair
Deficiency	CAST IN PLACE CONCRETE: CRACKS/SPALLING - MAJOR
Roof Plan reference	<b>Q869</b>

Deficiency Quantity	10
Quantity Uom	S.F.
Potential Action	REPLACE
Urgency of Action	PRIORITY 4
Purpose of Action	LEVEL 2
Deficiency Photo1

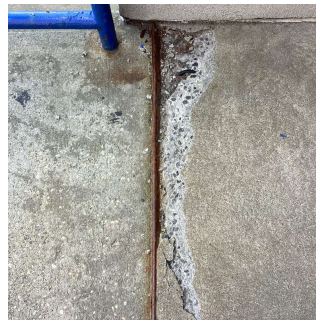
Facade A

4 - Between Fair and Poor

CONCRETE: CRACKS/SPALLING - MAJOR

20

REPLACE

PRIORITY 4

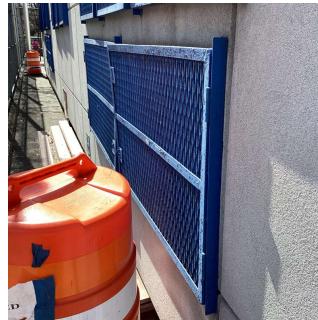
Facade B  
No violations recorded.

DETERIORATED/TORN-OUT/MISSING

10  
S.F.  
REPLACE  
PRIORITY 4  
LEVEL 2

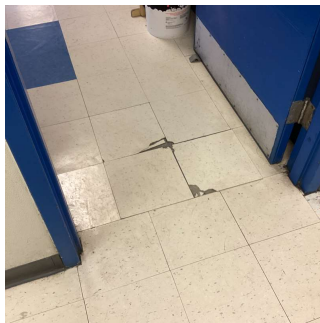
Question	Response
<b>INTERIOR</b>	
<b>CLASSROOMS/CORRIDORS/ADMIN SPACES</b>	
<b>Ceiling</b>	
Deficiency Quantity	100
Quantity Uom	S.F.
Potential Action	REPLACE
Urgency of Action	PRIORITY 5
Purpose of Action	LEVEL 2
Deficiency Photo1	 
	Room P01
Violations	No violations recorded.
<b>Door(s)</b>	Inspected
Condition	2 - Between Good and Fair
Deficiency	No deficiencies recorded
<b>Floor Finish</b>	Inspected
Condition	5 - Poor
Deficiency	VINYL TILES: DETERIORATED SUBSTRATE
Deficiency Location/Instance	Corridor near Room P04
Deficiency Quantity	10
Quantity Uom	S.F.
Potential Action	REPLACE
Urgency of Action	PRIORITY 3
Purpose of Action	LEVEL 2
Deficiency Photo1	 
	Corridor near Room P04
Violations	No violations recorded.
Deficiency	VINYL TILES: BROKEN/DETERIORATED/MISSING TILES
Deficiency Location/Instance	Rooms P01, P02, P03, P04, Corridor near Room P03 and others
Deficiency Quantity	600
Quantity Uom	S.F.
Potential Action	REPLACE

Urgency of Action	PRIORITY 3
Purpose of Action	LEVEL 2
