**NYC Department of Education**  
**Building Condition Assessment Survey 2023 - 2024**

Architectural Inspection

Q875

**Asset:** P.S. 233 MINISCHOOL2 (OLD P752)-Q, 114-43 142ND STREET, New York, 11436

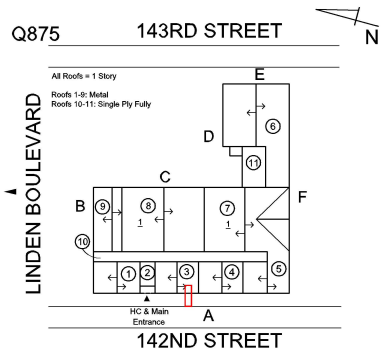
| Question | Response |
|---|--|
| Roof Plan reference | |

| Question | Response |
|---|--|
| Condition | 4 - Between Fair and Poor |
| Deficiency | METAL: DETERIORATED DOOR AND FRAME - MAJOR DETERIORATION |

| Deficiency Quantity | 2 |

| Potential Action | REPLACE |
| Urgency of Action | PRIORITY 4 |

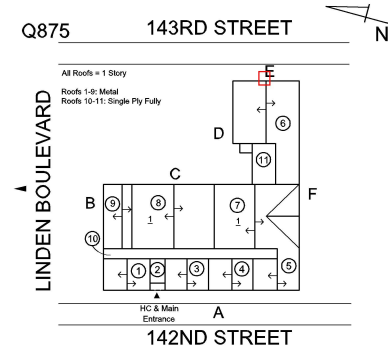
Roof Plan reference

**ROLL-UP DOOR: DETERIORATED DOOR AND FRAME - MINOR DETERIORATION**

60

MAINTENANCE

PRIORITY 3

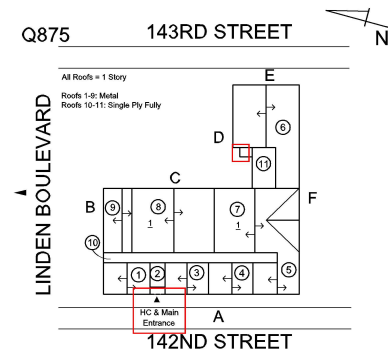
Roof Plan reference

**METAL: DETERIORATED DOOR - MINOR DETERIORATION**

2

MAINTENANCE

PRIORITY 3

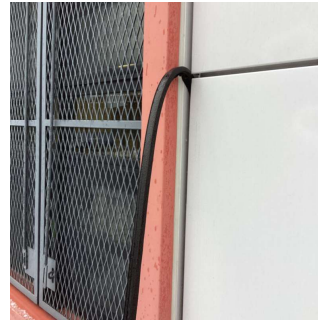
Facade F

| Question | Response |
|---|--|
| Deficiency | METAL/GLASS CURT WALL: DETERIORATED CONTROL/EXPANSION JOINTS |
| Deficiency Quantity | 20 |

| Question | Response |
|---|--|
| Potential Action | MAINTENANCE |
| Urgency of Action | PRIORITY 3 |

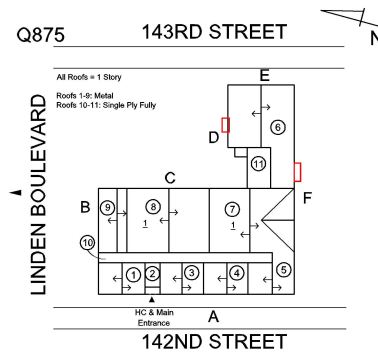
Roof Plan reference

4 - Between Fair and Poor

CLOGGED

2

MAINTENANCE

PRIORITY 5

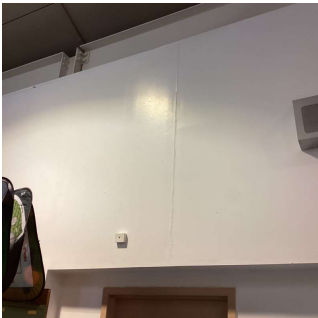
| Question | Response |
|--|--|
| Violations | Right Side<br>No violations recorded. |

| Question | Response |
|--|--|
| Condition | 2 - Between Good and Fair |
| Deficiency | GYPSON BOARD: DETERIORATED |
| Deficiency Location/Instance | Right Side, Center |

| Question | Response |
|--|--|
| Potential Action | REPLACE |
| Urgency of Action | PRIORITY 3 |

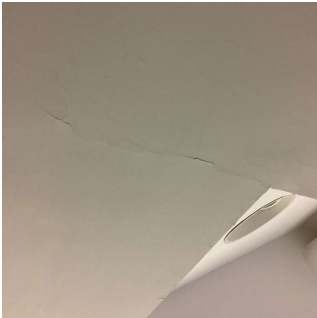
| Question | Response |
|--|--|
| Violations | Room 131<br>No violations recorded. |

| Question | Response |
|--|--|
| Condition | 2 - Between Good and Fair |
| Deficiency | GYPSON BOARD: DAMAGED/DETERIORATED |
| Deficiency Location/Instance | Rooms 123, 131, Corridor near Room 109 |

| Question | Response |
|--|--|
| Potential Action | REPLACE |
| Urgency of Action | PRIORITY 3 |

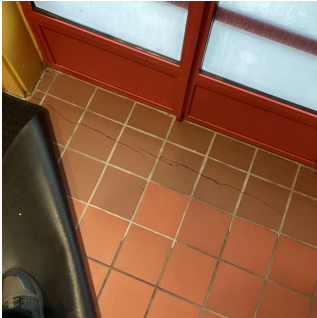
| Question | Response |
|--|--|
| Violations | Main Entrance Vestibule<br>No violations recorded. |

| Question | Response |
|--|--|
| Condition | 2 - Between Good and Fair |
| Deficiency | QUARRY TILE: DETERIORATED SUBSTRATE |
| Deficiency Location/Instance | Main Entrance Vestibule |

| Question | Response |
|--|--|
| Potential Action | REPLACE |
| Urgency of Action | PRIORITY 3 |

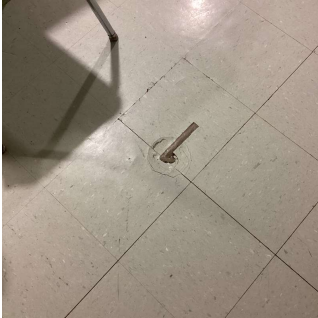
| Question | Response |
|--|--|
| | Room 131 |

| Question | Response |
|--|--|
| Deficiency | VINYL TILES: BROKEN/DETERIORATED/MISSING TILES |

| Question | Response |
|--|--|
| Deficiency Location/Instance | Rooms 114, 131 |

| Question | Response |
|--|--|
| Potential Action | REPLACE |
| Urgency of Action | PRIORITY 3 |

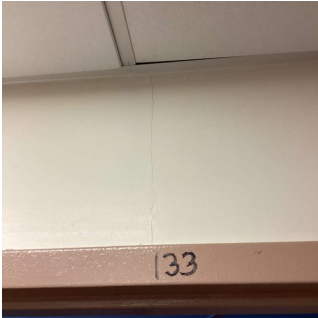
| Question | Response |
|--|--|
| | Room 131 |

| Question | Response |
|--|--|
| Condition | 2 - Between Good and Fair |
| Deficiency | GYPSUM BOARD: DETERIORATED |
| Deficiency Location/Instance | Rooms 118, 131, Corridor near Rooms 138, 146 |

| Question | Response |
|--|--|
| Potential Action | REPLACE |
| Urgency of Action | PRIORITY 3 |

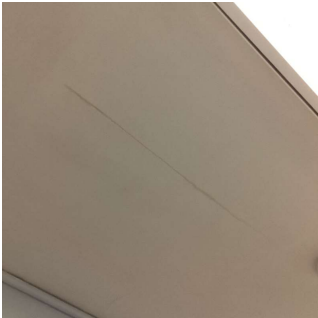
| Question | Response |
|---|--|
| | Room 136 |

| Question | Response |
|---|--|
| Condition | 2 - Between Good and Fair |
| Deficiency | GYP SUM BOARD: DAMAGED/DETERIORATED |
| Deficiency Location/Instance | Rooms 106, 136 |

| Question | Response |
|---|--|
| Potential Action | REPLACE |
| Urgency of Action | PRIORITY 3 |

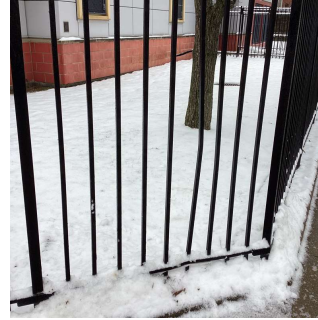
| Question | Response |
|--|--|
| Condition | 3 - Fair |
| Deficiency | WROUGHT IRON: DAMAGED/DETERIORATED |
| Deficiency Location/Instance | 142nd Street |

| Question | Response |
|--|--|
| Potential Action | REPLACE |

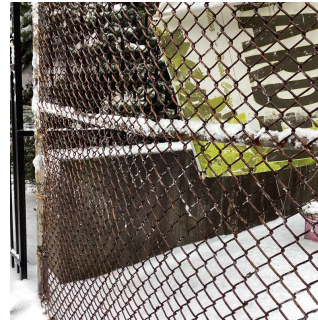
143rd Street

CHAIN LINK: DAMAGED POST/RAIL

REPLACE

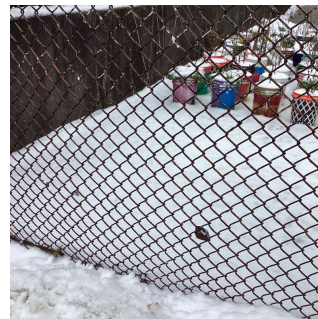
143rd Street

CHAIN LINK: RUST - MAJOR

REPLACE

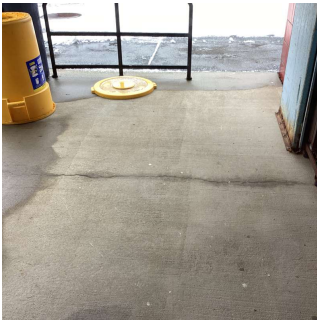
| Question | Response |
|---|--|
| Violations | Exit to Schoolyard<br>No violations recorded. |

| Question | Response |
|---|--|
| Condition | 2 - Between Good and Fair |
| Deficiency | DAMAGED/DETERIORATED/MISSING SECTIONS |
| Deficiency Location/Instance | Exit to Schoolyard |

| Question | Response |
|---|--|
| Potential Action | REPLACE |
| Urgency of Action | PRIORITY 3 |

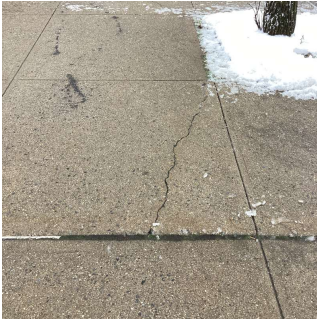
| Question | Response |
|---|--|
| Violations | 142nd Street<br>No violations recorded. |

| Question | Response |
|---|--|
| Condition | 3 - Fair |
| Deficiency | HEAVING |
| Deficiency Location/Instance | 142nd Street |

| Question | Response |
|---|--|
| Potential Action | REPLACE |
| Urgency of Action | PRIORITY 3 |

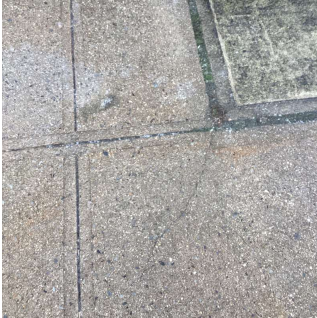
| Question | Response |
|---|--|
| Violations | 143rd Street<br>No violations recorded. |

| Question | Response |
|---|--|
| Deficiency | DAMAGED/DETERIORATED/MISSING SECTIONS |

| Question | Response |
|---|--|
| Deficiency Location/Instance | 143rd Street, 142nd Street |

| Question | Response |
|---|--|
| Potential Action | REPLACE |
| Urgency of Action | PRIORITY 3 |

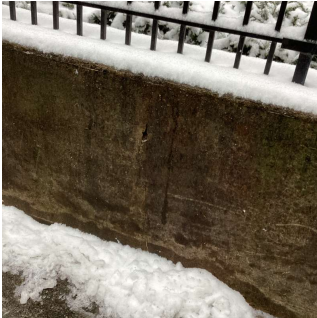
| Question | Response |
|---|--|
| Violations | Near Ramp<br>No violations recorded. |

| Question | Response |
|---|--|
| Condition | 3 - Fair |
| Deficiency | CAST IN PLACE CONCRETE: CRACKS/SPALLING - MAJOR |
| Deficiency Location/Instance | Near Parking Lot, Near Ramp |

| Question | Response |
|---|--|
| Potential Action | REPLACE |
| Urgency of Action | PRIORITY 3 |

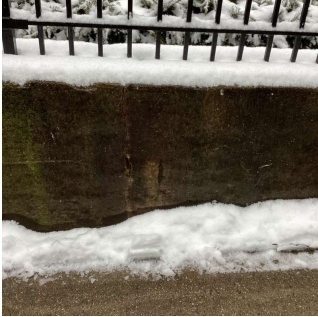
| Question | Response |
|---|--|
| Violations | Near Schoolyard<br>No violations recorded. |

| Question | Response |
|---|--|
| Condition | 2 - Between Good and Fair |
| Deficiency | CAST IN PLACE CONCRETE: CRACKS/SPALLING - MAJOR |
| Deficiency Location/Instance | Near Schoolyard |

| Question | Response |
|---|--|
| Potential Action | REPLACE |
| Urgency of Action | PRIORITY 3 |

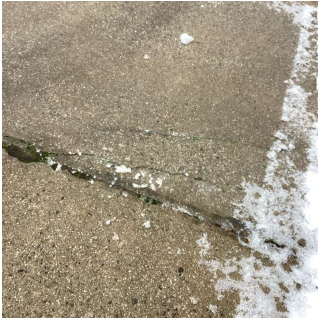
| Question | Response |
|---|--|
| Violations | Near Schoolyard<br>No violations recorded. |

| Question | Response |
|---|--|
| Condition | 2 - Between Good and Fair |
| Deficiency | CAST IN PLACE CONCRETE: CRACKS/SPALLING - MAJOR |
| Deficiency Location/Instance | Near Schoolyard |

| Question | Response |
|---|--|
| Potential Action | REPLACE |
| Urgency of Action | PRIORITY 3 |
