NYC Department of Education
Building Condition Assessment Survey 2023 - 2024

Architectural Inspection

Q876

Asset: P.S. 88 ANNEX - QUEENS, 869 CYPRESS AVENUE, New York, 11385

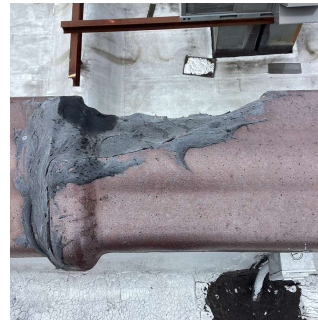
Roof 1
No violations recorded.

Question	Response
Architectural	
EXTERIOR	Inspected
AREAWAY	Does not Exist
AWNINGS AND CANOPIES	Does not Exist
CHIMNEY	Inspected
Material Type(s)	Masonry
Condition	2 - Between Good and Fair
Deficiency	No deficiencies recorded
COPING	Inspected
Condition	3 - Fair
Deficiency	TERRA COTTA: CRACKED/BROKEN PIECES

50
L.F.
REPLACE-IN-KIND
PRIORITY 4
LEVEL 2

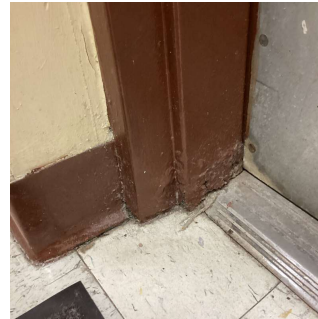
Facade A

METAL CLAD: DETERIORATED DOOR AND FRAME - MAJOR DETERIORATION

4

REPLACE

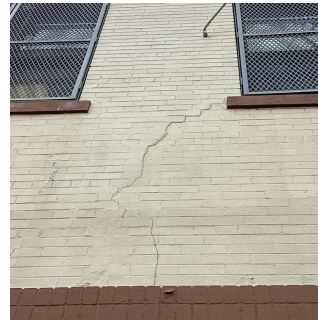
Facade A

BRICK: MAJOR / THRU CRACKS

REMOVE AND REBUILD

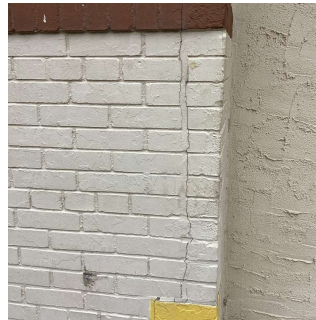
Facade A

BRICK: CRACKS/DISPLACED/SPALLED BRICK AT BUILDING CORNERS

REMOVE AND REBUILD

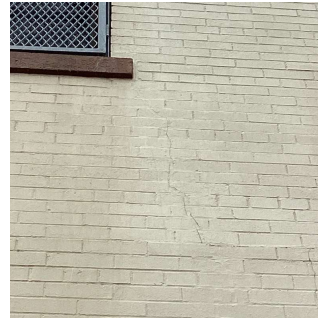
Facade A

BRICK: MINOR CRACKS AND SPALLING

RESTITCH

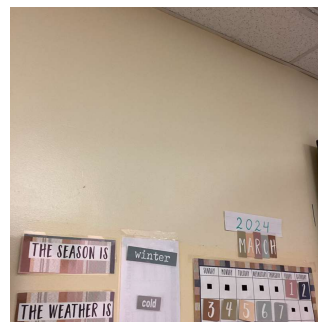
Facade E - Room 107

BRICK: WATER INFILTRATION IN INSTRUCTIONAL SPACE

REPAIR

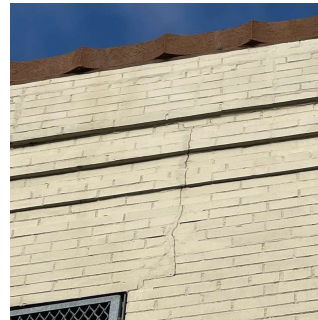
Roof 1 - Facade A

Question	Response
EXTERIOR	
EXTERIOR WALLS	Inspected
Violations	No violations recorded.
EXTERIOR SOFFITS	Inspected
Condition	2 - Between Good and Fair
Deficiency	No deficiencies recorded
LOADING DOCK	Does not Exist
LOUVER	Inspected
Condition	2 - Between Good and Fair
Deficiency	No deficiencies recorded
PARAPETS	Inspected
Material Type(s)	Masonry
Replacement Quantity	2,500
Replacement Uom	C.F.
Instance on All Facades	Inspected
Instance Condition	4 - Between Fair and Poor
Instance Quantity	2,500
Instance Quantity Uom	C.F.
Deficiency	BRICK: DETERIORATED JOINTS
Roof Plan reference	Q876
Deficiency Quantity	20
Quantity Uom	S.F.
Potential Action	REPOINT
Urgency of Action	PRIORITY 3
Purpose of Action	LEVEL 2
Deficiency Photo1	
	Roof 1
Violations	No violations recorded.
Deficiency	BRICK: MAJOR DETERIORATION/CRACKS

40
S.F.
REMOVE AND REBUILD
PRIORITY 4
LEVEL 2

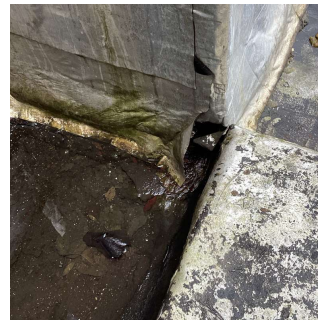
Roof 1
 No violations recorded.

Question	Response
EXTERIOR	
ROOF	
Roofing	
LEADERS, GUTTERS, DOWNSPOUTS, SCUPPERS	
Quantity Uom	L.F.
Potential Action	REPLACE
Urgency of Action	PRIORITY 4
Purpose of Action	LEVEL 2
Deficiency Photo1	 
Violations	Roof 2 - Facade C No violations recorded.
ROOF BARRIER/FENCE	Does not Exist
ROOF CAGE	Does not Exist
ROOFING	Inspected
Instance on Single Ply, Fully Adhered Roof: All Roofs	Inspected
Instance Condition	5 - Poor
Instance Photo	 
	Roof 1
Instance Quantity	10,000
Instance Quantity Uom	S.F.
Does the roof have major mechanical equipment sitting on Dunnage Steel less than 18" above the Roofing?	Yes
Does this roof instance have a Sustainable Roof System?	Yes
Sustainable Roof Type	White Roof
Sustainable Roof Location (Roof Number)	All Roofs
Do solar panels exist on these roofs?	No
Is/Are the roof(s) suitable for Solar Panel installation?	No
Installation Year	1997
Source of Installation	Custodial Staff
Deficiency	SINGLE PLY, FULLY ADHERED ROOF: ROOFING: OPEN SEAMS

Q876
 20
 L.F.
 REPAIR
 PRIORITY 4
 LEVEL 2

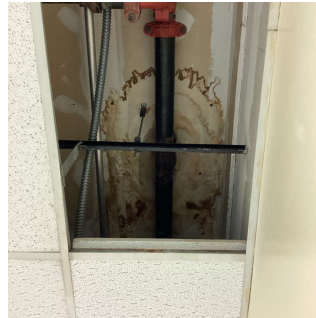
SINGLE PLY, FULLY ADHERED ROOF: ROOFING: MAJOR ACTIVE ROOF LEAKS IN INSTRUCTIONAL SPACE

Roof 1 - Corridor near Room 203 (Roof 1 - Room 204, Stair B/2, Roof 2 - Room 101 similar)

Q876
 400
 S.F.
 REPLACE ROOFING WITHOUT MAJOR EQUIPMENT REMOVAL
 PRIORITY 5
 LEVEL 2

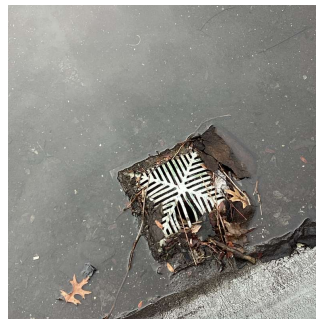
Roof 2

DETERIORATED

REPLACE

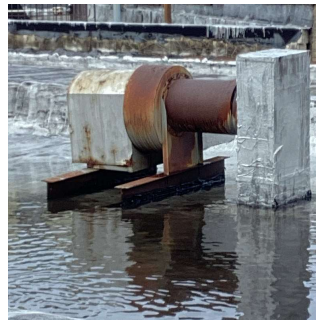
Roof 2

Deficiency	HEIGHT LESS THAN 18"
------------	----------------------

REPLACE

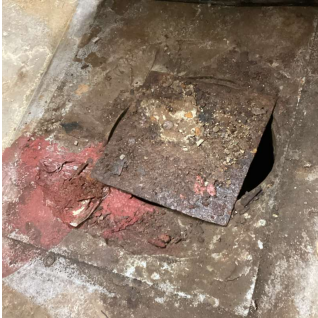
Deficiency	No deficiencies recorded
FLOOR STRUCTURE	Inspected
Condition	3 - Fair
Deficiency	CONCRETE SLAB ON GRADE: THRU CRACKS
Deficiency Location/Instance	Basement - Electrical/Boiler Room
Deficiency Quantity	20

Question	Response
INTERIOR	
STRUCTURAL	
FLOOR STRUCTURE	
Quantity Uom	S.F.
Potential Action	REPLACE
Urgency of Action	PRIORITY 4
Purpose of Action	LEVEL 5
Deficiency Photo1

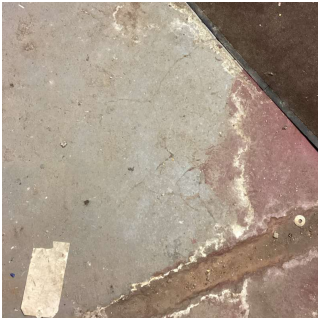
Violations	Basement - Electrical/Boiler Room No violations recorded.
Deficiency	CONCRETE SLAB ON GRADE: THRU CRACKS
Deficiency Location/Instance	Boiler Room
Deficiency Quantity	40
Quantity Uom	S.F.
Potential Action	REPAIR
Urgency of Action	PRIORITY 3
Purpose of Action	LEVEL 5
Deficiency Photo1

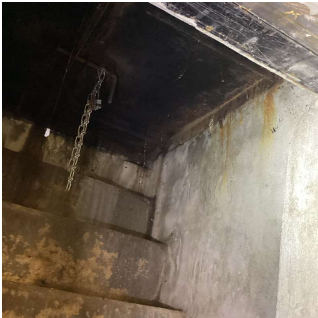
Question	Response
INTERIOR	
STRUCTURAL	
VAULTS-BUNKERS	
Slab Structure	
Deficiency	CONCRETE: WATER INFILTRATION IN ELECTRICAL PANEL ROOM
Deficiency Location/Instance	Basement - Electrical/Boiler Room
Deficiency Quantity	100
Quantity Uom	S.F.
Potential Action	INSTALL WATERPROOFING
Urgency of Action	PRIORITY 5
Purpose of Action	LEVEL 6
Deficiency Photo1

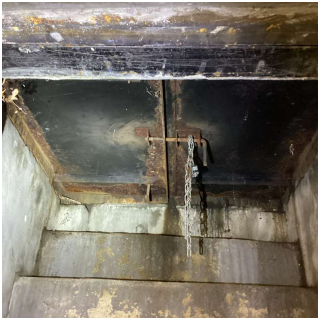
Violations	Basement - Electrical/Boiler Room No violations recorded.
Vault/Ash Hoist Doors and Framing	Inspected
Condition	5 - Poor
Deficiency	DETERIORATED/DAMAGED VAULT/ASH HOIST DOORS AND FRAMING
Deficiency Location/Instance	Basement - Electrical/Boiler Room
Deficiency Quantity	2
Quantity Uom	EACH
Potential Action	REPLACE
Urgency of Action	PRIORITY 4
Purpose of Action	LEVEL 2
Deficiency Photo1

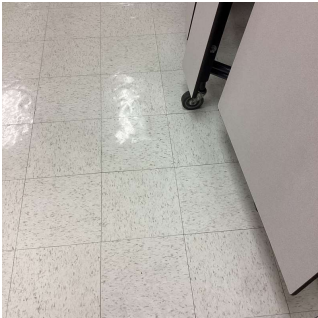
Center
Violations	No violations recorded.
Deficiency	VINYL TILES: BROKEN/DETERIORATED/MISSING TILES
Deficiency Location/Instance	Rear
Deficiency Quantity	10
Quantity Uom	S.F.
Potential Action	REPLACE
Urgency of Action	PRIORITY 3
Purpose of Action	LEVEL 2
Deficiency Photo1

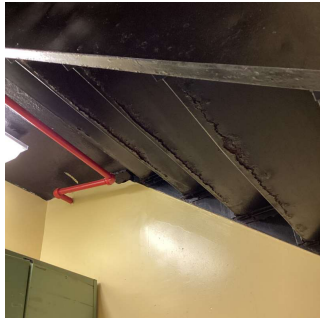
Stair A/1
Violations	No violations recorded.
Deficiency	METAL: RUST - MAJOR
Deficiency Location/Instance	Stair A/1
Deficiency Quantity	40
Quantity Uom	S.F.
Potential Action	REPLACE
Urgency of Action	PRIORITY 5
Purpose of Action	LEVEL 6
Deficiency Photo1

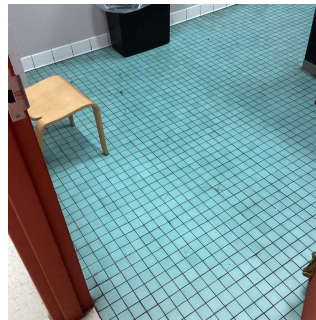
Room 207

CERAMIC TILE: BROKEN/MISSING TILES

REPLACE

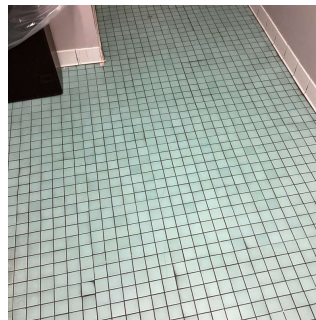
CERAMIC TILE: DETERIORATED SUBSTRATE

REPLACE
