NYC Department of Education
Building Condition Assessment Survey 2023 - 2024

Architectural Inspection

Q877

Asset: 51ST AVENUE ACADEMY - QUEENS, 76-05 51 AVENUE, New York, 11373

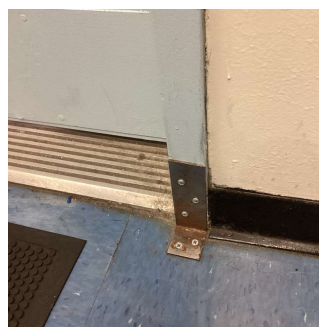
Question	Response
EXTERIOR	
DOORS	
DOORS AND FRAMES	
Deficiency Quantity	4
Quantity Uom	EACH
Potential Action	MAINTENANCE
Urgency of Action	PRIORITY 3
Purpose of Action	LEVEL 2
Deficiency Photo1	No photo recorded
Violations	No violations recorded.
Deficiency	METAL CLAD: DETERIORATED DOOR AND FRAME - MAJOR DETERIORATION
Roof Plan reference

Deficiency Quantity	2
Quantity Uom	EACH
Potential Action	REPLACE
Urgency of Action	PRIORITY 4
Purpose of Action	LEVEL 2
Deficiency Photo1

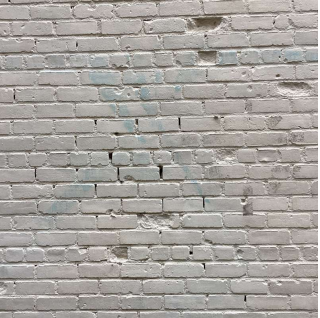
Question	Response
EXTERIOR	
EXTERIOR WALLS	
Instance Condition	4 - Between Fair and Poor
Instance Quantity	12,000
Instance Quantity Uom	S.F.
Deficiency	BRICK: DETERIORATED JOINTS
Roof Plan reference

Deficiency Quantity	20
Quantity Uom	S.F.
Potential Action	REPOINT
Urgency of Action	PRIORITY 4
Purpose of Action	LEVEL 2
Deficiency Photo1

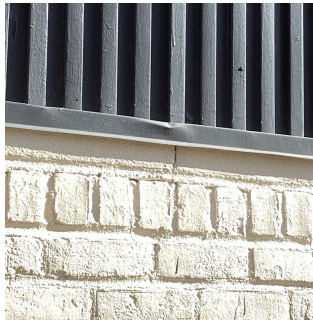
Violations	Facade B No violations recorded.
Deficiency	METAL PANEL: DAMAGED TRIM

10

REPLACE

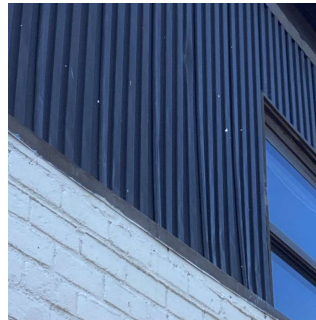
Facade D

METAL PANEL: SEVERE DENTS

40

REPLACE

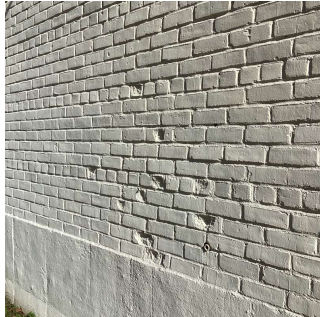
BRICK: MAJOR / THRU CRACKS

100

REMOVE AND REBUILD

Question	Response
EXTERIOR	
EXTERIOR WALLS	
Urgency of Action	PRIORITY 4
Purpose of Action	LEVEL 2
Deficiency Photo1

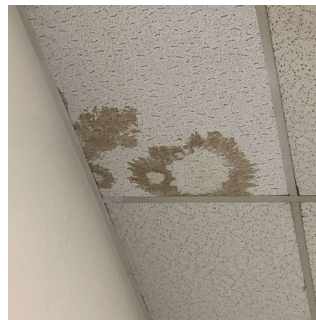
Deficiency	SINGLE PLY, FULLY ADHERED ROOF: ROOFING: MAJOR ACTIVE ROOF LEAKS IN INSTRUCTIONAL SPACE
------------	---

Deficiency Quantity	600
Quantity Uom	S.F.
Potential Action	REPLACE ROOFING WITHOUT MAJOR EQUIPMENT REMOVAL
Urgency of Action	PRIORITY 5
Purpose of Action	LEVEL 2
Deficiency Photo1

Roof 1 - Cafeteria (three locations) also Kitchen, Rooms R118, S119

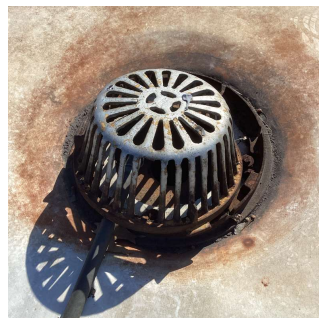
Condition	4 - Between Fair and Poor
-----------	---------------------------

Deficiency	DETERIORATED
------------	--------------

Deficiency Quantity	2
Quantity Uom	EACH
Potential Action	REPLACE
Urgency of Action	PRIORITY 4
Purpose of Action	LEVEL 2
Deficiency Photo1

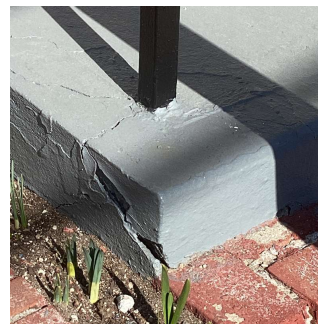
Facade A

Violations	Roof 1 No violations recorded.
Specialties	Inspected
BULKHEAD/PENTHOUSE	Does not Exist
CUPOLA/ SPIRES/ TOWERS	Does not Exist
DORMER	Does not Exist
DUNNAGE STEEL	Inspected
Condition	2 - Between Good and Fair
Deficiency	No deficiencies recorded
SKYLIGHT/ROOF VENT	Does not Exist
ROOF/GRAVITY TANK	Does not Exist
STAIRS/RAMPS: EXTERIOR	Inspected
BUILDING CHEEK/FLANK WALLS	Inspected
Condition	2 - Between Good and Fair
Deficiency	No deficiencies recorded
RAILINGS	Inspected
Condition	2 - Between Good and Fair
Deficiency	No deficiencies recorded
STAIRS/RAMPS	Inspected
Condition	5 - Poor
Deficiency	CONCRETE: CRACKS/SPALLING - MAJOR

10
 S.F.
 REPLACE
 PRIORITY 4
 LEVEL 2

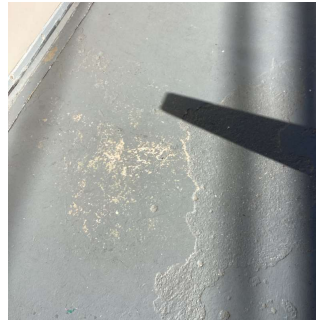
Facade A

CONCRETE: WORN-OUT TREAD/RISER/NOSING

20
 S.F.
 REPLACE
 PRIORITY 4
 LEVEL 2

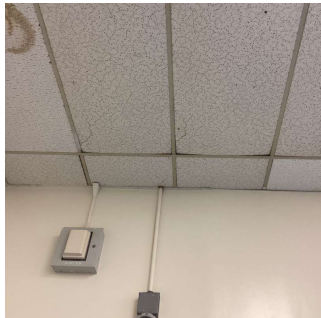
Question	Response
INTERIOR	
STRUCTURAL	
ROOF STRUCTURE	Inspected
Condition	2 - Between Good and Fair
Deficiency	No deficiencies recorded
VAULTS-BUNKERS	Does not Exist
AUDITORIUM	Does not Exist
CAFETERIA	Inspected
Instance on 1st Floor	Inspected
Ceiling	
Instance on 1st Floor	Inspected
Condition	2 - Between Good and Fair
Deficiency	ACOUSTIC TILES: DAMAGED/MISSING
Deficiency Location/Instance	Near nurse office
Deficiency Quantity	20
Quantity Uom	S.F.
Potential Action	REPLACE
Urgency of Action	PRIORITY 3
Purpose of Action	LEVEL 2
Deficiency Photo1

Violations	Near nurse office No violations recorded.
Deficiency	ACOUSTIC TILES: DAMAGED/MISSING - ACTIVE LEAK
Deficiency Location/Instance	Near center, Nurse Office, Serving Area
Deficiency Quantity	40
Quantity Uom	S.F.
Potential Action	REPLACE
Urgency of Action	PRIORITY 5
Purpose of Action	LEVEL 2
Deficiency Photo1

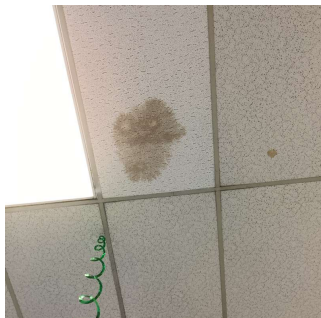
Violations	Near center No violations recorded.
Door(s)

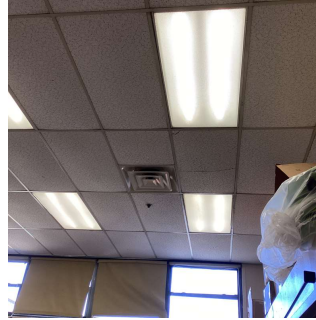
Room J110

Question	Response
INTERIOR	
CAFETERIA	
Floor Finish	
Urgency of Action	PRIORITY 3
Purpose of Action	LEVEL 2
Deficiency Photo1	 
	Near Entrance
Violations	No violations recorded.
Sliding-folding Partition	
Instance on 1st Floor	Does not Exist
Stage	
Instance on 1st Floor	Does not Exist
Walls	
Instance on 1st Floor	Inspected
Condition	2 - Between Good and Fair
Deficiency	PLASTER: CRACKS/SPALLING
Deficiency Location/Instance	Near center
Deficiency Quantity	10
Quantity Uom	S.F.
Potential Action	REPLACE
Urgency of Action	PRIORITY 3
Purpose of Action	LEVEL 2
Deficiency Photo1	 
	Near center
Violations	No violations recorded.
Window Curtains/Shades/Blinds	
Instance on 1st Floor	Does not Exist
CLASSROOMS/CORRIDORS/ADMIN SPACES	
	Inspected
Ceiling	
	Inspected
Condition	2 - Between Good and Fair
Deficiency	ACOUSTIC TILES: DAMAGED/MISSING
Deficiency Location/Instance	Rooms A101, H108, M113, J110
Deficiency Quantity	120
Quantity Uom	S.F.

Potential Action	REPLACE
Urgency of Action	PRIORITY 3
Purpose of Action	LEVEL 2
Deficiency Photo1

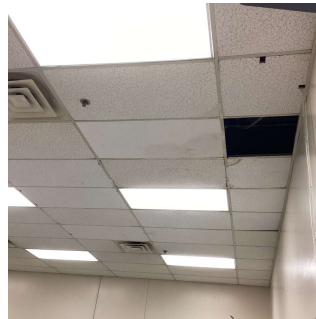
Room S119

Deficiency	PLASTER: CRACKS/SPALLING - ACTIVE LEAK
Deficiency Location/Instance	Rooms 118, S119
Deficiency Quantity	40
Quantity Uom	S.F.
Potential Action	REPLACE
Urgency of Action	PRIORITY 5
Purpose of Action	LEVEL 2
Deficiency Photo1

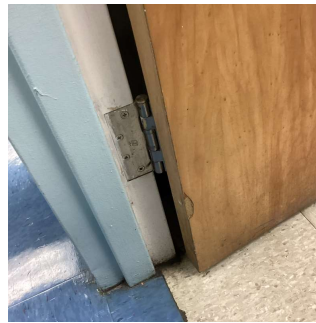
Deficiency	WOOD: DETERIORATED DOOR
Deficiency Location/Instance	Room 153
Deficiency Quantity	1
Quantity Uom	EACH
Potential Action	MAINTENANCE
Urgency of Action	PRIORITY 3
Purpose of Action	LEVEL 2

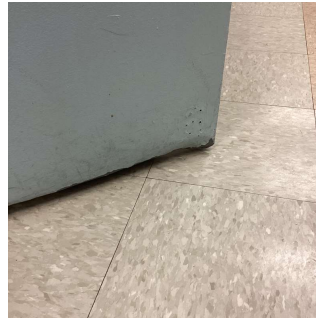
Room G107

METAL: DETERIORATED DOOR

Rooms E105, G107

MAINTENANCE

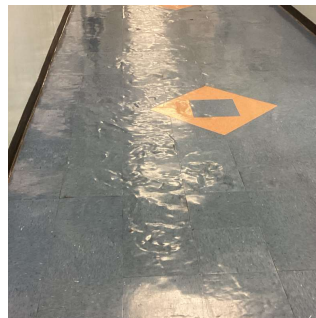
VINYL TILES: DETERIORATED SUBSTRATE

Rooms I109, K111, R118, Corridor near Room N114

REPLACE

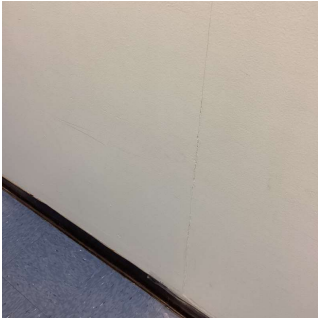
Question	Response
INTERIOR	
CLASSROOMS/CORRIDORS/ADMIN SPACES	
Floor Finish	
Violations	Corridor near Room N114 No violations recorded.
Deficiency	VINYL TILES: BROKEN/DETERIORATED/MISSING TILES
Deficiency Location/Instance	Rooms E106, E105, H108, K111, Near Exit 3, and others.
Deficiency Quantity	2,000
Quantity Uom	S.F.
Potential Action	REPLACE
Urgency of Action	PRIORITY 3
Purpose of Action	LEVEL 2
Deficiency Photo1	 
Violations	Room H108 No violations recorded.
Walls	Inspected
Condition	2 - Between Good and Fair
Deficiency	GYPNUM BOARD: DETERIORATED
Deficiency Location/Instance	Exit 1 - Vestibule, Near Exits 2, 3
Deficiency Quantity	40
Quantity Uom	S.F.
Potential Action	REPLACE
Urgency of Action	PRIORITY 3
Purpose of Action	LEVEL 2
Deficiency Photo1

Violations	Near Exit 3 No violations recorded.
Specialties	Does not Exist
GYMNASIUM	Does not Exist
INTERIOR DOOR HARDWARE	
Condition	3 - Fair
Deficiency	No deficiencies recorded

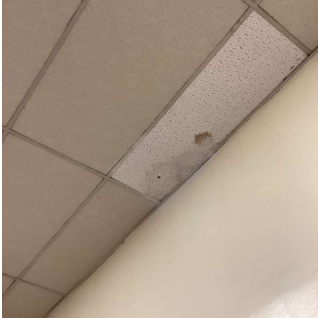
Question	Response
INTERIOR	
KITCHEN	Inspected
Instance on 1st Floor	Inspected
Ceiling	
Instance on 1st Floor	Inspected
Condition	2 - Between Good and Fair
Deficiency	ACOUSTIC TILES: DAMAGED/MISSING - ACTIVE LEAK
Deficiency Location/Instance	Near Serving Area
Deficiency Quantity	10
Quantity Uom	S.F.
Potential Action	REPLACE
Urgency of Action	PRIORITY 5
Purpose of Action	LEVEL 2
Deficiency Photo1

Near Serving Area
Violations	No violations recorded.
Door(s)	
Instance on 1st Floor	Inspected
Condition	2 - Between Good and Fair
Deficiency	No deficiencies recorded
Floor Finish	
Instance on 1st Floor	Inspected
Condition	4 - Between Fair and Poor
Deficiency	VINYL TILES: BROKEN/DETERIORATED/MISSING TILES
Deficiency Location/Instance	Storage Room - inside Cafeteria
Deficiency Quantity	100
Quantity Uom	S.F.
Potential Action	REPLACE
Urgency of Action	PRIORITY 3
Purpose of Action	LEVEL 2
Deficiency Photo1

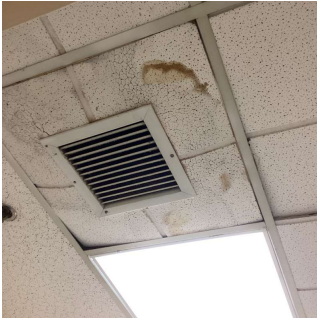
Question	Response
INTERIOR	
KITCHEN	Inspected
Walls	
Instance on 1st Floor	Inspected
Condition	2 - Between Good and Fair
Deficiency	No deficiencies recorded
LIBRARY	Does not Exist
LOCKER ROOM	Does not Exist
MULTI-PURPOSE ROOM	Does not Exist
SCIENCE DEMO ROOM	Does not Exist
SCIENCE LAB	Does not Exist
SCIENCE PREP ROOM	Does not Exist
SHOWER ROOM	Does not Exist
STAIRS/RAMPS: INTERIOR	Does not Exist
TOILET ROOMS - STAFF	Inspected
Ceiling	Inspected
Condition	4 - Between Fair and Poor
Deficiency	ACOUSTIC TILES: DAMAGED/MISSING
Deficiency Location/Instance	Women, Nurse Office
Deficiency Quantity	20
Quantity Uom	S.F.
Potential Action	REPLACE
Urgency of Action	PRIORITY 3
Purpose of Action	LEVEL 2
Deficiency Photo1

Violations	Nurse Office No violations recorded.
Door(s)	Inspected
Condition	5 - Poor
Deficiency	METAL: DETERIORATED DOOR
Deficiency Location/Instance	Women
Deficiency Quantity	1
Quantity Uom	EACH
Potential Action	MAINTENANCE

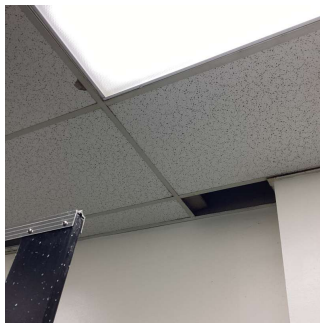
Question	Response
INTERIOR	
TOILET ROOMS - STUDENTS	
Ceiling	
Deficiency Photo1

Girls
Violations	No violations recorded.
Door(s)	
Condition	Inspected
	5 - Poor
Deficiency	METAL: DETERIORATED DOOR
Deficiency Location/Instance	Girls, Boys
Deficiency Quantity	2
Quantity Uom	EACH
Potential Action	MAINTENANCE
Urgency of Action	PRIORITY 3
Purpose of Action	LEVEL 2
Deficiency Photo1	 
	Girls
Violations	No violations recorded.
Floor Finish	
Condition	Inspected
	2 - Between Good and Fair
Deficiency	CERAMIC TILE: BROKEN/MISSING TILES
Deficiency Location/Instance	Boys
Deficiency Quantity	10
Quantity Uom	S.F.
Potential Action	REPLACE
Urgency of Action	PRIORITY 3
Purpose of Action	LEVEL 2

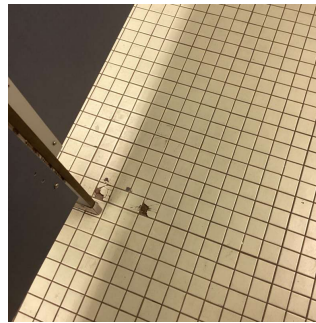
Boys

Floor Finish

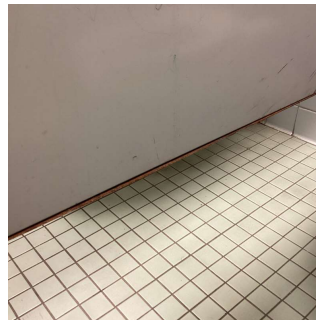
RUST - MAJOR

Girls

REPLACE
