NYC Department of Education
Building Condition Assessment Survey 2023 - 2024

Architectural Inspection

Q883

Asset: P.S. 182 - QUEENS, 90-40 150 STREET, New York, 11435

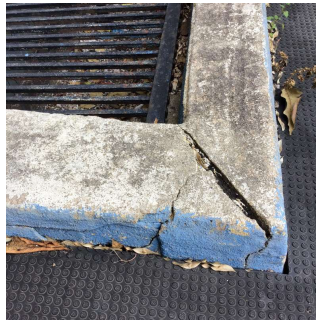
Question	Response
Architectural	
EXTERIOR	Inspected
AREAWAY	Inspected
Instance on AW1	Inspected
Instance Condition	3 - Fair
Instance Quantity	1
Instance Quantity Uom	EACH
Deficiency	AREAWAY WALLS: CRACKS AND SPALLING

AREAWAY

REPLACE

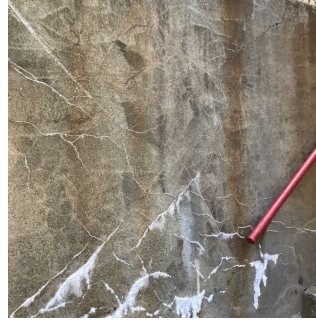
AW2

AREAWAY WALLS: CRACKS AND SPALLING

REPAIR

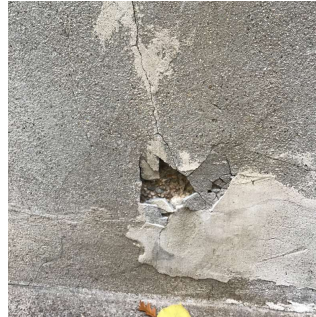
AW2

AREAWAY WALLS: CRACKS AND SPALLING

REPLACE

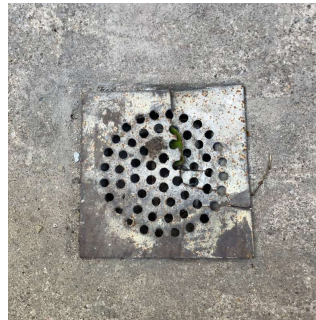
AW1

AREAWAY DRAINS: DETERIORATED

1
 EACH
 REPLACE
 PRIORITY 4
 LEVEL 2

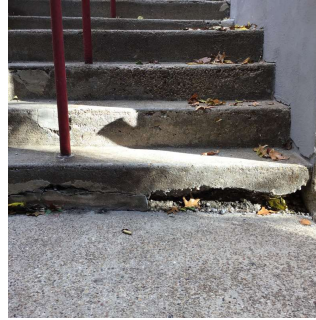
AW2

AREAWAY STAIRS: DETERIORATED
 TREADS/RISERS/NOSINGS

40
 S.F.
 REPLACE
 PRIORITY 4
 LEVEL 2

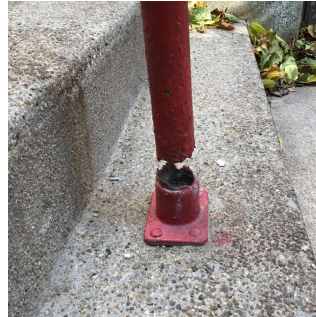
AW2

AREAWAY STAIRS: DETERIORATED RAILINGS

REPLACE

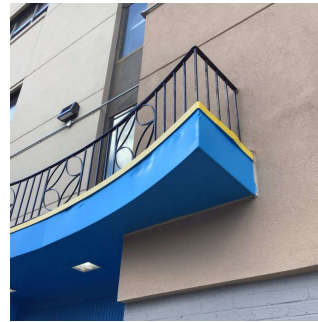
Facade A

METAL: DETERIORATION/DAMAGED/MISSING PIECES

10
S.F.
REPAIR
PRIORITY 3
LEVEL 2

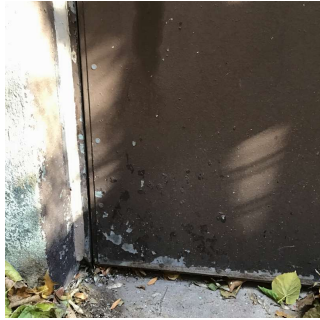
METAL CLAD: DETERIORATED DOOR - MINOR DETERIORATION

Question	Response
EXTERIOR	
DOORS	
DOORS AND FRAMES	
Deficiency Quantity	1
Quantity Uom	EACH
Potential Action	MAINTENANCE
Urgency of Action	PRIORITY 3
Purpose of Action	LEVEL 2
Deficiency Photo1

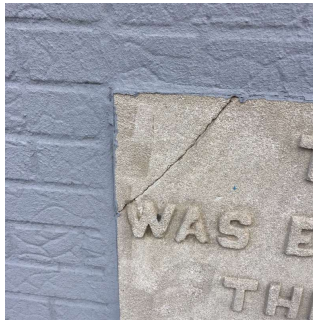
Facade A

Violations	AW2 No violations recorded.
DOOR HARDWARE	Inspected
Condition	3 - Fair
Deficiency	No deficiencies recorded
LINTELS	Inspected
Condition	2 - Between Good and Fair
Deficiency	No deficiencies recorded
TRANSOM/SIDE LIGHT	Inspected
Condition	2 - Between Good and Fair
Deficiency	No deficiencies recorded
EXTERIOR WALLS	Inspected
Material Type(s)	Masonry
Replacement Quantity	12,500
Replacement Uom	S.F.
Instance on All Facades	Inspected
Instance Condition	2 - Between Good and Fair
Instance Quantity	12,500
Instance Quantity Uom	S.F.
Deficiency	STONE: CHIPPED/SPALLED/BROKEN PIECES - MINOR
Roof Plan reference

REPAIR

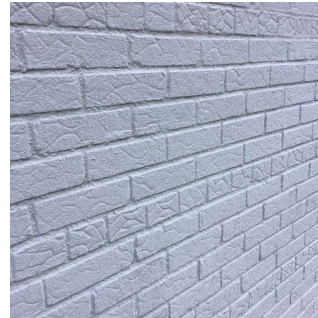
Facade A

BRICK: DETERIORATED JOINTS

PRIORITY 3
LEVEL 2

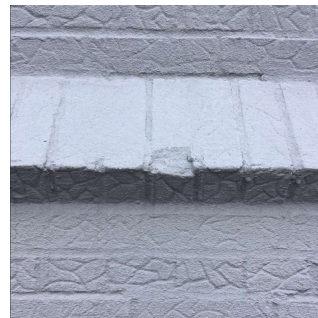
Facade A

BRICK: MINOR CRACKS AND SPALLING

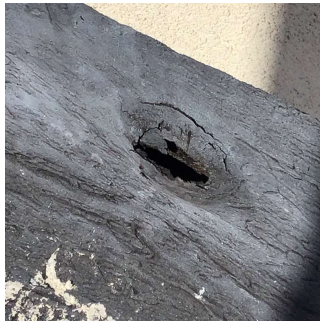
Question	Response
EXTERIOR	
ROOF	
Roofing	
ROOFING	
Deficiency	MODIFIED BITUMEN: FLASHING: BASE FLASHING DETERIORATED
Roof Plan reference

Deficiency Quantity	10
Quantity Uom	S.F.
Potential Action	REPAIR
Urgency of Action	PRIORITY 3
Purpose of Action	LEVEL 2
Deficiency Photo1

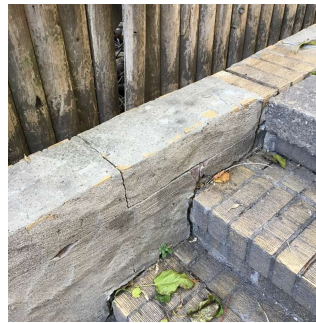
Facade E

Violations	BH1 No violations recorded.
ROOFING DRAINS	Does not Exist
Specialties	Inspected
BULKHEAD/PENTHOUSE	Inspected
Condition	2 - Between Good and Fair
Deficiency	No deficiencies recorded
CUPOLA/ SPIRES/ TOWERS	Does not Exist
DORMER	Does not Exist
DUNNAGE STEEL	Does not Exist
SKYLIGHT/ROOF VENT	Inspected
Material Type(s)	Glass
Condition	1 - Good
Deficiency	No deficiencies recorded
ROOF/GRAVITY TANK	Does not Exist
STAIRS/RAMPS: EXTERIOR	Inspected
BUILDING CHEEK/FLANK WALLS	Inspected
Condition	5 - Poor
Deficiency	BRICK: CRACKS/SPALLING - MAJOR

10
 S.F.
 REPLACE
 PRIORITY 4
 LEVEL 2

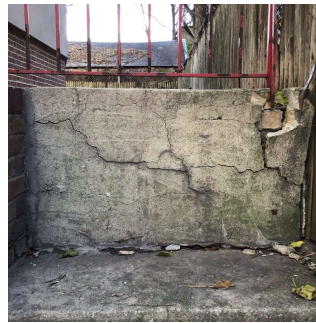
Facade E

CAST IN PLACE CONCRETE: CRACKS/SPALLING - MAJOR

20
 S.F.
 REPLACE
 PRIORITY 4
 LEVEL 2

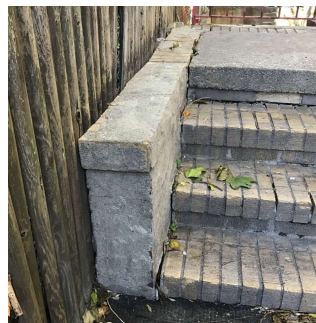
Facade E

BRICK: BULGING/DISPLACED

REPLACE

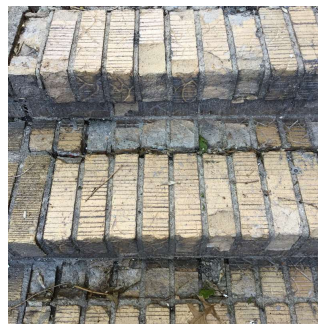
Facade E

BRICK: CRACKS/SPALLING - MAJOR

30
 S.F.
 REPLACE
 PRIORITY 4
 LEVEL 2

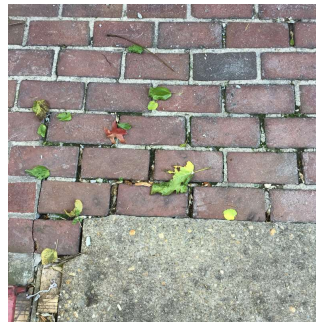
Facade E

BRICK: DETERIORATED JOINTS

20
 S.F.
 REPOINT
 PRIORITY 4
 LEVEL 2

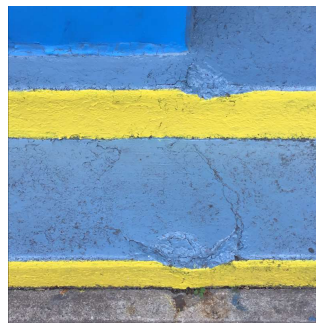
Facade A

CONCRETE: WORN-OUT TREAD/RISER/NOSING

10
 S.F.
 REPLACE
 PRIORITY 4
 LEVEL 2

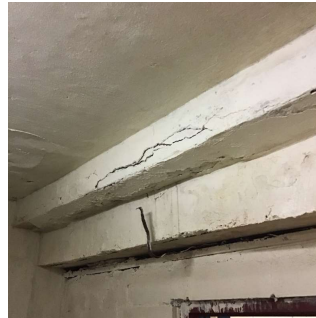
Priority Condition Exist Last Year?	Priority Category	Condition Description	Component Affected	Location Description	Person(s) Notified	Person(s) Title	PhotoImage
No	Potential Falling Debris	Deteriorated concrete fireproofing is a potential falling debris hazard.	INTERIOR STRUCTURAL COLUMNS/BEARING WALLS	Basement - above entry door of Oil Tank Room	Ramaish Mohanran	Fireman

Condition	3 - Fair
Deficiency	STEEL COLUMNS/BEAMS: DETERIORATED CONCRETE FIREPROOFING
Deficiency Location/Instance	Basement - Oil Tank Room (above door)
Deficiency Quantity	10
Quantity Uom	S.F.
Potential Action	REPLACE
Urgency of Action	PRIORITY 5

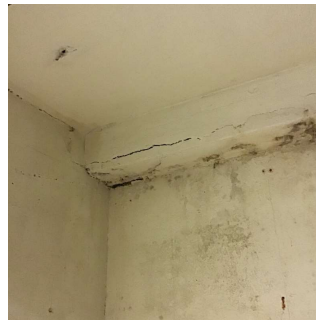
Basement - Oil Tank Room

STEEL COLUMNS/BEAMS: DETERIORATED CONCRETE FIREPROOFING

REPLACE

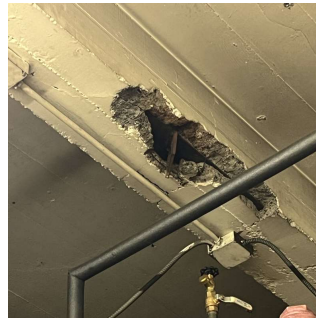
STEEL COLUMNS/BEAMS: DETERIORATED CONCRETE FIREPROOFING

REPLACE

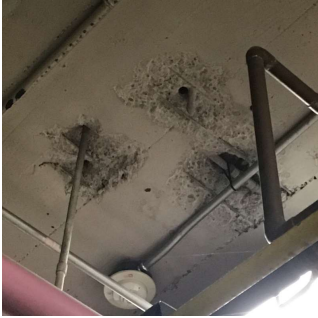
Room 310
Violations	No violations recorded.
Deficiency	CINDER CONCRETE FLAT SLAB: CRACKED/SPALLED/REINFORCEMENT EXPOSED
Deficiency Location/Instance	Boiler Room
Deficiency Quantity	40
Quantity Uom	S.F.
Potential Action	REPAIR
Urgency of Action	PRIORITY 4
Purpose of Action	LEVEL 5
Deficiency Photo1

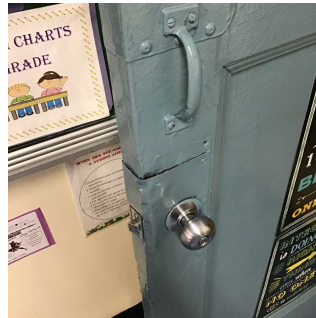
Room 306

METAL CLAD WOOD: DETERIORATED DOOR

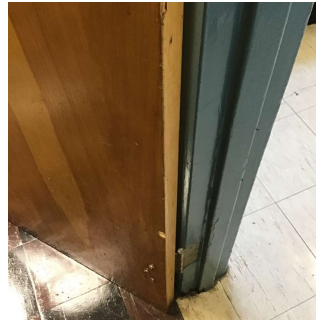
Room 102

WOOD: DETERIORATED DOOR

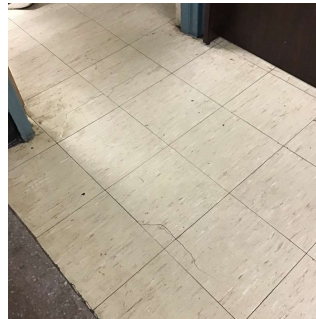
Main Entrance

VINYL TILES: BROKEN/DETERIORATED/MISSING TILES

REPLACE

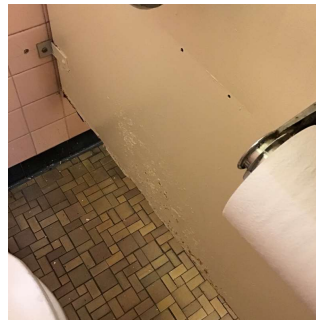
Basement - Womens

RUST - MAJOR

REPLACE

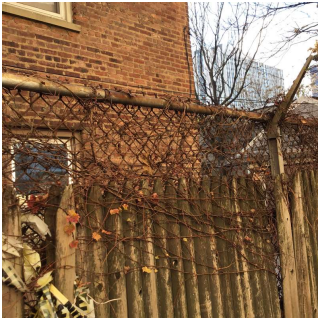
Question	Response
INTERIOR	
TOILET ROOMS - STUDENTS	
Floor Finish	
Deficiency Photo1	 
Violations	Room 210 No violations recorded.
Stalls	Inspected
Condition	2 - Between Good and Fair
Deficiency	No deficiencies recorded
Walls	Inspected
Condition	2 - Between Good and Fair
Deficiency	PLASTER: CRACKS/SPALLING
Deficiency Location/Instance	Rooms 204, 304
Deficiency Quantity	20
Quantity Uom	S.F.
Potential Action	REPLACE
Urgency of Action	PRIORITY 3
Purpose of Action	LEVEL 2
Deficiency Photo1	 
Violations	Room 204 No violations recorded.
LIFE SAFETY	Inspected
F.D. HOLDING AREA	Does not Exist
STEEL STAIRS	Does not Exist
SITE	Inspected
CONTAINERIZATION	Does not Exist
Drainage System for Asphalt	Does not Exist
Drainage System for Concrete	Does not Exist
Drainage System for Soil	Does not Exist
DRINKING FOUNTAINS	Does not Exist
FENCES	Inspected
Condition	3 - Fair
Deficiency	CHAIN LINK: RUST - MAJOR

Question	Response
SITE	
FENCES	
Deficiency Location/Instance	South Side of the building
Deficiency Quantity	400
Quantity Uom	S.F.
Potential Action	REPLACE
Urgency of Action	PRIORITY 3
Purpose of Action	LEVEL 2
Deficiency Photo1

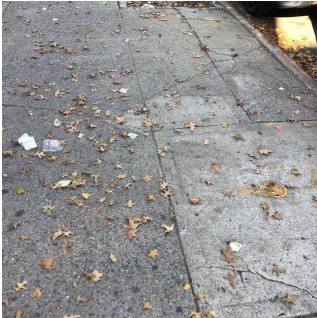
Violations	150th Street No violations recorded.
Deficiency	DAMAGED/DETERIORATED/MISSING SECTIONS
Deficiency Location/Instance	150th Street
Deficiency Quantity	400

Question	Response
SITE	
PAVING	
DOT Sidewalk	
Concrete	
Quantity Uom	S.F.
Potential Action	REPLACE
Urgency of Action	PRIORITY 3
Purpose of Action	LEVEL 2
Deficiency Photo1

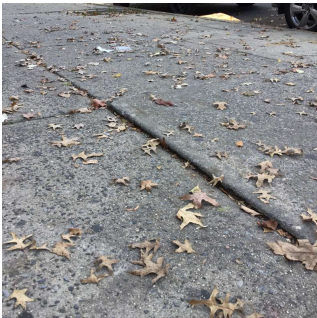
150th Street
Violations	No violations recorded.
Deficiency	HEAVING
Deficiency Location/Instance	150th Street
Deficiency Quantity	25
Quantity Uom	S.F.
Potential Action	REPLACE
Urgency of Action	PRIORITY 3
Purpose of Action	LEVEL 2
Deficiency Photo1

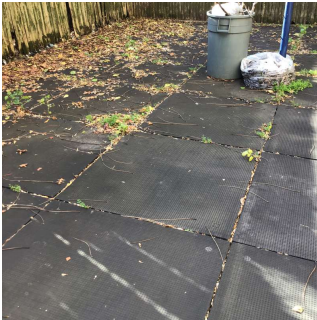
Question	Response
SITE	
PLAYGROUNDS	
Safety Surfacing	
Instance on South Side of Building	Inspected
Condition	3 - Fair
Deficiency	DETERIORATED/MISSING
Deficiency Location/Instance	Rear, Center, near Fence
Deficiency Quantity	60
Quantity Uom	S.F.
Potential Action	REPLACE
Urgency of Action	PRIORITY 3
Purpose of Action	LEVEL 2
Deficiency Photo1
