NYC Department of Education
Building Condition Assessment Survey 2023 - 2024

Architectural Inspection

Q884

Asset: P.S. 65 - QUEENS, 103-22 99TH STREET, New York, 11417

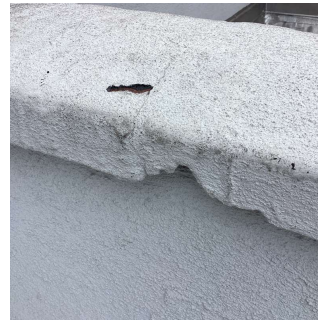
Roof 3
 No violations recorded.

Question	Response
Architectural	
EXTERIOR	Inspected
AREAWAY	Does not Exist
AWNINGS AND CANOPIES	Inspected
Condition	2 - Between Good and Fair
Deficiency	No deficiencies recorded
CHIMNEY	Inspected
Material Type(s)	Masonry
Condition	2 - Between Good and Fair
Deficiency	No deficiencies recorded
COPING	Inspected
Condition	3 - Fair
Deficiency	TERRA COTTA: CRACKED/BROKEN PIECES

10
 L.F.
 REPLACE-IN-KIND
 PRIORITY 4
 LEVEL 2

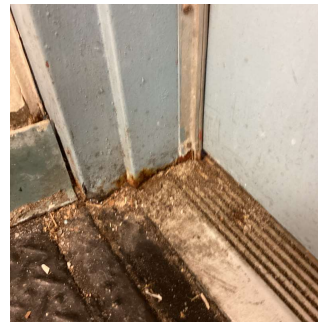
Facade A

METAL: DETERIORATED DOOR AND FRAME - MINOR DETERIORATION

1
 EACH
 MAINTENANCE
 PRIORITY 3
 LEVEL 2

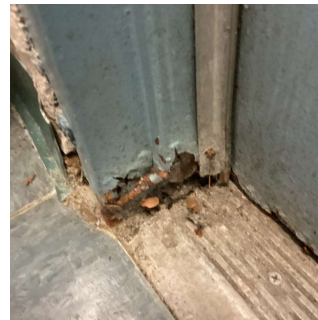
Facade D

METAL: DETERIORATED DOOR AND FRAME - MAJOR DETERIORATION

2

REPLACE

PRIORITY 4

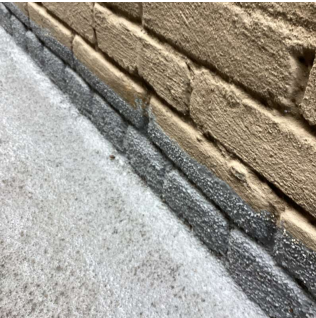
Question	Response
EXTERIOR	
EXTERIOR WALLS	Inspected
Material Type(s)	Masonry
Replacement Quantity	17,000
Replacement Uom	S.F.
Instance on All Facades	Inspected
Instance Condition	3 - Fair
Instance Quantity	17,000
Instance Quantity Uom	S.F.
Deficiency	BRICK: DETERIORATED JOINTS
Roof Plan reference	Q884
Elevation

Deficiency Quantity	30
Quantity Uom	S.F.
Potential Action	REPOINT
Urgency of Action	PRIORITY 4
Purpose of Action	LEVEL 2
Deficiency Photo1

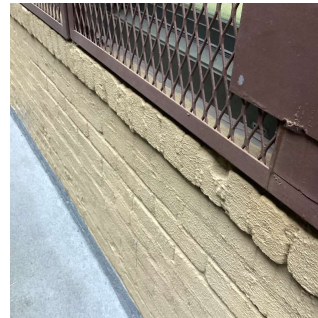
Violations	Facade B No violations recorded.
Deficiency	BRICK: DETERIORATED MASONRY SILLS - MINOR

20

REPAIR

PRIORITY 3

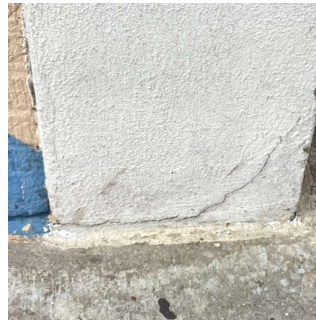
Facade A

STUCCO CEMENT SURFACE: CRACKS, SPALLING

30

REPLACE

PRIORITY 4

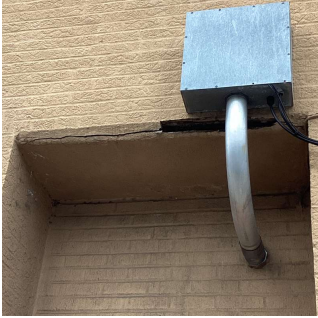
STUCCO/PLASTER: MAJOR CRACKS/SPALLING

10

Question	Response
EXTERIOR	
EXTERIOR SOFFITS	
Quantity Uom	S.F.
Potential Action	REPLACE
Urgency of Action	PRIORITY 5
Purpose of Action	LEVEL 6
Deficiency Photo1

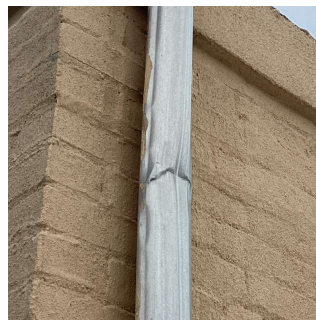
Roof 1
No violations recorded.

LEADERS, GUTTERS, DOWNSPOUTS, SCUPPERS	Inspected
Condition	3 - Fair
Deficiency	DAMAGED/MISSING

10
L.F.
REPLACE
PRIORITY 4
LEVEL 2

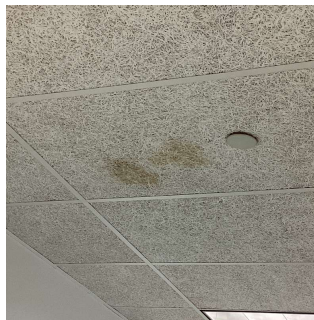
Roof 1 - 2nd Floor Corridor near Room 223

Deficiency	MODIFIED BITUMEN: ROOFING: MAJOR ACTIVE ROOF LEAKS IN INSTRUCTIONAL SPACE
------------	---

Deficiency Quantity	100
Quantity Uom	S.F.
Potential Action	REPLACE ROOFING WITHOUT MAJOR EQUIPMENT REMOVAL
Urgency of Action	PRIORITY 5
Purpose of Action	LEVEL 2
Deficiency Photo1

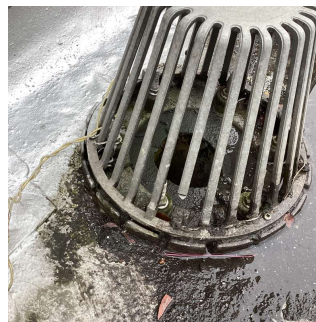
Roof 2
 No violations recorded.

Deficiency	DETERIORATED
------------	--------------

3
 EACH
 REPLACE
 PRIORITY 4
 LEVEL 2

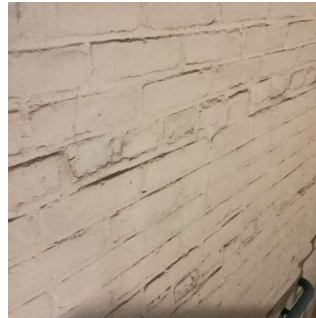
Roof 1 - Bulkhead 1

BULKHEAD/PENTHOUSE WALLS/INTERIOR: BRICK CRACKS/SPALLING

30
 S.F.
 REPLACE
 PRIORITY 3
 LEVEL 2

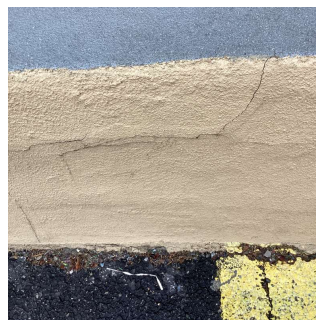
CAST IN PLACE CONCRETE: CRACKS/SPALLING - MINOR

10

REPAIR

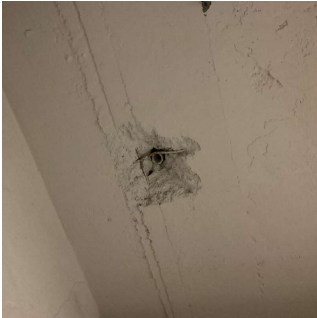
Question	Response
EXTERIOR	
WINDOWS	
WINDOWS	
Instance Quantity	5,000
Instance Quantity Uom	S.F.
Are these windows insulated	Yes
Installation Year	1996
Source of Installation	Custodial Staff
Deficiency	No deficiencies recorded
INTERIOR	Inspected
POOLS	Does not Exist
STRUCTURAL	Inspected
COLUMNS/BEAMS/BEARING WALLS	Inspected
Condition	2 - Between Good and Fair
Deficiency	No deficiencies recorded
FLOOR STRUCTURE	Inspected
Condition	2 - Between Good and Fair
Deficiency	CONCRETE: CRACKS/SPALLED/REINFORCEMENT EXPOSED
Deficiency Location/Instance	Basement - Rooms 35
Deficiency Quantity	10
Quantity Uom	S.F.
Potential Action	REPAIR
Urgency of Action	PRIORITY 3
Purpose of Action	LEVEL 5
Deficiency Photo1

Basement - Room 35
Violations	No violations recorded.
FOUNDATION WALLS	Inspected
Material Type(s)	Concrete
Condition	2 - Between Good and Fair
Deficiency	CONCRETE: CRACKED/SPALLED/REINFORCEMENT EXPOSED
Deficiency Location/Instance	Basement - Room 31

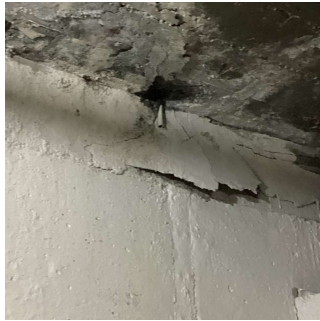
Deficiency Quantity	10
Quantity Uom	S.F.
Potential Action	REPAIR
Urgency of Action	PRIORITY 3
Purpose of Action	LEVEL 5

Basement - Room 31
Violations	No violations recorded.
ROOF STRUCTURE	
Condition	Inspected
	2 - Between Good and Fair
Deficiency	No deficiencies recorded
VAULTS-BUNKERS	
	Inspected
Foundation Walls	Inspected
Condition	3 - Fair
Deficiency	CRACKS, SPALLING
Deficiency Location/Instance	Basement - Room 31
Deficiency Quantity	10
Quantity Uom	S.F.
Potential Action	REPAIR
Urgency of Action	PRIORITY 4
Purpose of Action	LEVEL 5
Deficiency Photo1

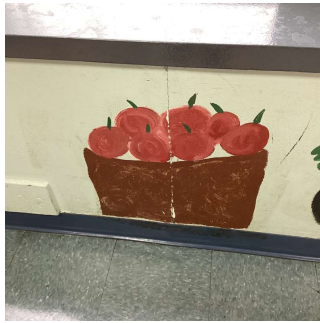
Question	Response
INTERIOR	
STRUCTURAL	
VAULTS-BUNKERS	
Slab Structure	
Deficiency Photo1	 
Violations	Basement - Room 31 No violations recorded.
Vault/Ash Hoist Doors and Framing	Does not Exist
AUDITORIUM	Does not Exist
CAFETERIA	Inspected
Instance on 1st Floor (1500SF)	Inspected
Ceiling	
Instance on 1st Floor (1500SF)	Inspected
Condition	2 - Between Good and Fair
Deficiency	No deficiencies recorded
Door(s)	
Instance on 1st Floor (1500SF)	Inspected
Condition	2 - Between Good and Fair
Deficiency	No deficiencies recorded
Fixed Equipment	
Instance on 1st Floor (1500SF)	Does not Exist
Floor Finish	
Instance on 1st Floor (1500SF)	Inspected
Condition	2 - Between Good and Fair
Deficiency	No deficiencies recorded
Sliding-folding Partition	
Instance on 1st Floor (1500SF)	Does not Exist
Stage	
Instance on 1st Floor (1500SF)	Does not Exist
Walls	
Instance on 1st Floor (1500SF)	Inspected
Condition	2 - Between Good and Fair
Deficiency	GYPSUM BOARD: DETERIORATED

Deficiency Location/Instance	Near Windows, Exit 2, Stair B
Deficiency Quantity	20
Quantity Uom	S.F.
Potential Action	REPLACE
Urgency of Action	PRIORITY 3
Purpose of Action	LEVEL 2

Violations	Near Windows No violations recorded.
Window Curtains/Shades/Blinds	
Instance on 1st Floor (1500SF)	Does not Exist
CLASSROOMS/CORRIDORS/ADMIN SPACES	
Ceiling	Inspected
Condition	2 - Between Good and Fair
Deficiency	TECTUM: DAMAGED/MISSING - ACTIVE LEAK
Deficiency Location/Instance	Corridor near Room 223
Deficiency Quantity	10
Quantity Uom	S.F.
Potential Action	REPLACE
Urgency of Action	PRIORITY 5
Purpose of Action	LEVEL 2
Deficiency Photo1

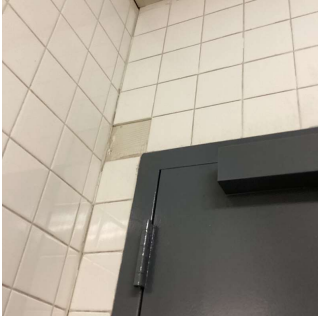
Question	Response
INTERIOR	
KITCHEN	
Floor Finish	
Instance on 1st Floor	Inspected
Condition	2 - Between Good and Fair
Deficiency	No deficiencies recorded
Walls	
Instance on 1st Floor	Inspected
Condition	2 - Between Good and Fair
Deficiency	CERAMIC TILE: BROKEN/ MISSING
Deficiency Location/Instance	Serving Area
Deficiency Quantity	10
Quantity Uom	S.F.
Potential Action	REPLACE
Urgency of Action	PRIORITY 3
Purpose of Action	LEVEL 2
Deficiency Photo1

Violations	Serving Area No violations recorded.
Deficiency	GYPSUM BOARD: DETERIORATED
Deficiency Location/Instance	Office, Locker Room
Deficiency Quantity	20
Quantity Uom	S.F.
Potential Action	REPLACE
Urgency of Action	PRIORITY 3
Purpose of Action	LEVEL 2
Deficiency Photo1

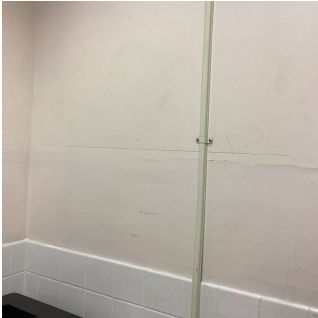
Violations	Office No violations recorded.
LIBRARY	
Instance on 2nd Floor	Inspected
Built-in Furnishing	
Instance on 2nd Floor	Does not Exist
Ceiling

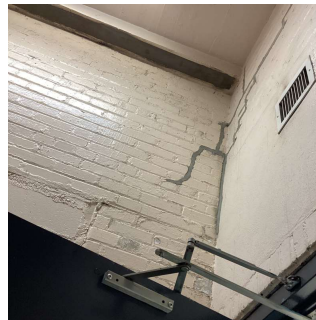
Stair D/1

BRICK: CRACKS/SPALLING

REPLACE

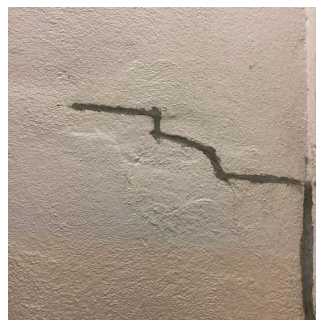
PLASTER: CRACKS/SPALLING

Question	Response
INTERIOR	
STAIRS/RAMPS: INTERIOR	
Walls	
Violations	Stair D/1 No violations recorded.
Deficiency	GYPSUM BOARD: DETERIORATED
Deficiency Location/Instance	Stairs B/Basement, D/1
Deficiency Quantity	30
Quantity Uom	S.F.
Potential Action	REPLACE
Urgency of Action	PRIORITY 3
Purpose of Action	LEVEL 2
Deficiency Photo1	 
Violations	Stair D/1 No violations recorded.
TOILET ROOMS - STAFF	
Ceiling	Inspected
Condition	2 - Between Good and Fair
Deficiency	No deficiencies recorded
Door(s)	Inspected
Condition	2 - Between Good and Fair
Deficiency	No deficiencies recorded
Floor Finish	Inspected
Condition	2 - Between Good and Fair
Deficiency	No deficiencies recorded
Stalls	Does not Exist
Walls	Inspected
Condition	2 - Between Good and Fair
Deficiency	No deficiencies recorded
TOILET ROOMS - STUDENTS	
Ceiling	Inspected
Condition	2 - Between Good and Fair
Deficiency	No deficiencies recorded
Door(s)	Inspected
Condition	2 - Between Good and Fair

REPLACE

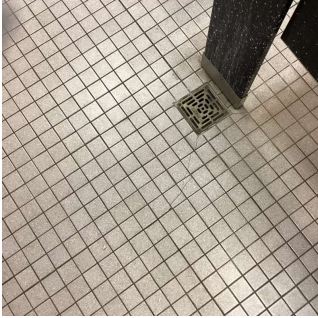
Deficiency	No deficiencies recorded
Floor Finish	Inspected
Condition	2 - Between Good and Fair
Deficiency	CERAMIC TILE: BROKEN/MISSING TILES
Deficiency Location/Instance	Rooms 502, 504, 511, 513
Deficiency Quantity	30
Quantity Uom	S.F.

Question	Response
INTERIOR	
TOILET ROOMS - STUDENTS	
Floor Finish	
Potential Action	REPLACE
Urgency of Action	PRIORITY 3
Purpose of Action	LEVEL 2
Deficiency Photo1

Room 504
Violations	No violations recorded.
Stalls	Inspected
Condition	2 - Between Good and Fair
Deficiency	No deficiencies recorded
Walls	Inspected
Condition	2 - Between Good and Fair
Deficiency	GYPSUM BOARD: DETERIORATED
Deficiency Location/Instance	Rooms 201/202, 502, 504, 511, 513, and others.
Deficiency Quantity	100
Quantity Uom	S.F.
Potential Action	REPLACE
Urgency of Action	PRIORITY 3
Purpose of Action	LEVEL 2
Deficiency Photo1	 
	Room 504
Violations	No violations recorded.
Deficiency	CERAMIC TILE: BROKEN/ MISSING
Deficiency Location/Instance	Room 510
Deficiency Quantity	10
Quantity Uom	S.F.
Potential Action	REPLACE
Urgency of Action	PRIORITY 3
Purpose of Action	LEVEL 2

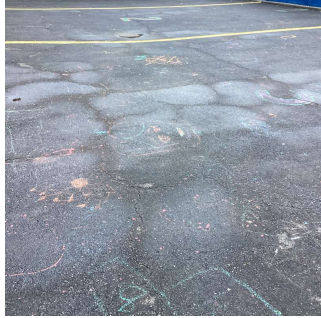
Question	Response
SITE	
PAVING	
Student Use	
Gravel Exists?	No
Asphalt	Inspected
Condition	4 - Between Fair and Poor
Deficiency	CRACKS - MAJOR
Deficiency Location/Instance	Near 98th Street
Deficiency Quantity	2,000
Quantity Uom	S.F.
Potential Action	REPLACE
Urgency of Action	PRIORITY 3
Purpose of Action	LEVEL 2
Deficiency Photo1

Near 98th Street
Violations	No violations recorded.
Concrete	Does not Exist
Pavers	Does not Exist
Site Sidewalks & Walkways	Inspected
Asphalt	Does not Exist
Concrete	Inspected
Condition	2 - Between Good and Fair
Deficiency	DAMAGED/DETERIORATED/MISSING SECTIONS
Deficiency Location/Instance	Entrance 98th Street
Deficiency Quantity	30
Quantity Uom	S.F.
Potential Action	REPLACE
Urgency of Action	PRIORITY 3
Purpose of Action	LEVEL 2
Deficiency Photo1

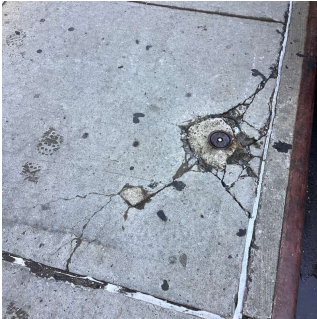
Question	Response
SITE	
PAVING	
DOT Sidewalk	Inspected
Asphalt	Does not Exist
Concrete	Inspected
Condition	4 - Between Fair and Poor
Deficiency	DAMAGED/DETERIORATED/MISSING SECTIONS
Deficiency Location/Instance	98th Street, 99th Street
Deficiency Quantity	600
Quantity Uom	S.F.
Potential Action	REPLACE
Urgency of Action	PRIORITY 3
Purpose of Action	LEVEL 2
Deficiency Photo1

99th Street
Violations	No violations recorded.
Deficiency	DAMAGED CURBS
Deficiency Location/Instance	98th street, 99th Street
Deficiency Quantity	90
Quantity Uom	L.F.
Potential Action	REPLACE
Urgency of Action	PRIORITY 3
Purpose of Action	LEVEL 2
Deficiency Photo1

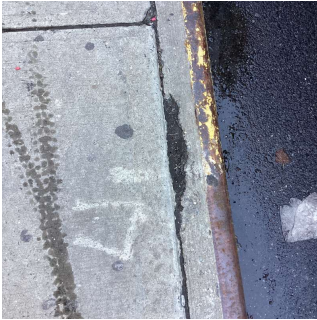
99th Street
Violations	No violations recorded.
Pavers	Does not Exist
PLAYGROUNDS	Does not Exist
PLAYING SURFACE	Does not Exist
RETAINING WALLS	Does not Exist
SEATING	Does not Exist
SITE WALLS (NOT RETAINING WALLS)	Does not Exist
STAIRS/RAMPS: EXTERIOR	Does not Exist
