**NYC Department of Education**  
**Building Condition Assessment Survey 2023 - 2024**

Architectural Inspection

Q891

**Asset:** R. F. WAGNER SEC SCL ARTS & TECH-Q, 47-07 30TH PLACE, New York, 11101

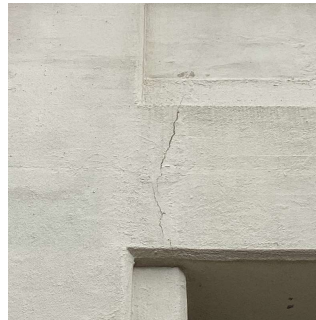
Facade A

STUCCO CEMENT SURFACE: CRACKS, SPALLING

REPLACE

PRIORITY 4

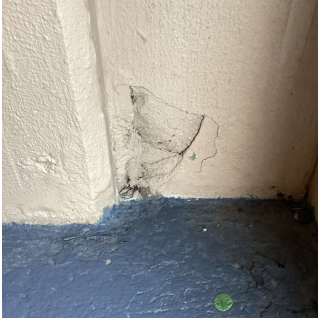
CAST IN PLACE / PRE-CAST CONCRETE: MAJOR  
CRACKS/SPALLING

Question	Response
<b>EXTERIOR</b>	
<b>EXTERIOR WALLS</b>	
Potential Action	REPLACE
Urgency of Action	PRIORITY 4
Purpose of Action	LEVEL 2
Deficiency Photo1

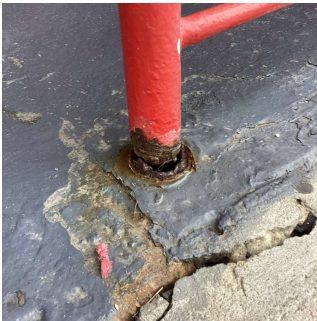
Facade A
Violations	No violations recorded.
<b>EXTERIOR SOFFITS</b>	
Condition	Inspected
Deficiency	2 - Between Good and Fair
	No deficiencies recorded
<b>LOADING DOCK</b>	
	Not Required
<b>LOUVER</b>	
Condition	Inspected
Deficiency	2 - Between Good and Fair
	No deficiencies recorded
<b>PARAPETS</b>	
	Not Required
<b>PLAZA DECK</b>	
	Does not Exist
<b>ROOF</b>	
	Not Required
<b>STAIRS/RAMPS: EXTERIOR</b>	
	Inspected
<b>BUILDING CHEEK/FLANK WALLS</b>	
Condition	Inspected
Deficiency	2 - Between Good and Fair
	No deficiencies recorded
<b>RAILINGS</b>	
Condition	Inspected
Deficiency	4 - Between Fair and Poor
Roof Plan reference	RUST - MAJOR

Deficiency Quantity	20
Quantity Uom	L.F.
Potential Action	REPLACE
Urgency of Action	PRIORITY 4
Purpose of Action	LEVEL 2

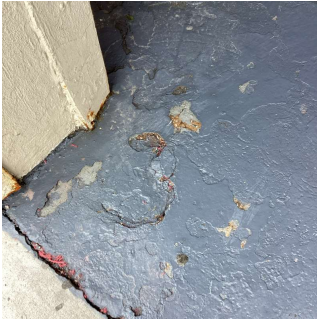
Violations	Facade A No violations recorded.
<b>STAIRS/RAMPS</b>	
Condition	Inspected 5 - Poor
Deficiency	CONCRETE: CRACKS/SPALLING - MAJOR
Roof Plan reference	Q891

Deficiency Quantity	40
Quantity Uom	S.F.
Potential Action	REPLACE
Urgency of Action	PRIORITY 4
Purpose of Action	LEVEL 2
Deficiency Photo1

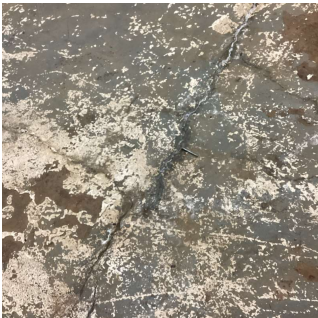
Question	Response
<b>EXTERIOR</b>	
<b>WINDOWS</b>	
<b>LINTELS</b>	Inspected
Condition	2 - Between Good and Fair
Deficiency	No deficiencies recorded
<b>WINDOWS</b>	Inspected
Material Type(s)	Aluminum
Instance on Aluminum - Double Hung: Facades A, B, D (1st, 2nd Floors)	Inspected
Instance Condition	2 - Between Good and Fair
Instance Quantity	2,000
Instance Quantity Uom	S.F.
Are these windows insulated	Yes
Installation Year	2015
Source of Installation	Custodial Staff
Deficiency	No deficiencies recorded
<b>INTERIOR</b>	Inspected
<b>POOLS</b>	Does not Exist
<b>STRUCTURAL</b>	Inspected
<b>COLUMNS/BEAMS/BEARING WALLS</b>	Inspected
Condition	2 - Between Good and Fair
Deficiency	No deficiencies recorded
<b>FLOOR STRUCTURE</b>	Inspected
Condition	3 - Fair
Deficiency	CONCRETE SLAB ON GRADE: THRU CRACKS
Deficiency Location/Instance	Electrical Panel Room, Boiler Room
Deficiency Quantity	100
Quantity Uom	S.F.
Potential Action	REPAIR

Urgency of Action	PRIORITY 3
Purpose of Action	LEVEL 5
Deficiency Photo1

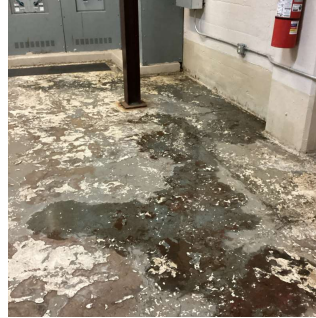
Violations	Electrical Panel Room No violations recorded.
<b>FOUNDATION WALLS</b>	Inspected
Material Type(s)	Concrete
Condition	4 - Between Fair and Poor
Deficiency	CONCRETE: WATER INFILTRATION IN ELECTRICAL PANEL ROOM
Deficiency Location/Instance	Electrical Panel Room
Deficiency Quantity	100
Quantity Uom	S.F.
Potential Action	INSTALL WATERPROOFING

PRIORITY 5  
LEVEL 6

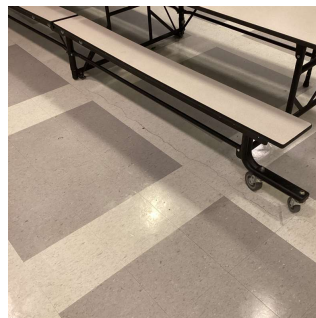
VINYL TILES: DETERIORATED SUBSTRATE

Near Room 112, Center, Near Entrance

REPLACE

PRIORITY 3

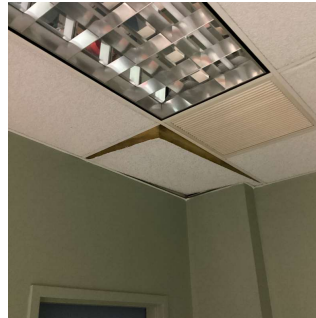
Priority Condition Exist Last Year?	Priority Category	Condition Description	Component Affected	Location Description	Person(s) Notified	Person(s) Title	PhotoImage
No	Potential Falling Debris	Loose ceiling tile is a potential safety hazard.	INTERIOR   CLASSROOMS /CORRIDORS/ ADMIN SPACES   Ceiling	Room 289	Kevin Lendle	Fireman

ACOUSTIC TILES: DAMAGED/MISSING

Room 289

REPLACE

PRIORITY 5

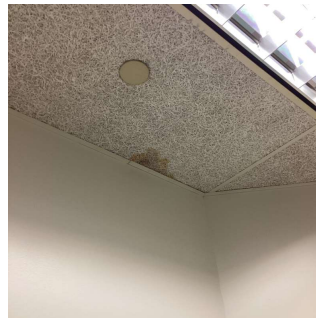
Corridor near Room 118

TECTUM: DAMAGED/MISSING

Corridor near Room 118, Rooms 234, 262, 270

REPLACE

PRIORITY 3

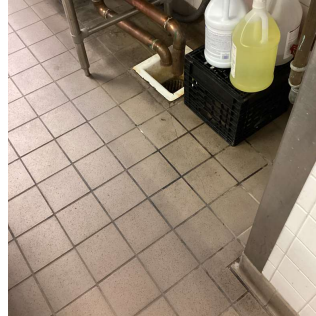
**QUARRY TILE: BROKEN/MISSING TILES**

Near Sinks

REPLACE

PRIORITY 3

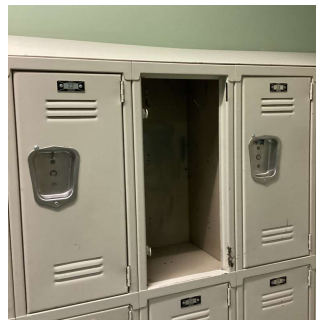
Instance on 2nd Floor - Boys (72 Lockers)	Inspected
Condition	2 - Between Good and Fair
Deficiency	DAMAGED UNITS
Deficiency Location/Instance	Locker 25
Deficiency Quantity	1
Quantity Uom	EACH
Potential Action	REPLACE
Urgency of Action	PRIORITY 3
Purpose of Action	LEVEL 2
Deficiency Photo1

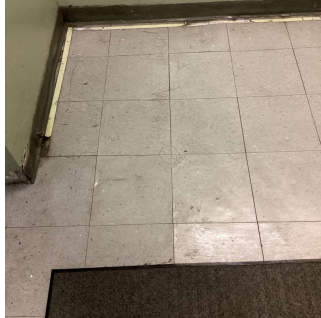
Deficiency	VINYL TILES: BROKEN/DETERIORATED/MISSING TILES
Deficiency Location/Instance	Stair H/1
Deficiency Quantity	20
Quantity Uom	S.F.
Potential Action	REPLACE
Urgency of Action	PRIORITY 3
Purpose of Action	LEVEL 2
Deficiency Photo1

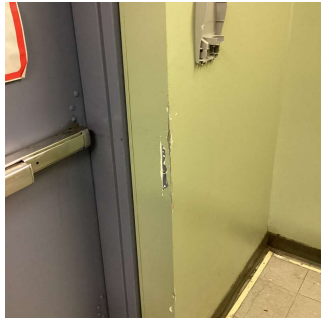
Stair H/1

Deficiency	GYPSUM BOARD: DETERIORATED
Deficiency Location/Instance	Stair H/1, 2
Deficiency Quantity	20
Quantity Uom	S.F.
Potential Action	REPLACE
Urgency of Action	PRIORITY 3
Purpose of Action	LEVEL 2
Deficiency Photo1

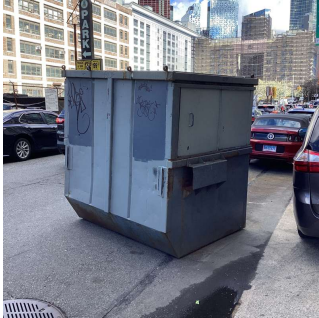
Question	Response
<b>INTERIOR</b>	
<b>TOILET ROOMS - STUDENTS</b>	
<b>Ceiling</b>	
Quantity Uom	S.F.
Potential Action	REPLACE
Urgency of Action	PRIORITY 3
Purpose of Action	LEVEL 2
Deficiency Photo1	 
Violations	1st Floor - Boys No violations recorded.
<b>Door(s)</b>	Inspected
Condition	2 - Between Good and Fair
Deficiency	No deficiencies recorded
<b>Floor Finish</b>	Inspected
Condition	2 - Between Good and Fair
Deficiency	No deficiencies recorded
<b>Stalls</b>	Inspected
Condition	2 - Between Good and Fair
Deficiency	No deficiencies recorded
<b>Walls</b>	Inspected
Condition	2 - Between Good and Fair
Deficiency	No deficiencies recorded
<b>LIFE SAFETY</b>	Inspected
<b>F.D. HOLDING AREA</b>	Does not Exist
<b>STEEL STAIRS</b>	Does not Exist
<b>SITE</b>	Inspected
<b>CONTAINERIZATION</b>	Inspected
Condition	5 - Poor
Deficiency	CONTAINER DAMAGED
Deficiency Location/Instance	30th Place
Deficiency Quantity	1
Quantity Uom	EACH
Potential Action	REPLACE
