NYC Department of Education
Building Condition Assessment Survey 2023 - 2024

Architectural Inspection

Asset: P.S. 892 - QUEENS, 199-10 112TH AVENUE, New York, 11412

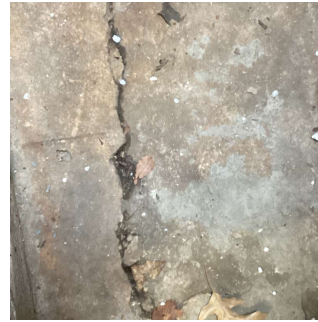
Facade C - AW10

AREAWAY SLAB: CRACKS AND SPALLING

REPAIR

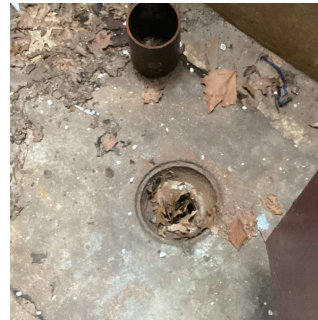
Facade C - AW10

AREAWAY DRAINS: DETERIORATED

REPLACE

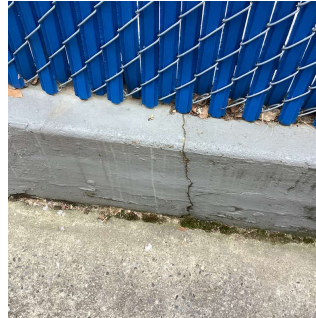
Facade C - AW6

AREAWAY WALLS: CRACKS AND SPALLING

Deficiency Quantity	40
Quantity Uom	S.F.
Potential Action	REPAIR
Urgency of Action	PRIORITY 3
Purpose of Action	LEVEL 2
Deficiency Photo1

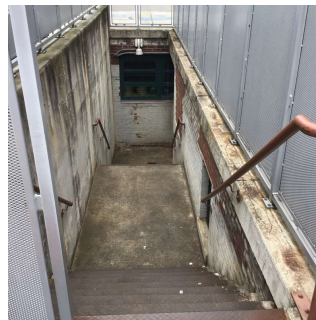
AW7

Deficiency AREAWAY STAIRS: DETERIORATED TREADS/RISERS/NOSINGS

Deficiency Quantity	10
Quantity Uom	S.F.
Potential Action	REPAIR
Urgency of Action	PRIORITY 3
Purpose of Action	LEVEL 2
Deficiency Photo1

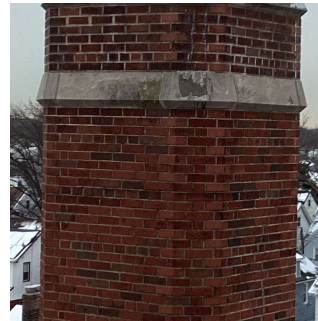
Roof 5 - Chimney 1

Deficiency BRICK: DETERIORATED JOINTS

50
S.F.
REPOINT
PRIORITY 3
LEVEL 2

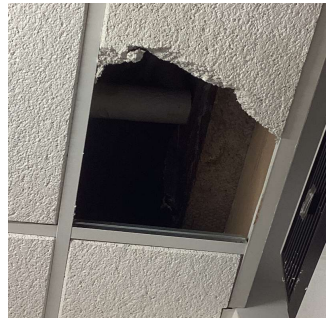
Question	Response
EXTERIOR	
EXTERIOR WALLS	
Instance Condition	5 - Poor
Instance Quantity	12,000
Instance Quantity Uom	S.F.
Deficiency	BRICK: WATER INFILTRATION IN INSTRUCTIONAL SPACE
Roof Plan reference

Deficiency Quantity	1,300
Quantity Uom	S.F.
Potential Action	REPAIR
Urgency of Action	PRIORITY 5
Purpose of Action	LEVEL 2
Deficiency Photo1

Violations	Facade C - Room 314, also Rooms 310, 312, 316, 320, 220, 216, 214, 212, 210, Facade A - Rooms 301, 303, 201
Violations	No violations recorded.
Deficiency	BRICK: DETERIORATED JOINTS

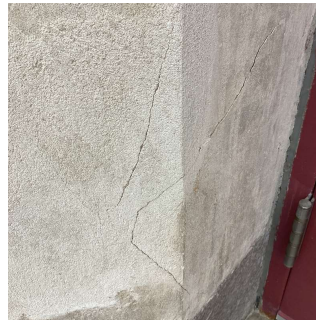
Facade A

STONE: CHIPPED/SPALLED/BROKEN PIECES - MINOR

REPAIR

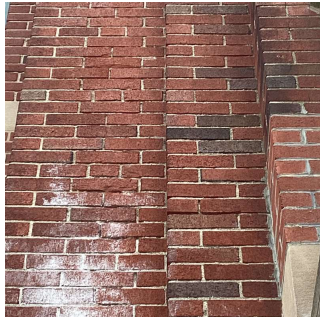
BRICK: DETERIORATED JOINTS

Question	Response
EXTERIOR	
EXTERIOR WALLS	
Urgency of Action	PRIORITY 4
Purpose of Action	LEVEL 2
Deficiency Photo1

Violations	Facade A No violations recorded.
Deficiency	BRICK: EFFLORESCENCE
Rooftop reference

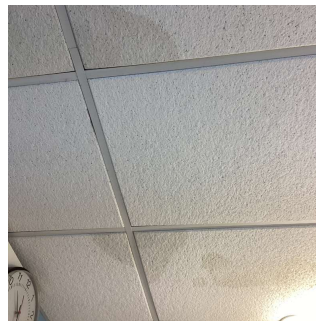
Roof 3 - Room 311

Sustainable Roof Location (Roof Number)	All Roofs
Do solar panels exist on these roofs?	No
Is/Are the roof(s) suitable for Solar Panel installation?	Yes
Installation Year	2015
Source of Installation	Custodial Staff
Deficiency	MODIFIED BITUMEN: ROOFING: MAJOR ACTIVE ROOF LEAKS IN INSTRUCTIONAL SPACE

100
S.F.
REPLACE ROOFING WITHOUT MAJOR EQUIPMENT
REMOVAL
PRIORITY 5
LEVEL 2

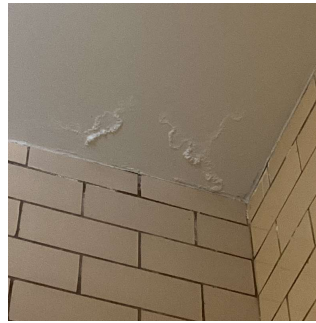
Roof 1 - Bulkhead

BULKHEAD/PENTHOUSE WALLS/INTERIOR: PLASTER
CRACKS/SPALLING

10
S.F.
REPLACE

PRIORITY 3
LEVEL 2

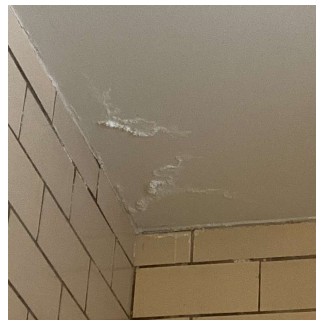
Roof 1 - Bulkhead

BULKHEAD/PENTHOUSE ROOF: MAJOR LEAKAGE

100
S.F.
REPLACE
PRIORITY 5
LEVEL 2

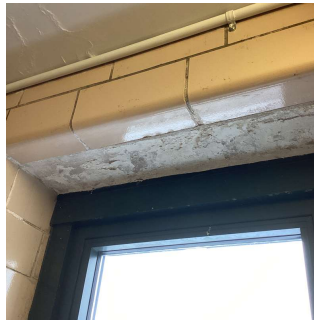
Roof 1 - Bulkhead
No violations recorded.

BULKHEAD/PENTHOUSE WINDOWS: AIR/WATER INFILTRATION WITH DAMAGED CAULKING

10
L.F.
MAINTENANCE
PRIORITY 3
LEVEL 2

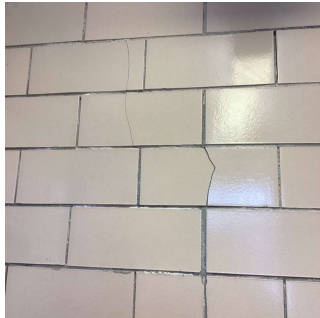
BULKHEAD/PENTHOUSE WALLS/INTERIOR: SALT GLAZED BRICK CRACKS/SPALLING

10
S.F.
REPLACE
PRIORITY 3
LEVEL 2

Violations	Roof 1 - Bulkhead No violations recorded.
Deficiency	BULKHEAD/PENTHOUSE WALLS/EXTERIOR: WATER INFILTRATION
Roof Plan reference

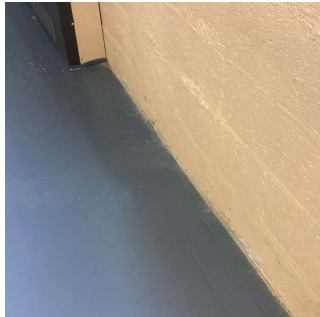
Deficiency Quantity	100
Quantity Uom	S.F.
Potential Action	REPAIR
Urgency of Action	PRIORITY 5
Purpose of Action	LEVEL 2
Deficiency Photo1

Violations	Roof 1 - Penthouse No violations recorded.
CUPOLA/ SPIRES/ TOWERS	Does not Exist
DORMER	Does not Exist
DUNNAGE STEEL	Inspected
Condition	2 - Between Good and Fair
Deficiency	No deficiencies recorded
SKYLIGHT/ROOF VENT	Does not Exist
ROOF/GRAVITY TANK	Does not Exist

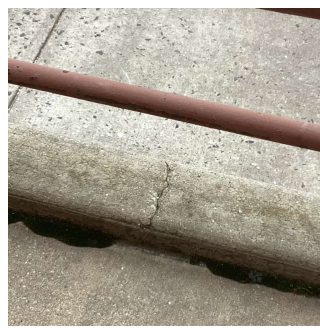
Violations	<p>Facade D</p> <p>No violations recorded.</p>

Question	Response
EXTERIOR	
STAIRS/RAMPS: EXTERIOR	Inspected
BUILDING CHEEK/FLANK WALLS	Inspected
Condition	2 - Between Good and Fair
Deficiency	CAST IN PLACE CONCRETE: CRACKS/SPALLING - MINOR
Roof Plan reference

Deficiency Quantity	10
Quantity Uom	S.F.
Potential Action	REPAIR
Urgency of Action	PRIORITY 3
Purpose of Action	LEVEL 2
Deficiency Photo1

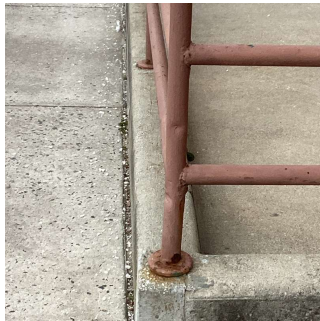
RAILINGS	Inspected
Condition	3 - Fair
Deficiency	DAMAGED
Roof Plan reference

Deficiency Quantity	10
Quantity Uom	L.F.
Potential Action	REPLACE
Urgency of Action	PRIORITY 4
Purpose of Action	LEVEL 2

Violations	Facade D No violations recorded.
STAIRS/RAMPS	
Condition	Inspected 3 - Fair
Deficiency	STONE: DETERIORATED JOINTS
Roof Plan reference

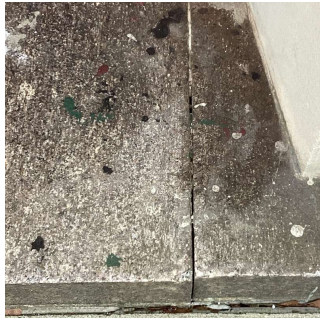
Deficiency Quantity	10
Quantity Uom	L.F.
Potential Action	REPOINT
Urgency of Action	PRIORITY 3
Purpose of Action	LEVEL 2
Deficiency Photo1

Violations	Facade A No violations recorded.
Deficiency	STONE: CRACKS/SPALLING - MINOR

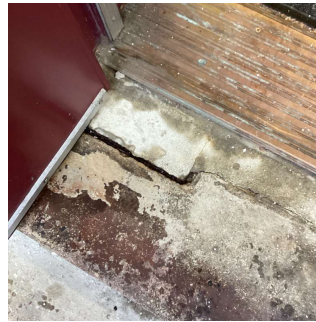
Facade B
 No violations recorded.

20
 S.F.
 REPAIR
 PRIORITY 3
 LEVEL 2

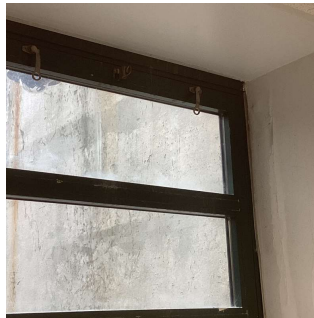
Facade C - Room C20
No violations recorded.

WINDOWS	Inspected
Replacement Quantity	8,000
Replacement Uom	S.F.
EXTERIOR GUARDS	Inspected
Condition	2 - Between Good and Fair
Deficiency	No deficiencies recorded
LINTELS	Inspected
Condition	2 - Between Good and Fair
Deficiency	No deficiencies recorded
WINDOWS	Inspected
Material Type(s)	Aluminum
Instance on Aluminum - Other: All Facades	Inspected
Instance Condition	3 - Fair
Instance Quantity	8,000
Instance Quantity Uom	S.F.
Are these windows insulated	Yes
Installation Year	2015
Source of Installation	Custodial Staff
Deficiency	ALUMINUM - OTHER: AIR/WATER INFILTRATION

20
L.F.
REPLACE TRIM, SILLS OR WEATHERSTRIPPING
PRIORITY 5
LEVEL 2

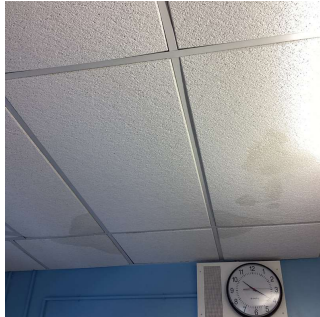
Instance on Basement (1,500 SF)	Does not Exist
CLASSROOMS/CORRIDORS/ADMIN SPACES	
Ceiling	Inspected
Condition	2 - Between Good and Fair
Deficiency	ACOUSTIC TILES: DAMAGED/MISSING - ACTIVE LEAK
Deficiency Location/Instance	Rooms 201, 210, 214, 220, 311, 314
Deficiency Quantity	80
Quantity Uom	S.F.
Potential Action	REPLACE
Urgency of Action	PRIORITY 5

Violations	Room 311 No violations recorded.
Deficiency	GYPSUM BOARD: DAMAGED/DETERIORATED
Deficiency Location/Instance	Corridor near Stair C/Basement
Deficiency Quantity	20
Quantity Uom	S.F.
Potential Action	REPLACE
Urgency of Action	PRIORITY 3
Purpose of Action	LEVEL 2
Deficiency Photo1

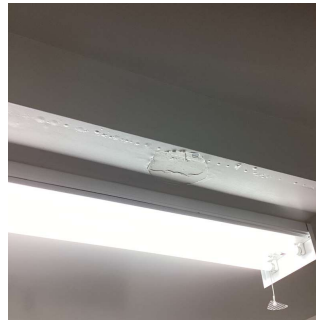
Deficiency	GYPSUM BOARD: DAMAGED/DETERIORATED - ACTIVE LEAK
Deficiency Location/Instance	Room C26g
Deficiency Quantity	10
Quantity Uom	S.F.
Potential Action	REPLACE
Urgency of Action	PRIORITY 5
Purpose of Action	LEVEL 2
Deficiency Photo1

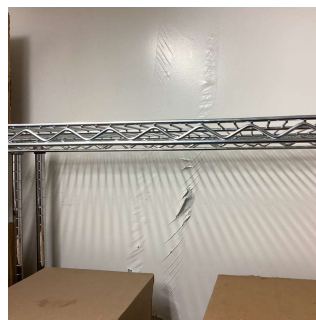
Instance on Basement	Inspected
Condition	2 - Between Good and Fair
Deficiency	GYPSUM BOARD: DETERIORATED - ACTIVE LEAK
Deficiency Location/Instance	Room C26g
Deficiency Quantity	20
Quantity Uom	S.F.
Potential Action	REPLACE
Urgency of Action	PRIORITY 5
Purpose of Action	LEVEL 2
Deficiency Photo1

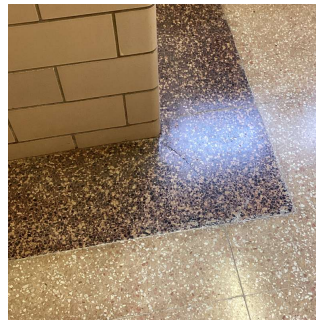
Stair D/Bulkhead

TERRAZZO: CRACKS

REPLACE

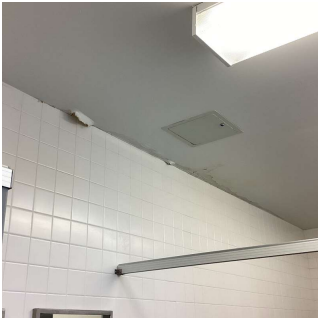
Question	Response
INTERIOR	
STAIRS/RAMPS: INTERIOR	
Walls	
Deficiency Photo1	 
Violations	Stair D/1 No violations recorded.
TOILET ROOMS - STAFF	Inspected
Ceiling	Inspected
Condition	2 - Between Good and Fair
Deficiency	No deficiencies recorded
Door(s)	Inspected
Condition	2 - Between Good and Fair
Deficiency	No deficiencies recorded
Floor Finish	Inspected
Condition	2 - Between Good and Fair
Deficiency	No deficiencies recorded
Stalls	Does not Exist
Walls	Inspected
Condition	2 - Between Good and Fair
Deficiency	GYPSON BOARD: DETERIORATED
Deficiency Location/Instance	Room 112a
Deficiency Quantity	10
Quantity Uom	S.F.
Potential Action	REPLACE
Urgency of Action	PRIORITY 3
Purpose of Action	LEVEL 2
Deficiency Photo1	 
Violations	Room 112a No violations recorded.
TOILET ROOMS - STUDENTS	Inspected
Ceiling	Inspected
Condition	2 - Between Good and Fair
Deficiency	GYPSON BOARD: DAMAGED/DETERIORATED
Deficiency Location/Instance	Rooms 202, 218b

Question	Response
INTERIOR	
TOILET ROOMS - STUDENTS	
Ceiling	
Deficiency Quantity	30
Quantity Uom	S.F.
Potential Action	REPLACE
Urgency of Action	PRIORITY 3
Purpose of Action	LEVEL 2
Deficiency Photo1

Room 202
Violations	No violations recorded.
Door(s)	Inspected
Condition	2 - Between Good and Fair
Deficiency	No deficiencies recorded
Floor Finish	Inspected
Condition	2 - Between Good and Fair
Deficiency	No deficiencies recorded
Stalls	Inspected
Condition	2 - Between Good and Fair
Deficiency	No deficiencies recorded
Walls	Inspected
Condition	2 - Between Good and Fair
Deficiency	No deficiencies recorded
LIFE SAFETY	Inspected
F.D. HOLDING AREA	Does not Exist
STEEL STAIRS	Does not Exist
SITE	Inspected
CONTAINERIZATION	Does not Exist
Drainage System for Asphalt	Does not Exist
Drainage System for Concrete	Inspected
Catch Basins/Manhole - Surrounded by concrete	Inspected
Condition	2 - Between Good and Fair
Deficiency	No deficiencies recorded

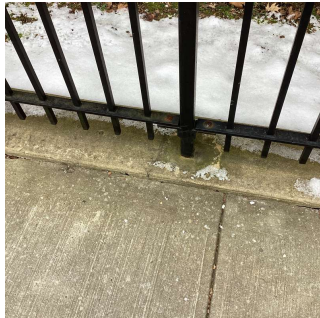
Violations	112th Avenue No violations recorded.
Deficiency	CONCRETE CURB: DAMAGED/DETERIORATED
Deficiency Location/Instance	112th Avenue, 199th Street
Deficiency Quantity	20
Quantity Uom	S.F.
Potential Action	REPLACE
Urgency of Action	PRIORITY 3
Purpose of Action	LEVEL 2
Deficiency Photo1

Violations	112th Avenue No violations recorded.
IRRIGATION SYSTEM	Does not Exist
PAVING	Inspected
Student Non-Use	Does not Exist
Student Use	Does not Exist
Site Sidewalks & Walkways	Inspected
Asphalt	Does not Exist
Concrete	Inspected
Condition	2 - Between Good and Fair
Deficiency	No deficiencies recorded
Pavers	Does not Exist
DOT Sidewalk	Inspected
Asphalt	Does not Exist
Concrete	Inspected
Condition	4 - Between Fair and Poor

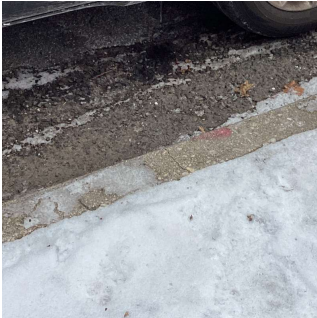
Question	Response
SITE	
PAVING	
DOT Sidewalk	
Concrete	
Deficiency	DAMAGED CURBS
Deficiency Location/Instance	200th Street, 199th Street
Deficiency Quantity	30
Quantity Uom	L.F.
Potential Action	REPLACE
Urgency of Action	PRIORITY 3
Purpose of Action	LEVEL 2
Deficiency Photo1

200th Street
Violations	No violations recorded.
Deficiency	DAMAGED/DETERIORATED/MISSING SECTIONS
Deficiency Location/Instance	200th Street, 112th Avenue, 199th Street
Deficiency Quantity	1,225
Quantity Uom	S.F.
Potential Action	REPLACE
Urgency of Action	PRIORITY 3
Purpose of Action	LEVEL 2
Deficiency Photo1

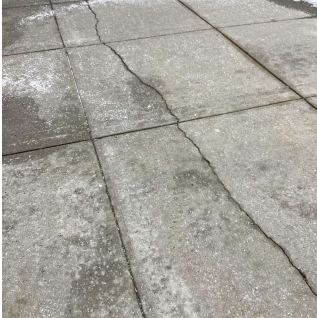
112th Avenue
Violations	No violations recorded.
Pavers	Does not Exist
PLAYGROUNDS	
Instance on Behind Building	Inspected
Instance on Behind Building	Inspected
Benches	
Instance on Behind Building	Does not Exist
Fence	
Instance on Behind Building	Inspected
Condition	2 - Between Good and Fair
Deficiency	No deficiencies recorded
Pavement
