**NYC Department of Education**  
**Building Condition Assessment Survey 2023 - 2024**

Architectural Inspection

Q907

**Asset:** P.S. 43 ANNEX - QUEENS, 12 MARVIN STREET, New York, 11691

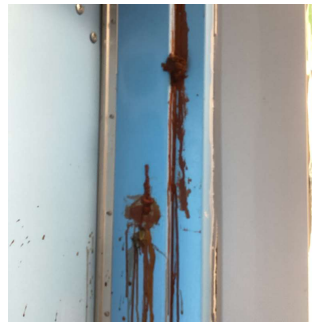
Facade C

Question	Response
<b>EXTERIOR</b>	
<b>COPING</b>	
Roof Plan reference	
Deficiency Quantity	20
Quantity Uom	L.F.
Potential Action	MAINTENANCE
Urgency of Action	PRIORITY 3
Purpose of Action	LEVEL 2
Deficiency Photo1	
Violations	Roof 1 No violations recorded.
<b>CORNICE</b>	Does not Exist
<b>DOORS</b>	Inspected
<b>DOORS AND FRAMES</b>	Inspected
Condition	5 - Poor
Deficiency	METAL: DETERIORATED DOOR AND FRAME - MAJOR DETERIORATION
Roof Plan reference	
Deficiency Quantity	4
Quantity Uom	EACH
Potential Action	REPLACE
Urgency of Action	PRIORITY 4
Purpose of Action	LEVEL 2

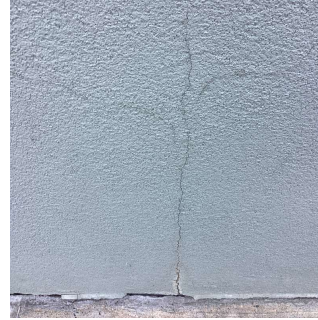
Facade A

STUCCO CEMENT SURFACE: CRACKS, SPALLING

S.F.  
 REPLACE  
 PRIORITY 4  
 LEVEL 2

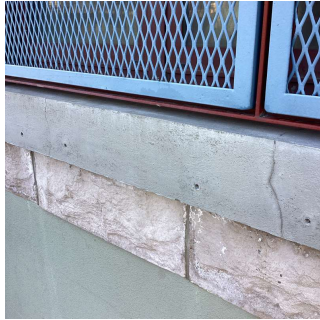
BRICK: DETERIORATED MASONRY SILLS - MINOR

30  
 L.F.  
 REPAIR  
 PRIORITY 3  
 LEVEL 2

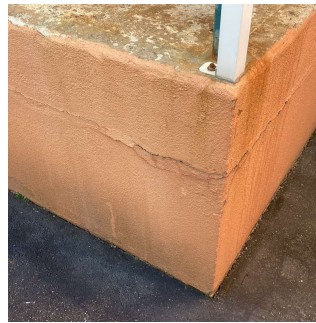
Facade C

Deficiency      STUCCO CEMENT SURFACE: CRACKS/SPALLING - MINOR  
 Roof Plan reference

Deficiency Quantity	50
Quantity Uom	S.F.
Potential Action	REPAIR
Urgency of Action	PRIORITY 3
Purpose of Action	LEVEL 2

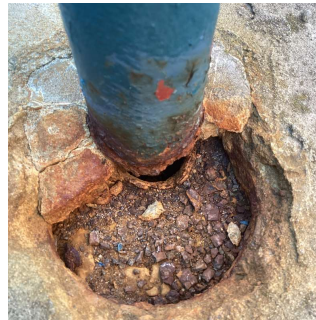
Facade C

4 - Between Fair and Poor

RUST - MAJOR

REPLACE

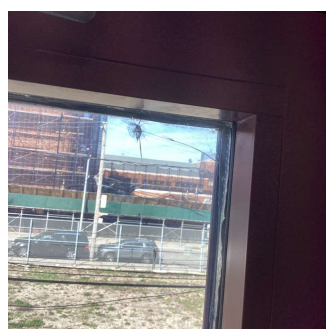
<b>LINTELS</b>	Inspected
Condition	2 - Between Good and Fair
Deficiency	No deficiencies recorded
<b>WINDOWS</b>	Inspected
Material Type(s)	Aluminum
Instance on Aluminum - Other: Facades A, C	Inspected
Instance Condition	3 - Fair
Instance Quantity	3,800
Instance Quantity Uom	S.F.
Are these windows insulated	Yes
Installation Year	2004
Source of Installation	Custodial Staff
Deficiency	ALUMINUM - OTHER: BROKEN PANE

Violations	Facade A - 2nd Floor Administration Room No violations recorded.
<b>INTERIOR</b>	Inspected
<b>POOLS</b>	Does not Exist
<b>STRUCTURAL</b>	Inspected
<b>COLUMNS/BEAMS/BEARING WALLS</b>	Inspected
Condition	2 - Between Good and Fair
Deficiency	No deficiencies recorded
<b>FLOOR STRUCTURE</b>	Inspected
Condition	2 - Between Good and Fair
Deficiency	No deficiencies recorded
<b>FOUNDATION WALLS</b>	Inspected
Material Type(s)	Concrete
Condition	2 - Between Good and Fair

Deficiency Quantity	30
Quantity Uom	S.F.
Potential Action	MAINTENANCE
Urgency of Action	PRIORITY 3
Purpose of Action	LEVEL 2
Deficiency Photo1

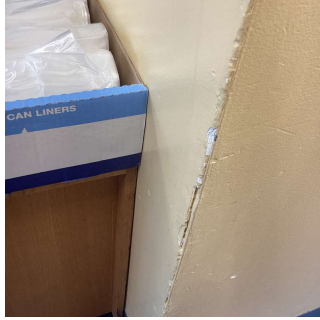
Question	Response
<b>INTERIOR</b>	
<b>CLASSROOMS/CORRIDORS/ADMIN SPACES</b>	
<b>Door(s)</b>	Inspected
Violations	No violations recorded.
<b>Floor Finish</b>	Inspected
Condition	2 - Between Good and Fair
Deficiency	VINYL TILES: BROKEN/DETERIORATED/MISSING TILES
Deficiency Location/Instance	Corridor near Room 201
Deficiency Quantity	10
Quantity Uom	S.F.
Potential Action	REPLACE
Urgency of Action	PRIORITY 3
Purpose of Action	LEVEL 2
Deficiency Photo1	 
Violations	Corridor near Room 201 No violations recorded.
<b>Walls</b>	Inspected
Condition	2 - Between Good and Fair
Deficiency	GYPSUM BOARD: DETERIORATED
Deficiency Location/Instance	Administration 2nd Floor, Corridor near Rooms 101, 103, Administration 2nd Floor
Deficiency Quantity	50
Quantity Uom	S.F.
Potential Action	REPLACE
Urgency of Action	PRIORITY 3
Purpose of Action	LEVEL 2
Deficiency Photo1

Violations	Administration 2nd Floor No violations recorded.
<b>Specialties</b>	Does not Exist

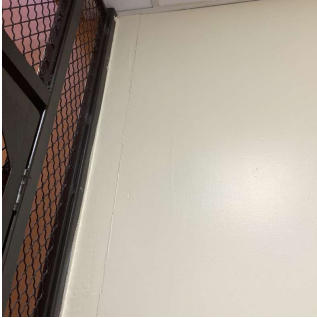
Question	Response
<b>INTERIOR</b>	
<b>STAIRS/RAMPS: INTERIOR</b>	
<b>Partition</b>	Does not Exist
<b>Railings</b>	Inspected
Condition	2 - Between Good and Fair
Deficiency	No deficiencies recorded
<b>Stairs and Landings</b>	Inspected
Condition	2 - Between Good and Fair
Deficiency	No deficiencies recorded
<b>Walls</b>	Inspected
Condition	2 - Between Good and Fair
Deficiency	GYP SUM BOARD: DETERIORATED
Deficiency Location/Instance	Stair B/2
Deficiency Quantity	10
Quantity Uom	S.F.
Potential Action	REPLACE
Urgency of Action	PRIORITY 3
Purpose of Action	LEVEL 2
Deficiency Photo1

Violations	Stair B/2 No violations recorded.
<b>TOILET ROOMS - STAFF</b>	Inspected
<b>Ceiling</b>	Inspected
Condition	2 - Between Good and Fair
Deficiency	No deficiencies recorded
<b>Door(s)</b>	Inspected
Condition	2 - Between Good and Fair
Deficiency	No deficiencies recorded
<b>Floor Finish</b>	Inspected
Condition	2 - Between Good and Fair
Deficiency	No deficiencies recorded

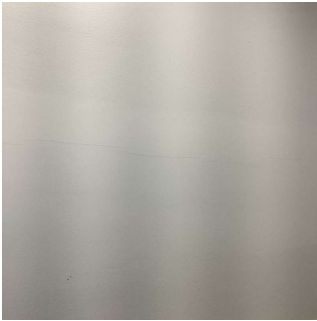
<b>Stalls</b>	Does not Exist
<b>Walls</b>	Inspected
Condition	2 - Between Good and Fair
Deficiency	GYP SUM BOARD: DETERIORATED
Deficiency Location/Instance	1st Floor
Deficiency Quantity	10
Quantity Uom	S.F.
Potential Action	REPLACE
Urgency of Action	PRIORITY 3
Purpose of Action	LEVEL 2

Violations	1st Floor No violations recorded.
<b>TOILET ROOMS - STUDENTS</b>	
<b>Ceiling</b>	Inspected
Condition	2 - Between Good and Fair
Deficiency	ACOUSTIC TILES: DAMAGED/MISSING
Deficiency Location/Instance	Room 203/204
Deficiency Quantity	10
Quantity Uom	S.F.
Potential Action	REPLACE
Urgency of Action	PRIORITY 3
Purpose of Action	LEVEL 2
Deficiency Photo1	 
Violations	Room 203/204 No violations recorded.
<b>Door(s)</b>	Inspected
Condition	2 - Between Good and Fair
Deficiency	No deficiencies recorded
<b>Floor Finish</b>	Inspected
Condition	2 - Between Good and Fair
Deficiency	CERAMIC TILE: BROKEN/MISSING TILES
Deficiency Location/Instance	Rooms 104, 201/202
Deficiency Quantity	20
Quantity Uom	S.F.
Potential Action	REPLACE
Urgency of Action	PRIORITY 3
Purpose of Action	LEVEL 2

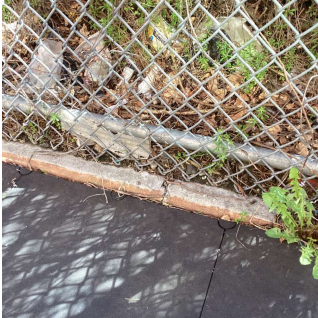
Question	Response
<b>SITE</b>	
<b>DRINKING FOUNTAINS</b>	Does not Exist
<b>FENCES</b>	Inspected
Condition	3 - Fair
Deficiency	CONCRETE CURB: DAMAGED/DETERIORATED
Deficiency Location/Instance	Playground Area
Deficiency Quantity	50
Quantity Uom	S.F.
Potential Action	REPLACE
Urgency of Action	PRIORITY 3
Purpose of Action	LEVEL 2
Deficiency Photo1

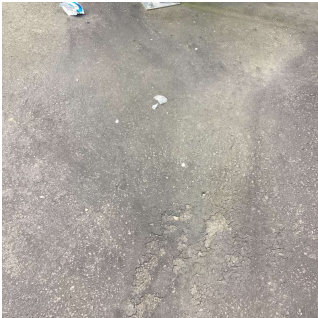
Near Marvin Street
Violations	No violations recorded.
<b>Concrete</b>	Inspected
Condition	2 - Between Good and Fair
Deficiency	No deficiencies recorded

Playground Area
Violations	No violations recorded.
<b>IRRIGATION SYSTEM</b>	Does not Exist
<b>PAVING</b>	Inspected
<b>Student Non-Use</b>	Inspected
Gravel Exists?	No
<b>Asphalt</b>	Inspected
Condition	2 - Between Good and Fair
Deficiency	CRACKS - MAJOR
Deficiency Location/Instance	Near Marvin Street, Entrance
Deficiency Quantity	30
Quantity Uom	S.F.
Potential Action	REPLACE
Urgency of Action	PRIORITY 3
Purpose of Action	LEVEL 2
Deficiency Photo1

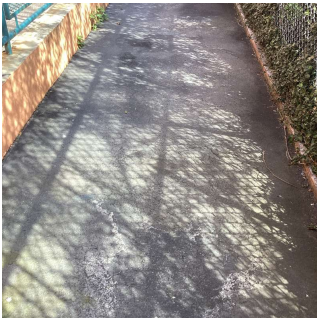
Question	Response
<b>SITE</b>	
<b>PLAYGROUNDS</b>	
<b>Benches</b>	
Condition	2 - Between Good and Fair
Deficiency	No deficiencies recorded
<b>Fence</b>	
Instance on Schoolyard	Does not Exist
<b>Pavement</b>	
Instance on Schoolyard	Inspected
Condition	3 - Fair
Deficiency	ASPHALT: CRACKS - MAJOR
Deficiency Location/Instance	Near Ramp
Deficiency Quantity	60
Quantity Uom	S.F.
Potential Action	REPLACE
Urgency of Action	PRIORITY 3
Purpose of Action	LEVEL 2
Deficiency Photo1
