NYC Department of Education
Building Condition Assessment Survey 2023 - 2024

Architectural Inspection

Asset: I.S. 230 ANNEX (PLAY YARD) - QUEENS, 33-54 74TH STREET, New York, 11372

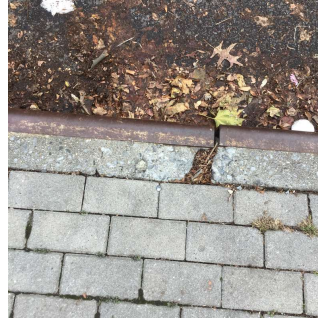
74th Street

Urgency of Action
 Purpose of Action
 Deficiency Photo1

PRIORITY 3
 LEVEL 2

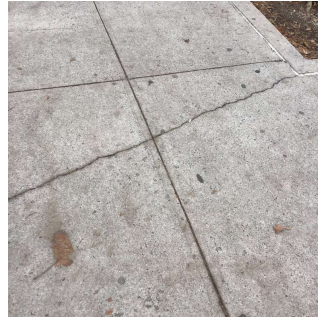
DAMAGED/DETERIORATED/MISSING SECTIONS

34th Avenue, 74th Street

125

REPLACE

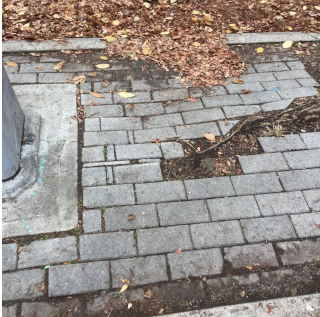
Deficiency

DAMAGED/MISSING

34th Avenue, 74th Street

10

REPLACE

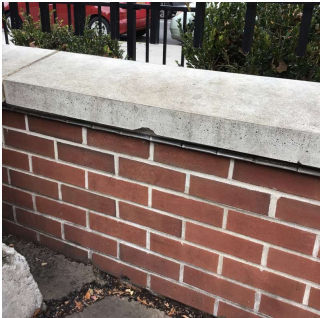
Violations	34th Avenue No violations recorded.
PLAYGROUNDS	Does not Exist
PLAYING SURFACE	Does not Exist
RETAINING WALLS	Inspected
Are there any Retaining Walls 6' OR higher facing public street/sidewalk?	No
Condition	2 - Between Good and Fair
Deficiency	BRICK: DETERIORATED COPING STONE
Deficiency Location/Instance	Near 74th Street
Deficiency Quantity	10
Quantity Uom	S.F.
Potential Action	REPLACE
Urgency of Action	PRIORITY 3
Purpose of Action	LEVEL 2
Deficiency Photo1
