NYC Department of Education
Building Condition Assessment Survey 2023 - 2024

Architectural Inspection

Asset: P.S. 116 TRANSPORTABLE - Q, 107-25 WREN PLACE, New York, 11433

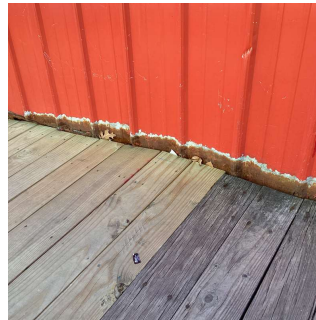
Facade A

METAL PANEL: DAMAGED TRIM

Deficiency Quantity

30

Potential Action

REPLACE

PRIORITY 4

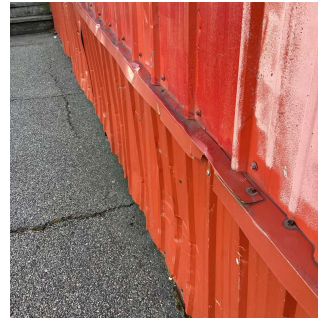
Facade A

METAL PANEL: SEVERE DENTS

Deficiency Quantity

30

Potential Action

REPLACE

PRIORITY 4
LEVEL 2

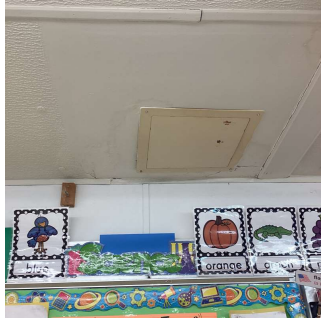
Roof 2
Instance Quantity	2,600
Instance Quantity Uom	S.F.
Does the roof have major mechanical equipment sitting on Dunnage Steel less than 18" above the Roofing?	No
Does this roof instance have a Sustainable Roof System?	No
Do solar panels exist on these roofs?	No
Is/Are the roof(s) suitable for Solar Panel installation?	No
Installation Year	1997
Source of Installation	Custodial Staff
Deficiency	SINGLE PLY, FULLY ADHERED ROOF: ROOFING: MAJOR ACTIVE ROOF LEAKS IN INSTRUCTIONAL SPACE
Roof Plan reference	Q930

Violations	Roof 1 - Room T-6, also T-5, Roof 2 - Room - T-3 No violations recorded.
STAIRS/RAMPS: EXTERIOR	Inspected
RAILINGS	Inspected
Condition	5 - Poor
Deficiency	DAMAGED
Roof Plan reference	Q930

Deficiency Quantity	300

Quantity Uom	S.F.
Potential Action	REPLACE ROOFING WITHOUT MAJOR EQUIPMENT REMOVAL
Urgency of Action	PRIORITY 5
Purpose of Action	LEVEL 2

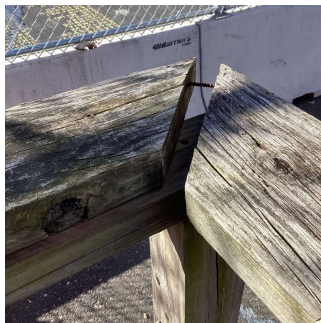
Violations	Facade A No violations recorded.
STAIRS/RAMPS	Inspected
Condition	5 - Poor
Deficiency	WOOD: DETERIORATED

Deficiency Quantity	30
Quantity Uom	L.F.
Potential Action	REPLACE
Urgency of Action	PRIORITY 4
Purpose of Action	LEVEL 2
Deficiency Photo1

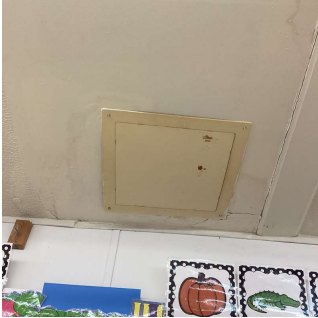
Question	Response
INTERIOR	
STRUCTURAL	
FLOOR STRUCTURE	Inspected
Condition	2 - Between Good and Fair
Deficiency	No deficiencies recorded
ROOF STRUCTURE	Inspected
Condition	2 - Between Good and Fair
Deficiency	No deficiencies recorded
CLASSROOMS/CORRIDORS/ADMIN SPACES	Inspected
Ceiling	Inspected
Condition	2 - Between Good and Fair
Deficiency	GYPSUM BOARD: DAMAGED/DETERIORATED - ACTIVE LEAK
Deficiency Location/Instance	Rooms T6, T5, T3
Deficiency Quantity	40
Quantity Uom	S.F.
Potential Action	REPLACE
Urgency of Action	PRIORITY 5
Purpose of Action	LEVEL 2
Deficiency Photo1

Violations	Room T6 No violations recorded.
Door(s)	Inspected
Condition	2 - Between Good and Fair
Deficiency	No deficiencies recorded
Floor Finish	Inspected
Condition	2 - Between Good and Fair
Deficiency	VINYL TILES: DETERIORATED SUBSTRATE
Deficiency Location/Instance	T4, T5
Deficiency Quantity	30
Quantity Uom	S.F.
Potential Action	REPLACE
Urgency of Action	PRIORITY 3

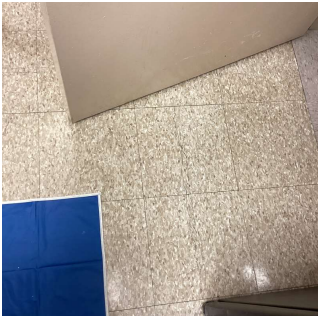
Question	Response
INTERIOR	
CLASSROOMS/CORRIDORS/ADMIN SPACES	
Floor Finish	Inspected
	T4
Violations	No violations recorded.
Walls	Inspected
Condition	2 - Between Good and Fair
Deficiency	GYPSUM BOARD: DETERIORATED - ACTIVE LEAK
Deficiency Location/Instance	T5
Deficiency Quantity	10
Quantity Uom	S.F.
Potential Action	REPLACE
Urgency of Action	PRIORITY 5
Purpose of Action	LEVEL 2
Deficiency Photo1	 
Violations	Room T5 No violations recorded.
INTERIOR DOOR HARDWARE	
Condition	Inspected
Deficiency	3 - Fair No deficiencies recorded
TOILET ROOMS - STAFF	
Ceiling	Inspected
Condition	2 - Between Good and Fair
Deficiency	No deficiencies recorded
Door(s)	Inspected
Condition	2 - Between Good and Fair
Deficiency	No deficiencies recorded
Floor Finish	Inspected
Condition	2 - Between Good and Fair
Deficiency	No deficiencies recorded
Walls	Inspected
Condition	2 - Between Good and Fair
Deficiency	No deficiencies recorded
TOILET ROOMS - STUDENTS

Purpose of Action	LEVEL 2
Deficiency Photo1
