**NYC Department of Education
Building Condition Assessment Survey 2023 - 2024**

Architectural Inspection

Q943

Asset: B. N. CARDOZO HS TRANSPORTABLE - Q, 57-00 223 STREET, New York, 11364

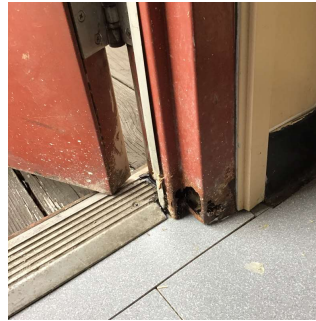
Facade A - T2

Question	Response
Architectural	
EXTERIOR	Inspected
AWNINGS AND CANOPIES	Does not Exist
DOORS	Inspected
DOORS AND FRAMES	Inspected
Condition	5 - Poor
Deficiency	METAL: DETERIORATED DOOR AND FRAME - MAJOR DETERIORATION
Roof Plan reference	
Deficiency Quantity	3
Quantity Uom	EACH
Potential Action	REPLACE
Urgency of Action	PRIORITY 4
Purpose of Action	LEVEL 2

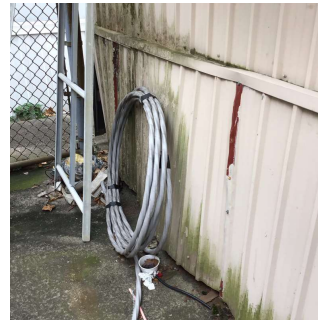
Facade B

4 - Between Fair and Poor

METAL PANEL: SEVERE DENTS

REPLACE

PRIORITY 4

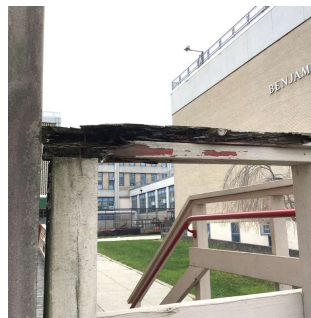
Question	Response
EXTERIOR	
ROOF	
Roofing	
ROOFING	
Does the roof have major mechanical equipment sitting on Dunnage Steel less than 18" above the Roofing?	No
Does this roof instance have a Sustainable Roof System?	No
Do solar panels exist on these roofs?	No
Is/Are the roof(s) suitable for Solar Panel installation?	No
Installation Year	2000
Source of Installation	Custodial Staff
Deficiency	No deficiencies recorded
STAIRS/RAMPS: EXTERIOR	Inspected
RAILINGS	Inspected
Condition	4 - Between Fair and Poor
Deficiency	DAMAGED
Roof Plan reference

Violations	Facade E - T4 No violations recorded.
STAIRS/RAMPS	Inspected
Condition	5 - Poor
Deficiency	WOOD: DETERIORATED

Deficiency Quantity	20
Quantity Uom	L.F.
Potential Action	REPLACE
Urgency of Action	PRIORITY 4
Purpose of Action	LEVEL 2
Deficiency Photo1

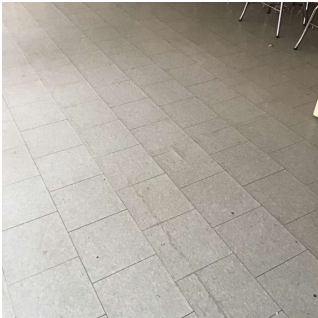
Question	Response
INTERIOR	
STRUCTURAL	
FLOOR STRUCTURE	Inspected
Condition	2 - Between Good and Fair
Deficiency	No deficiencies recorded
ROOF STRUCTURE	Inspected
Condition	2 - Between Good and Fair
Deficiency	No deficiencies recorded
CLASSROOMS/CORRIDORS/ADMIN SPACES	Inspected
Ceiling	Inspected
Condition	2 - Between Good and Fair
Deficiency	No deficiencies recorded
Door(s)	Inspected
Condition	2 - Between Good and Fair
Deficiency	No deficiencies recorded
Floor Finish	Inspected
Condition	5 - Poor
Deficiency	VINYL TILES: DETERIORATED SUBSTRATE
Deficiency Location/Instance	T1,2,3,4
Deficiency Quantity	1,200
Quantity Uom	S.F.
Potential Action	REPLACE
Urgency of Action	PRIORITY 3
Purpose of Action	LEVEL 2
Deficiency Photo1
