**NYC Department of Education**  
**Building Condition Assessment Survey 2023 - 2024**

Architectural Inspection

**Asset: JOHN BOWNE HS TRANSPORTABLE - Q, 63-25 MAIN STREET, New York, 11367**

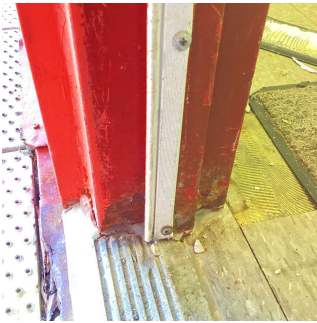
METAL: DETERIORATED DOOR AND FRAME - MINOR DETERIORATION

Violations	Facade A No violations recorded.
<b>DOOR HARDWARE</b>	Inspected
Condition	3 - Fair
Deficiency	No deficiencies recorded
<b>EXTERIOR WALLS</b>	Inspected
Material Type(s)	Steel
Replacement Quantity	10,800
Replacement Uom	S.F.
Instance on All Facades	Inspected
Instance Condition	5 - Poor
Instance Quantity	10,800
Instance Quantity Uom	S.F.
Deficiency	METAL PANEL: MAJOR RUSTING
Roof Plan reference	Q951

Potential Action

MAINTENANCE

PRIORITY 3

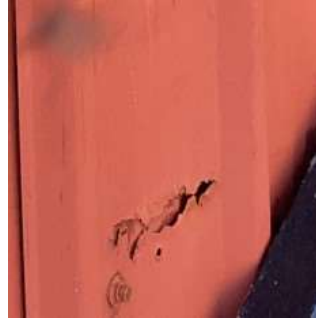
Facade A

Deficiency Quantity	60
Quantity Uom	S.F.
Potential Action	REPLACE
Urgency of Action	PRIORITY 4
Purpose of Action	LEVEL 2

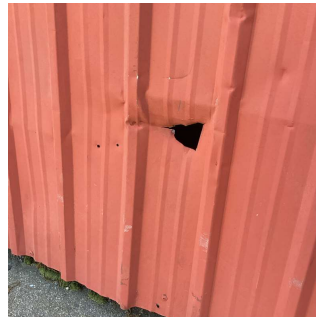
Facade N

**METAL PANEL: SEVERE DENTS**

320

REPLACE

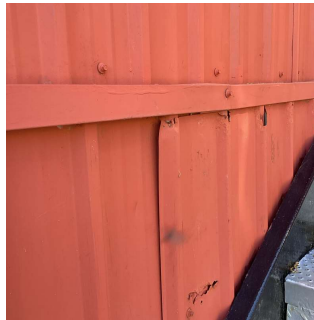
Facade A

**METAL PANEL: DETERIORATED JOINTS**

90

REPAIR

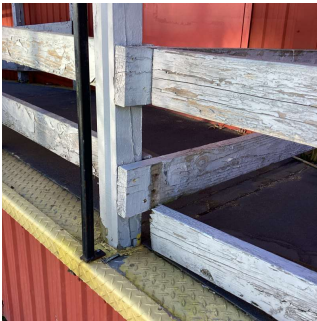
Question	Response
<b>EXTERIOR</b>	
<b>ROOF</b>	
<b>Roofing</b>	
<b>ROOFING</b>	
Roof Plan reference	
Deficiency Quantity	100
Quantity Uom	S.F.
Potential Action	REPLACE ROOFING WITHOUT MAJOR EQUIPMENT REMOVAL
Urgency of Action	PRIORITY 5
Purpose of Action	LEVEL 2
Deficiency Photo1	
Violations	Roof 6 - T11 No violations recorded.
<b>STAIRS/RAMPS: EXTERIOR</b>	Inspected
<b>RAILINGS</b>	Inspected
Condition	4 - Between Fair and Poor
Deficiency	DAMAGED
Roof Plan reference	
Deficiency Quantity	20
Quantity Uom	L.F.
Potential Action	REPLACE
Urgency of Action	PRIORITY 4
Purpose of Action	LEVEL 2

Violations	Facade A No violations recorded.
<b>STAIRS/RAMPS</b>	
Condition	Inspected 5 - Poor
Deficiency	METAL: DAMAGED/DETERIORATED
Roof Plan reference	Q951

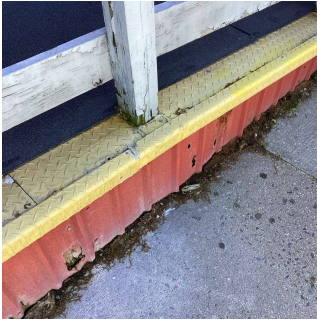
Deficiency Quantity	120
Quantity Uom	S.F.
Potential Action	REPLACE
Urgency of Action	PRIORITY 4
Purpose of Action	LEVEL 2
Deficiency Photo1

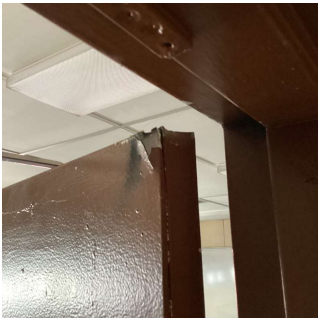
Inside T8

Condition	Inspected
Deficiency	5 - Poor
Deficiency Location/Instance	METAL: DETERIORATED DOOR
Deficiency Quantity	Inside T8, T9
Quantity Uom	2
Potential Action	EACH
Urgency of Action	MAINTENANCE
Purpose of Action	PRIORITY 3
Deficiency Photo1	LEVEL 2

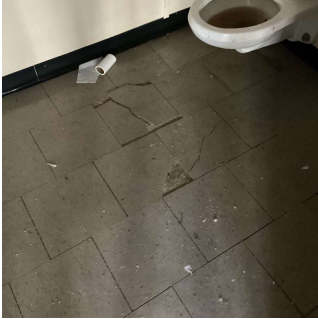
Question	Response
<b>INTERIOR</b>	
<b>TOILET ROOMS - STUDENTS</b>	
<b>Door(s)</b>	Inspected
Violations	No violations recorded.
<b>Floor Finish</b>	Inspected
Condition	2 - Between Good and Fair
Deficiency	VINYL TILES: BROKEN/DETERIORATED/MISSING TILES
Deficiency Location/Instance	Inside T2
Deficiency Quantity	20
Quantity Uom	S.F.
Potential Action	REPLACE
Urgency of Action	PRIORITY 3
Purpose of Action	LEVEL 2
Deficiency Photo1

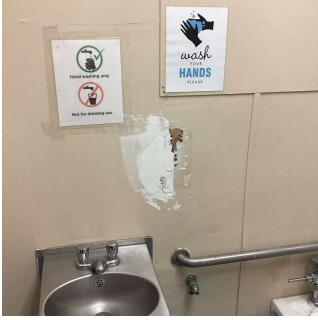
Violations	Inside T2 No violations recorded.
<b>Walls</b>	Inspected
Condition	2 - Between Good and Fair
Deficiency	GYPSON BOARD: DETERIORATED
Deficiency Location/Instance	Inside T1, T2, T9, T10, T11 and other
Deficiency Quantity	70
Quantity Uom	S.F.
Potential Action	REPLACE
Urgency of Action	PRIORITY 3
Purpose of Action	LEVEL 2
Deficiency Photo1
