NYC Department of Education
Building Condition Assessment Survey 2023 - 2024

Architectural Inspection

Asset: ADULT BASIC EDUCATION - QUEENS, 27-35 JACKSON AVENUE, New York, 11101

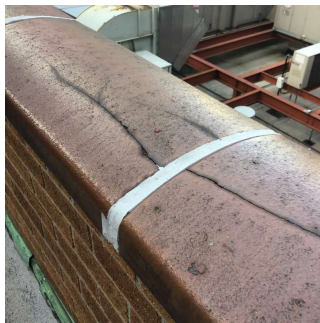
Question	Response
Architectural	
EXTERIOR	Inspected
AREAWAY	Does not Exist
AWNINGS AND CANOPIES	Does not Exist
CHIMNEY	Not Required
COPING	Inspected
Condition	3 - Fair
Deficiency	TERRA COTTA: CRACKED/BROKEN PIECES
Roof Plan reference

Violations	Roof 1 No violations recorded.
CORNICE	Does not Exist
DOORS	Inspected
DOORS AND FRAMES	Inspected
Condition	5 - Poor
Deficiency	METAL: DETERIORATED DOOR AND FRAME - MAJOR DETERIORATION
Roof Plan reference	<p>Q972</p>

Deficiency Quantity	20
Quantity Uom	L.F.
Potential Action	REPLACE-IN-KIND
Urgency of Action	PRIORITY 4

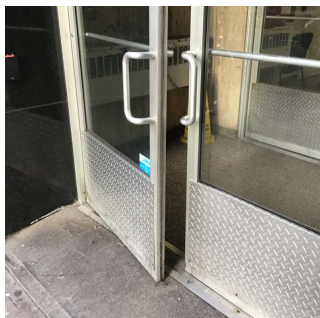
Violations	Facade A - doors do not close properly No violations recorded.
DOOR HARDWARE	Inspected
Condition	3 - Fair
Deficiency	No deficiencies recorded
LINTELS	Inspected
Condition	2 - Between Good and Fair
Deficiency	No deficiencies recorded

Deficiency Quantity	2
Quantity Uom	EACH
Potential Action	REPLACE
Urgency of Action	PRIORITY 4
Purpose of Action	LEVEL 2
Deficiency Photo1

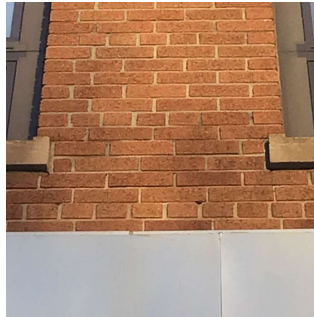
Facade A

BRICK: DETERIORATED JOINTS

1,000

REPOINT

PRIORITY 3

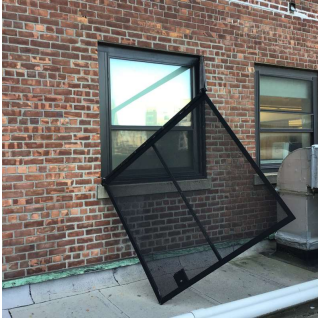
Replacement Quantity	1,300
Replacement Uom	S.F.
EXTERIOR GUARDS	Inspected
Condition	3 - Fair
Deficiency	DETERIORATED/TORN-OUT/MISSING
Roof Plan reference

Violations	Roof 1 No violations recorded.
LINTELS	Inspected
Condition	2 - Between Good and Fair
Deficiency	No deficiencies recorded
WINDOWS	Inspected
Material Type(s)	Aluminum
Instance on Aluminum - Other: All Facades	Inspected
Instance Condition	3 - Fair
Instance Quantity	1,300
Instance Quantity Uom	S.F.
Are these windows insulated	Yes
Installation Year	2000
Source of Installation	Custodial Staff
Deficiency	No deficiencies recorded
INTERIOR	Inspected
POOLS	Does not Exist
STRUCTURAL	Inspected
COLUMNS/BEAMS/BEARING WALLS	
Condition	2 - Between Good and Fair
Deficiency	STEEL COLUMNS/BEAMS: DETERIORATED CONCRETE FIREPROOFING
Deficiency Location/Instance	Room
Deficiency Quantity	10
Quantity Uom	S.F.
Potential Action	REPLACE
Urgency of Action	PRIORITY 3
Purpose of Action	LEVEL 5

Question	Response
EXTERIOR	
WINDOWS	
EXTERIOR GUARDS	
Quantity Uom	S.F.
Potential Action	REPLACE
Urgency of Action	PRIORITY 5
Purpose of Action	LEVEL 6
Deficiency Photo1

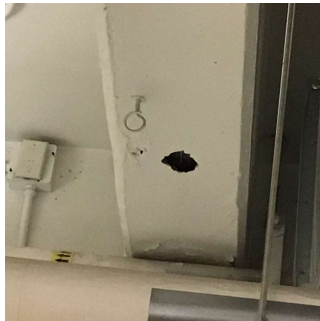
Question	Response
INTERIOR	
STRUCTURAL	
COLUMNS/BEAMS/BEARING WALLS	
Deficiency Photo1

Mechanical Equipment Room 323
Violations	No violations recorded.
FLOOR STRUCTURE	
Condition	Inspected
	2 - Between Good and Fair
Deficiency	No deficiencies recorded
FOUNDATION WALLS	
	Not Required
ROOF STRUCTURE	
Condition	Inspected
	2 - Between Good and Fair
Deficiency	No deficiencies recorded
VAULTS-BUNKERS	
	Does not Exist
AUDITORIUM	
	Does not Exist
CAFETERIA	
	Does not Exist
CLASSROOMS/CORRIDORS/ADMIN SPACES	
Ceiling	Inspected
Condition	2 - Between Good and Fair
Deficiency	GYPSUM BOARD: DAMAGED/DETERIORATED
Deficiency Location/Instance	Rooms 305, 311, 313, 319
Deficiency Quantity	40
Quantity Uom	S.F.
Potential Action	REPLACE
Urgency of Action	PRIORITY 3
Purpose of Action	LEVEL 2
Deficiency Photo1

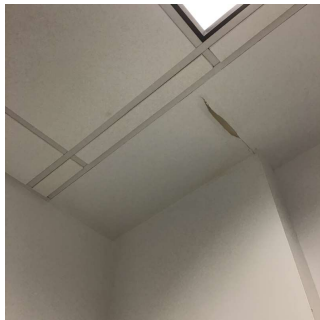
Room 305
Violations	No violations recorded.
Deficiency	ACOUSTIC TILES: DAMAGED/MISSING
Deficiency Location/Instance	Rooms 301, 311, 316, Corridor near Room 309

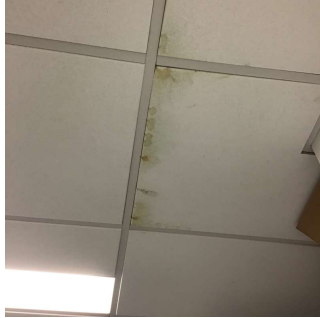
Room 311
Violations	No violations recorded.
Door(s)	Inspected
Condition	2 - Between Good and Fair
Deficiency	No deficiencies recorded
Floor Finish	Inspected
Condition	2 - Between Good and Fair
Deficiency	VINYL TILES: BROKEN/DETERIORATED/MISSING TILES
Deficiency Location/Instance	Room 321
Deficiency Quantity	10
Quantity Uom	S.F.
Potential Action	REPLACE
Urgency of Action	PRIORITY 3
Purpose of Action	LEVEL 2
Deficiency Photo1

Question	Response
INTERIOR	
CLASSROOMS/CORRIDORS/ADMIN SPACES	
Ceiling	
Potential Action	REPLACE
Urgency of Action	PRIORITY 3
Purpose of Action	LEVEL 2
Deficiency Photo1

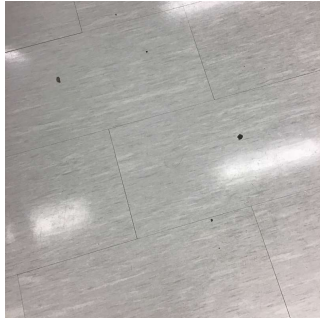
Room 321
Violations	No violations recorded.
Walls	Inspected
Condition	2 - Between Good and Fair
Deficiency	GYPSUM BOARD: DETERIORATED
Deficiency Location/Instance	Rooms 219, 305, 313, 314, Corridor near Room 215, and others.
Deficiency Quantity	200
Quantity Uom	S.F.
Potential Action	REPLACE
Urgency of Action	PRIORITY 3
Purpose of Action	LEVEL 2

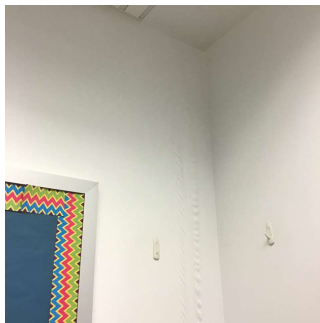
Room 305
Violations	No violations recorded.
Specialties	Does not Exist
GYMNASIUM	Does not Exist
INTERIOR DOOR HARDWARE	Inspected
Condition	2 - Between Good and Fair
Deficiency	No deficiencies recorded
INTERIOR GUARDS	Does not Exist
KITCHEN	Inspected
Instance on 2nd Floor	Inspected
Ceiling	
Instance on 2nd Floor	Inspected
Condition	2 - Between Good and Fair
Deficiency	No deficiencies recorded
Door(s)	
Instance on 2nd Floor	Inspected
Condition	2 - Between Good and Fair
Deficiency	No deficiencies recorded
Floor Finish	
Instance on 2nd Floor	Inspected
Condition	2 - Between Good and Fair
Deficiency	No deficiencies recorded
Walls	
Instance on 2nd Floor	Inspected
Condition	2 - Between Good and Fair
Deficiency	No deficiencies recorded
LIBRARY	Does not Exist
LOCKER ROOM	Does not Exist
MULTI-PURPOSE ROOM	Inspected
Instance on Room 208	Inspected

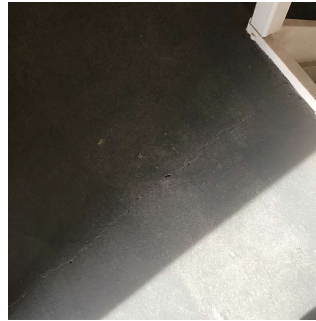
Stair B/2

Question	Response
INTERIOR	
SCIENCE DEMO ROOM	Does not Exist
SCIENCE LAB	Does not Exist
SCIENCE PREP ROOM	Does not Exist
SHOWER ROOM	Does not Exist
STAIRS/RAMPS: INTERIOR	Inspected
Do Letter Stair Signs Exist?	Yes
Ceiling	Inspected
Condition	2 - Between Good and Fair
Deficiency	ACOUSTIC TILES: DAMAGED/MISSING
Deficiency Location/Instance	Stair B/1
Deficiency Quantity	10
Quantity Uom	S.F.
Potential Action	REPLACE
Urgency of Action	PRIORITY 3
Purpose of Action	LEVEL 2
Deficiency Photo1	 
Violations	Stair B/1 No violations recorded.
Door(s)	Inspected
Condition	2 - Between Good and Fair
Deficiency	No deficiencies recorded
Partition	Does not Exist
Railings	Inspected
Condition	2 - Between Good and Fair
Deficiency	No deficiencies recorded
Stairs and Landings	Inspected
Condition	2 - Between Good and Fair
Deficiency	CONCRETE: CRACKS/SPALLING - MAJOR
Deficiency Location/Instance	Stairs A/1, 2, C/1, B/2
Deficiency Quantity	50
Quantity Uom	S.F.

Potential Action	REPLACE
Urgency of Action	PRIORITY 3
Purpose of Action	LEVEL 2

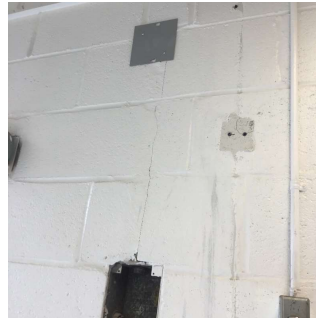
MASONRY: CRACKS/SPALLING

Stair B/2

REPLACE

PRIORITY 3

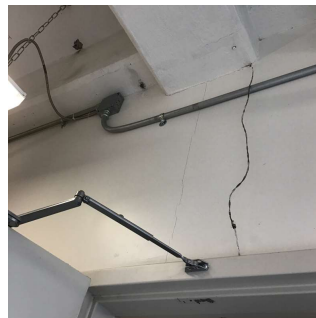
GYPSUM BOARD: DETERIORATED

Stairs A/2, B/2

Question	Response
INTERIOR	
STAIRS/RAMPS: INTERIOR	
Walls	
Violations	Stair B/2 No violations recorded.
Deficiency	PLASTER: CRACKS/SPALLING
Deficiency Location/Instance	Stair B/2
Deficiency Quantity	10
Quantity Uom	S.F.
Potential Action	REPLACE
Urgency of Action	PRIORITY 3
Purpose of Action	LEVEL 2
Deficiency Photo1

REPLACE

PRIORITY 3

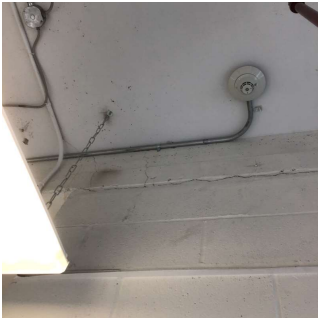
Violations	Stair B/2 No violations recorded.
TOILET ROOMS - STAFF	
Ceiling	Inspected
Condition	3 - Fair
Deficiency	GYPSUM BOARD: DAMAGED/DETERIORATED
Deficiency Location/Instance	Room 308
Deficiency Quantity	20
Quantity Uom	S.F.
Potential Action	REPLACE
Urgency of Action	PRIORITY 3
Purpose of Action	LEVEL 2
Deficiency Photo1

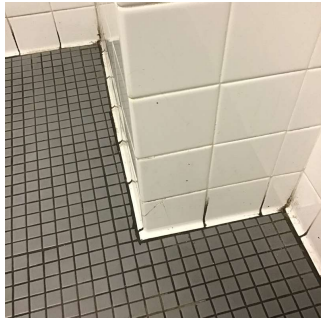
Question	Response
INTERIOR	
TOILET ROOMS - STAFF	
Stalls	Does not Exist
Walls	Inspected
Condition	2 - Between Good and Fair
Deficiency	CERAMIC TILE: BROKEN/ MISSING
Deficiency Location/Instance	Room 324
Deficiency Quantity	10
Quantity Uom	S.F.
Potential Action	REPLACE
Urgency of Action	PRIORITY 3
Purpose of Action	LEVEL 2
Deficiency Photo1

Violations	Room 324 No violations recorded.
TOILET ROOMS - STUDENTS	
Ceiling	Inspected
Condition	2 - Between Good and Fair
Deficiency	No deficiencies recorded
Door(s)	Inspected
Condition	2 - Between Good and Fair
Deficiency	No deficiencies recorded
Floor Finish	Inspected
Condition	2 - Between Good and Fair
Deficiency	No deficiencies recorded
Stalls	Inspected
Condition	2 - Between Good and Fair
Deficiency	No deficiencies recorded
Walls	Inspected
Condition	2 - Between Good and Fair
Deficiency	No deficiencies recorded
LIFE SAFETY	
F.D. HOLDING AREA	Does not Exist
STEEL STAIRS	Does not Exist
