**NYC Department of Education
Building Condition Assessment Survey 2023 - 2024**

Architectural Inspection

Asset: P.S. 232 TRANSPORTABLE - Q, 153-23 83RD STRET, New York, 11414

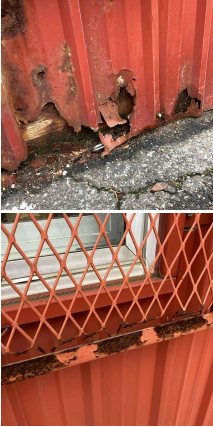
No	Protruding Elements	Corroded metal panels with sharp edges is a protruding element hazard.	EXTERIOR EXTERIOR WALLS	Multiple locations at entrance facades	Wilmer Varela	Custodian

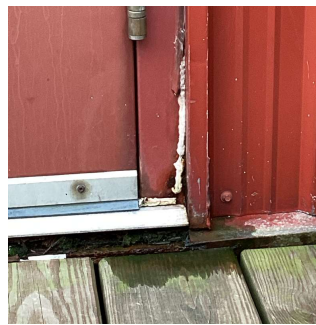
Facade E - T4

Question	Response
Architectural	
EXTERIOR	Inspected
AWNINGS AND CANOPIES	Does not Exist
DOORS	Inspected
DOORS AND FRAMES	Inspected
Condition	3 - Fair
Deficiency	METAL: DETERIORATED DOOR AND FRAME - MINOR DETERIORATION

Q983
4
EACH
MAINTENANCE
PRIORITY 3
LEVEL 2

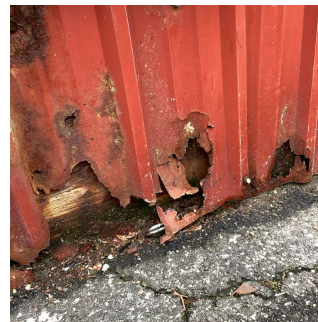
Facade E - T4

METAL PANEL: MAJOR RUSTING

REPLACE

PRIORITY 5

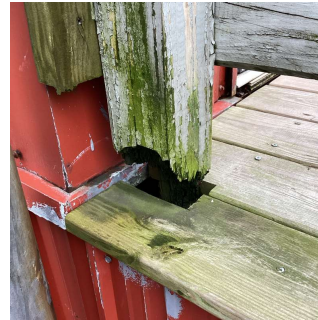
Facade E - T3

5 - Poor

DAMAGED

REPLACE

PRIORITY 4

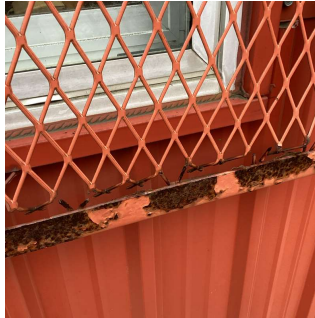
Facade E - T4

4 - Between Fair and Poor

DETERIORATED/TORN-OUT/MISSING

30
S.F.
REPLACE
PRIORITY 5
LEVEL 6

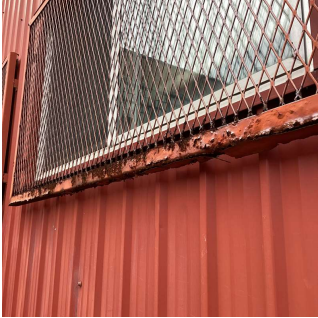
DETERIORATED/TORN-OUT/MISSING

Question	Response
EXTERIOR	
WINDOWS	
EXTERIOR GUARDS	
Potential Action	REPLACE
Urgency of Action	PRIORITY 4
Purpose of Action	LEVEL 2
Deficiency Photo1

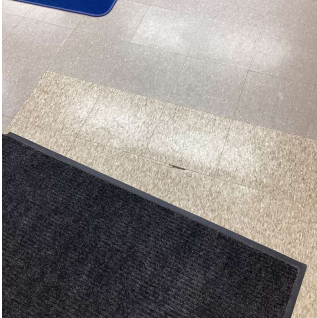
Deficiency	No deficiencies recorded
Door(s)	Inspected
Condition	2 - Between Good and Fair
Deficiency	No deficiencies recorded
Floor Finish	Inspected
Condition	2 - Between Good and Fair
Deficiency	VINYL TILES: BROKEN/DETERIORATED/MISSING TILES
Deficiency Location/Instance	T4, T2
Deficiency Quantity	20

Question	Response
INTERIOR	
CLASSROOMS/CORRIDORS/ADMIN SPACES	
Floor Finish	
Quantity Uom	S.F.
Potential Action	REPLACE
Urgency of Action	PRIORITY 3
Purpose of Action	LEVEL 2
Deficiency Photo1

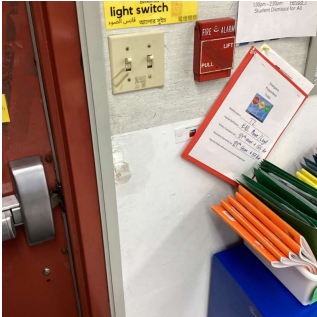
T4
Violations	No violations recorded.
Walls	Inspected
Condition	2 - Between Good and Fair
Deficiency	GYPNUM BOARD: DETERIORATED
Deficiency Location/Instance	T2, T4
Deficiency Quantity	20
Quantity Uom	S.F.
Potential Action	REPLACE
Urgency of Action	PRIORITY 3
Purpose of Action	LEVEL 2
Deficiency Photo1
