**NYC Department of Education**  
**Building Condition Assessment Survey 2023 - 2024**

Architectural Inspection

Q986

**Asset:** P.S. 96 TRANSPORTABLE - Q, 130-01 ROCKAWAY BLVD, New York, 11420

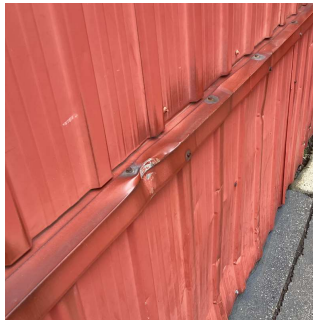
Facade A

Question	Response
<b>Architectural</b>	
<b>EXTERIOR</b>	Inspected
<b>AWNINGS AND CANOPIES</b>	Inspected
Condition	1 - Good
Deficiency	No deficiencies recorded
<b>DOORS</b>	Inspected
<b>DOORS AND FRAMES</b>	Inspected
Condition	2 - Between Good and Fair
Deficiency	No deficiencies recorded
<b>DOOR HARDWARE</b>	Inspected
Condition	3 - Fair
Deficiency	No deficiencies recorded
<b>EXTERIOR WALLS</b>	Inspected
Material Type(s)	Steel
Replacement Quantity	1,800
Replacement Uom	S.F.
Instance on All Facades	Inspected
Instance Condition	5 - Poor
Instance Quantity	1,800
Instance Quantity Uom	S.F.
Deficiency	METAL PANEL: DAMAGED TRIM

Deficiency Quantity

20

Quantity Uom

L.F.

Urgency of Action

PRIORITY 4

Potential Action

REPLACE

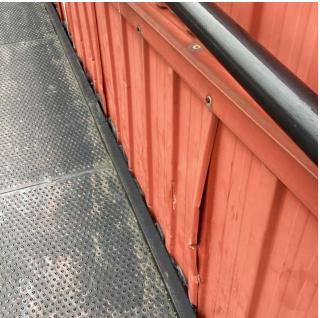
METAL PANEL: SEVERE DENTS

Deficiency Quantity	200
Quantity Uom	S.F.
Potential Action	REPLACE
Urgency of Action	PRIORITY 4
Purpose of Action	LEVEL 2
Deficiency Photo1

Violations	Facade A No violations recorded.
<b>EXTERIOR SOFFITS</b>	Does not Exist
<b>LOUVER</b>	Inspected
Condition	2 - Between Good and Fair
Deficiency	No deficiencies recorded
<b>ROOF</b>	Inspected
<b>Roofing</b>	Inspected
Replacement Quantity	1,300
Replacement Uom	S.F.
<b>LEADERS, GUTTERS, DOWNSPOUTS, SCUPPERS</b>	Does not Exist
<b>ROOFING</b>	Inspected
Instance on Single Ply, Fully Adhered Roof: Roof 1	Inspected
Instance Condition	3 - Fair
Instance Quantity	1,300
Instance Quantity Uom	S.F.
Does the roof have major mechanical equipment sitting on Dunnage Steel less than 18" above the Roofing?	No
Does this roof instance have a Sustainable Roof System?	No
Do solar panels exist on these roofs?	No
Is/Are the roof(s) suitable for Solar Panel installation?	No

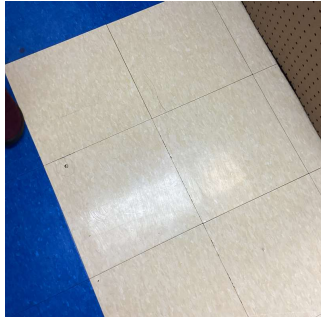
Condition	2 - Between Good and Fair
Deficiency	No deficiencies recorded
<b>ROOF STRUCTURE</b>	Inspected
Condition	2 - Between Good and Fair
Deficiency	No deficiencies recorded
<b>CLASSROOMS/CORRIDORS/ADMIN SPACES</b>	Inspected
<b>Ceiling</b>	Inspected
Condition	2 - Between Good and Fair
Deficiency	No deficiencies recorded
<b>Door(s)</b>	Inspected
Condition	2 - Between Good and Fair
Deficiency	No deficiencies recorded
<b>Floor Finish</b>	Inspected
Condition	2 - Between Good and Fair
Deficiency	VINYL TILES: BROKEN/DETERIORATED/MISSING TILES
Deficiency Location/Instance	Rooms T1, T2
Deficiency Quantity	20
Quantity Uom	S.F.
Potential Action	REPLACE
Urgency of Action	PRIORITY 3

Question	Response
<b>INTERIOR</b>	
<b>CLASSROOMS/CORRIDORS/ADMIN SPACES</b>	
<b>Floor Finish</b>	
Purpose of Action	LEVEL 2
Deficiency Photo1
