NYC Department of Education
Building Condition Assessment Survey 2023 - 2024

Architectural Inspection

Q998

Asset: NYC SCHOOL CONSTR. AUTHORITY - QUEENS, 30-30 THOMSON AVE, New York, 11101

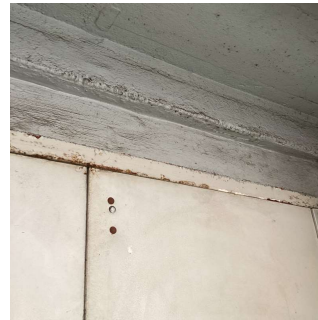
Facade B

Question	Response
Architectural	
EXTERIOR	Inspected
AREAWAY	Does not Exist
AWNINGS AND CANOPIES	Not Required
CHIMNEY	Does not Exist
COPING	Inspected
Condition	2 - Between Good and Fair
Deficiency	No deficiencies recorded
CORNICE	Does not Exist
DOORS	Inspected
DOORS AND FRAMES	Inspected
Condition	3 - Fair
Deficiency	METAL: DETERIORATED DOOR AND FRAME - MINOR DETERIORATION

2
EACH
MAINTENANCE
PRIORITY 3
LEVEL 2

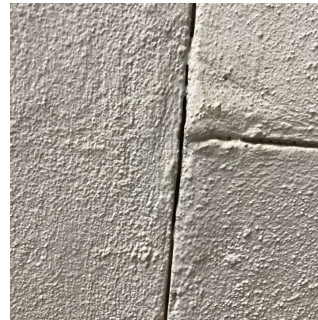
Facade A - Main Entrance

CAST IN PLACE / PRE-CAST CONCRETE: DETERIORATED JOINTS

REPOINT

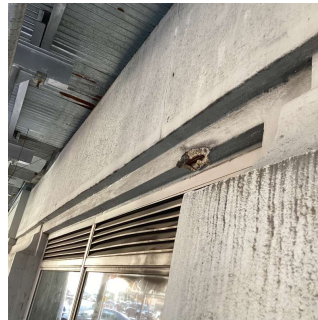
Facade A

CAST IN PLACE / PRE-CAST CONCRETE: MAJOR
 CRACKS/SPALLING

REPLACE

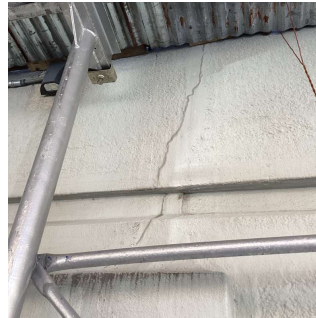
Facade B
No violations recorded.

CAST IN PLACE / PRE-CAST CONCRETE: MINOR
CRACKS/SPALLING

REPAIR

PRIORITY 3
LEVEL 2

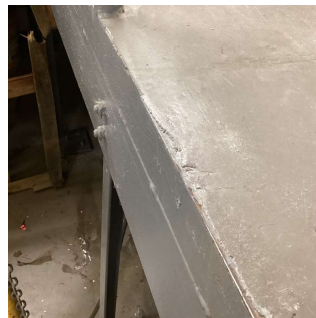
Loading Dock
No violations recorded.

Inspected
2 - Between Good and Fair
DETERIORATED CONCRETE PLATFORM WITH CRACKED,
SPALLED CONCRETE OR EXPOSED REINFORCING

10
S.F.
REPAIR
PRIORITY 3
LEVEL 2

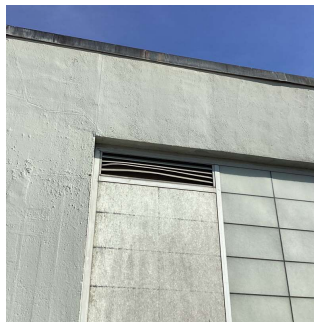
Facade E
No violations recorded.

Inspected
3 - Fair
BROKEN/ DENTED BLADES

10
S.F.
REPLACE
PRIORITY 4
LEVEL 2

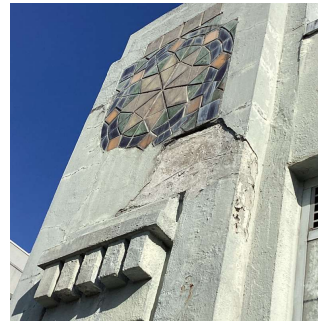
Facade D - Roof 2

Material Type(s)	Inspected Concrete, Metal
Replacement Quantity	9,500
Replacement Uom	C.F.
Instance on All Facades	Inspected
Instance Condition	3 - Fair
Instance Quantity	9,500
Instance Quantity Uom	C.F.
Deficiency	CONCRETE: MAJOR DETERIORATION/CRACKS

30
S.F.
REMOVE AND REBUILD
PRIORITY 4
LEVEL 2

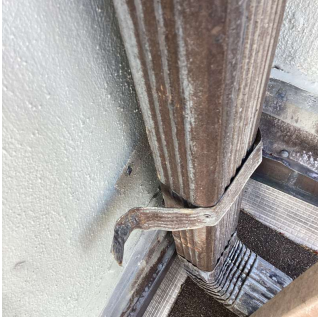
LOOSE

Violations	Roof 2 - BH3 No violations recorded.
ROOF BARRIER/FENCE	Does not Exist
ROOF CAGE	Does not Exist
ROOFING	Inspected
Instance on Modified Bitumen: Roof 1	Inspected
Instance Condition	3 - Fair
Instance Photo	 
	Roof 1
Instance Quantity	55,000
Instance Quantity Uom	S.F.
Does the roof have major mechanical equipment sitting on Dunnage Steel less than 18" above the Roofing?	No
Does this roof instance have a Sustainable Roof System?	Yes
Sustainable Roof Type	White Roof
Sustainable Roof Location (Roof Number)	Roof 1
Do solar panels exist on these roofs?	No
Is/Are the roof(s) suitable for Solar Panel installation?	Yes
Installation Year	1995
Source of Installation	Custodial Staff
Deficiency	MODIFIED BITUMEN: FLASHING: PITCH POCKET DETERIORATED - MINOR
Roof Plan reference

2
EACH
MAINTENANCE

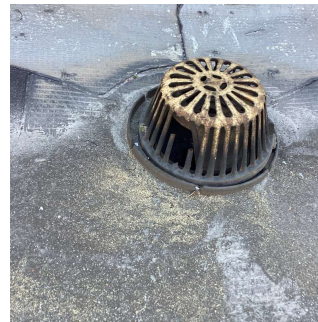
Roof 1 - West side

Question	Response
EXTERIOR	
ROOF	
Roofing	
ROOFING	
Quantity Uom	EACH
Potential Action	REPAIR
Urgency of Action	PRIORITY 3
Purpose of Action	LEVEL 2
Deficiency Photo1	 
Violations	Roof 1 - North side by roof top package unit No violations recorded.
Instance on Modified Bitumen: Roofs 2-4	Inspected
Instance Condition	2 - Between Good and Fair
Instance Photo	 
	Roof 2
Instance Quantity	10,000
Instance Quantity Uom	S.F.
Does the roof have major mechanical equipment sitting on Dunnage Steel less than 18" above the Roofing?	No
Does this roof instance have a Sustainable Roof System?	Yes
Sustainable Roof Type	White Roof
Sustainable Roof Location (Roof Number)	Roofs 2-4
Do solar panels exist on these roofs?	No
Is/Are the roof(s) suitable for Solar Panel installation?	Yes
Installation Year	2018
Source of Installation	Custodial Staff
Deficiency	No deficiencies recorded
ROOFING DRAINS	Inspected
Condition	5 - Poor
Deficiency	DETERIORATED

3
EACH
REPLACE
PRIORITY 4
LEVEL 2

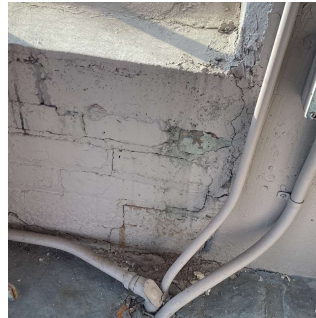
Roof 1 - BH1

**BULKHEAD/PENTHOUSE WALLS/INTERIOR: BRICK
CRACKS/SPALLING**

20
S.F.
REPLACE
PRIORITY 3
LEVEL 2

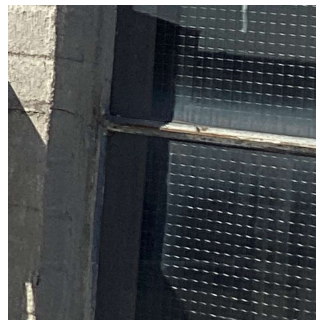
BH2

BULKHEAD/PENTHOUSE WINDOWS: DAMAGED, DETERIORATED WINDOWS

REPLACE

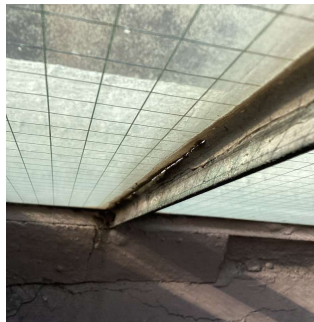
Roof 1 - BH1

BULKHEAD/PENTHOUSE WINDOWS: AIR/WATER INFILTRATION WITH DAMAGED CAULKING

30
L.F.
MAINTENANCE
PRIORITY 3
LEVEL 2

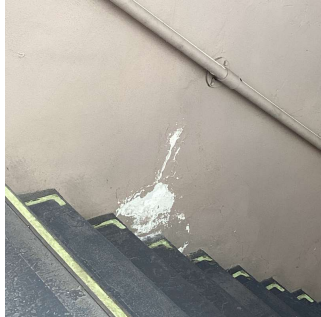
BULKHEAD/PENTHOUSE WALLS/INTERIOR: PLASTER CRACKS/SPALLING

Violations	Roof 1 - BH1 No violations recorded.
CUPOLA/ SPIRES/ TOWERS	Inspected
Condition	3 - Fair
Deficiency	LOSS OF PAINT
Roof Plan reference

20
S.F.
REPLACE
PRIORITY 3
LEVEL 2

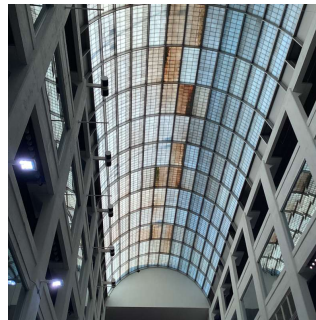
Atrium

WATER INFILTRATION

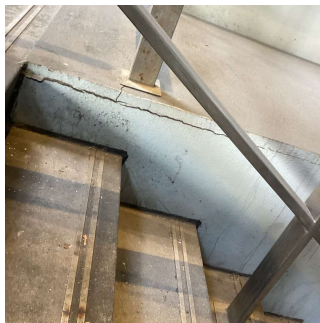
CAST IN PLACE CONCRETE: CRACKS/SPALLING - MAJOR

Question	Response
EXTERIOR	
STAIRS/RAMPS: EXTERIOR	
BUILDING CHEEK/FLANK WALLS	
Deficiency Photo1

Violations	Facade A - Main Entrance No violations recorded.
RAILINGS	
Condition	Inspected 2 - Between Good and Fair
Deficiency	No deficiencies recorded
STAIRS/RAMPS	
Condition	Inspected 3 - Fair
Deficiency	CONCRETE: CRACKS/SPALLING - MINOR
Roof Plan reference

REPLACE

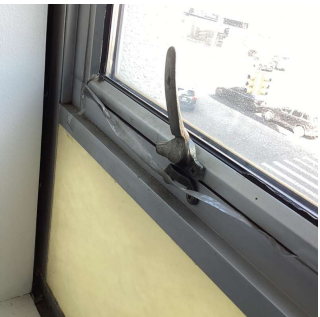
Question	Response
EXTERIOR	
WINDOWS	
WINDOWS	Inspected
Material Type(s)	Aluminum
Instance on Aluminum - Other: All Facades	Inspected
Instance Condition	3 - Fair
Instance Quantity	16,000
Instance Quantity Uom	S.F.
Are these windows insulated	Yes
Installation Year	1985
Source of Installation	Custodial Staff
Deficiency	ALUMINUM - OTHER: AIR/WATER INFILTRATION, DETERIORATED JOINTS WITH DAMAGED CAULKING
Roof Plan reference

Violations	Facade A - West side at Room 3212 (Conference Room), Facade C - Room 1224 No violations recorded.
INTERIOR	Inspected
POOLS	Does not Exist

Deficiency Quantity	60
Quantity Uom	L.F.
Potential Action	MAINTENANCE
Urgency of Action	PRIORITY 3
Purpose of Action	LEVEL 2
Deficiency Photo1

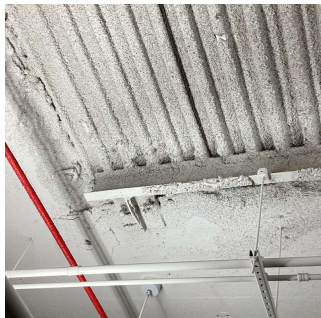
Question	Response
INTERIOR	
STRUCTURAL	Inspected
COLUMNS/BEAMS/BEARING WALLS	Inspected
Condition	2 - Between Good and Fair
Deficiency	STEEL COLUMNS/BEAMS: DETERIORATED/MISSING SPRAY-ON FIREPROOFING
Deficiency Location/Instance	4th Floor - East side Cubicle near Column H
Deficiency Quantity	10
Quantity Uom	S.F.
Potential Action	REPLACE
Urgency of Action	PRIORITY 3
Purpose of Action	LEVEL 5
Deficiency Photo1

Violations	4th Floor Cubicle near Column H No violations recorded.
FLOOR STRUCTURE	Inspected
Condition	3 - Fair
Deficiency	CONCRETE: CRACKS/SPALLED/REINFORCEMENT EXPOSED
Deficiency Location/Instance	2nd Floor - East side - Near Room 2311
Deficiency Quantity	40
Quantity Uom	S.F.
Potential Action	REPAIR
Urgency of Action	PRIORITY 4
Purpose of Action	LEVEL 5
Deficiency Photo1

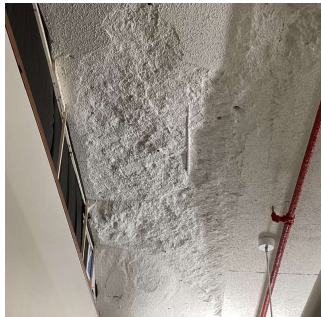
Violations	2nd Floor - East side - Near Room 2311 No violations recorded.
FOUNDATION WALLS	Inspected
Material Type(s)	Concrete
Condition	2 - Between Good and Fair

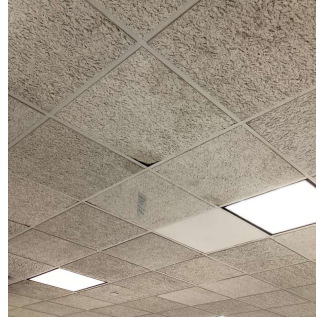
Question	Response
INTERIOR	
STRUCTURAL	
ROOF STRUCTURE	
Deficiency Location/Instance	Roof 1 - BH 1
Deficiency Quantity	10
Quantity Uom	S.F.
Potential Action	REPAIR
Urgency of Action	PRIORITY 3
Purpose of Action	LEVEL 5
Deficiency Photo1	 
Violations	Roof 1 - BH 1 No violations recorded.
Deficiency	CONCRETE: CRACKED/SPALLED/REINFORCEMENT EXPOSED
Deficiency Location/Instance	Roof 1 - BH 1, Roof 2 - Towel
Deficiency Quantity	20
Quantity Uom	S.F.
Potential Action	REPAIR
Urgency of Action	PRIORITY 4
Purpose of Action	LEVEL 5
Deficiency Photo1	 
Violations	Roof 1 - BH 1 No violations recorded.
VAULTS-BUNKERS	
Does not Exist	
AUDITORIUM	
Does not Exist	
CAFETERIA	
Does not Exist	
CLASSROOMS/CORRIDORS/ADMIN SPACES	
Ceiling	
Condition	Inspected
Condition	2 - Between Good and Fair
Deficiency	ACOUSTIC TILES: DAMAGED/MISSING
Deficiency Location/Instance	Room 2104, Near Room 3209
Deficiency Quantity	30
Quantity Uom	S.F.
Potential Action	REPLACE

PRIORITY 3
LEVEL 2

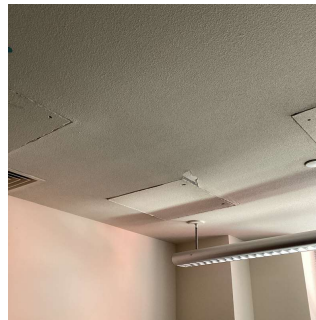
Room 4235

GYPSON BOARD: DAMAGED/DETERIORATED
Rooms 2115, 4235, Near Room 1231
40
S.F.
REPLACE
PRIORITY 3
LEVEL 2

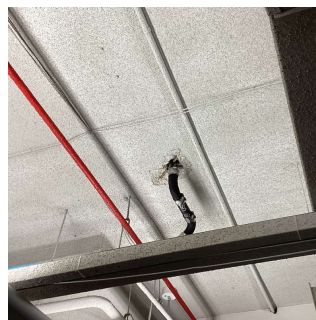
PLASTER: CRACKS/SPALLING
4th Floor Near Room 4114
10
S.F.
REPLACE
PRIORITY 3
LEVEL 2

Question	Response
INTERIOR	
CLASSROOMS/CORRIDORS/ADMIN SPACES	
Ceiling	Inspected
	4th Floor Near Room 4114
Violations	No violations recorded.
Door(s)	Inspected
Condition	3 - Fair
Deficiency	WOOD: DETERIORATED DOOR AND FRAME
Deficiency Location/Instance	Room 3212
Deficiency Quantity	1
Quantity Uom	EACH
Potential Action	MAINTENANCE
Urgency of Action	PRIORITY 3
Purpose of Action	LEVEL 2
Deficiency Photo1

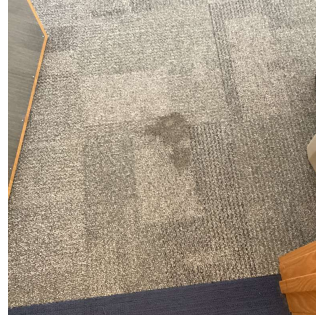
6th Floor Near Elevator
Violations	No violations recorded.
Floor Finish	Inspected
Condition	2 - Between Good and Fair
Deficiency	CARPET: WORN/DETERIORATED
Deficiency Location/Instance	Near Rooms 2318, 2321, Room 6020
Deficiency Quantity	40

Quantity Uom	S.F.
Potential Action	REPLACE

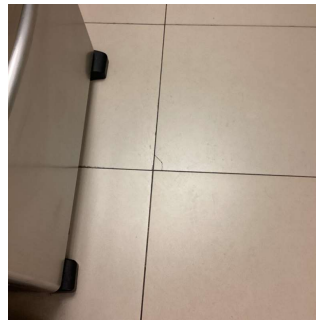
CERAMIC TILE: BROKEN/MISSING TILES
6th Floor Pantry
10
S.F.
REPLACE
PRIORITY 3
LEVEL 2

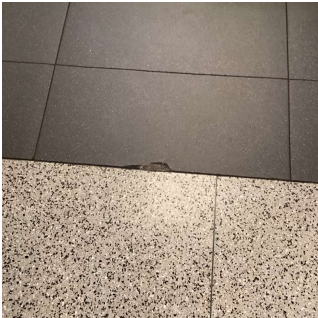
Question	Response
INTERIOR	
CLASSROOMS/CORRIDORS/ADMIN SPACES	
Floor Finish	
Violations	Room 5200B No violations recorded.
Deficiency	STONE: BROKEN/MISSING TILES
Deficiency Location/Instance	Main Entrance Lobby, Atrium
Deficiency Quantity	20
Quantity Uom	S.F.
Potential Action	REPLACE
Urgency of Action	PRIORITY 3
Purpose of Action	LEVEL 2
Deficiency Photo1

Violations	Main Entrance Lobby No violations recorded.
Deficiency	TERRAZZO: CRACKS
Deficiency Location/Instance	Main Entrance Vestibule, Main Entrance Lobby, 1st Floor Atrium
Deficiency Quantity	375
Quantity Uom	S.F.
Potential Action	REPLACE
Urgency of Action	PRIORITY 3
Purpose of Action	LEVEL 2
Deficiency Photo1

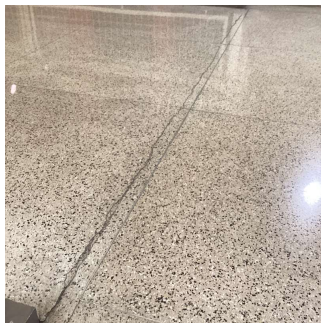
Question	Response
INTERIOR	
STAIRS/RAMPS: INTERIOR	
Do Letter Stair Signs Exist?	No
Ceiling	Not Required
Door(s)	Does not Exist
Partition	Does not Exist
Railings	Inspected
Condition	2 - Between Good and Fair
Deficiency	No deficiencies recorded
Stairs and Landings	Inspected
Condition	2 - Between Good and Fair
Deficiency	TERRAZZO: CRACKS
Deficiency Location/Instance	Atrium Stair at 4th Floor
Deficiency Quantity	75
Quantity Uom	S.F.
Potential Action	REPLACE
Urgency of Action	PRIORITY 3
Purpose of Action	LEVEL 2
Deficiency Photo1

Atrium Stair at 4th Floor
Violations	No violations recorded.
Walls	Not Required
TOILET ROOMS - STAFF	Inspected
Ceiling	Inspected
Condition	2 - Between Good and Fair
Deficiency	ACOUSTIC TILES: DAMAGED/MISSING
Deficiency Location/Instance	Room 1118
Deficiency Quantity	10
Quantity Uom	S.F.
Potential Action	REPLACE
Urgency of Action	PRIORITY 3
Purpose of Action	LEVEL 2
Deficiency Photo1

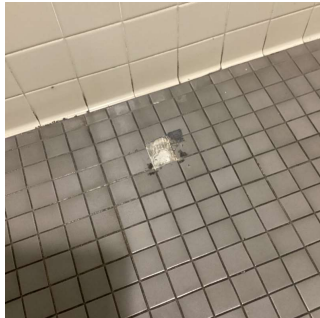
Question	Response
INTERIOR	
TOILET ROOMS - STAFF	
Ceiling	Inspected
Violations	No violations recorded.
Door(s)	Inspected
Condition	5 - Poor
Deficiency	METAL: DETERIORATED DOOR
Deficiency Location/Instance	Room 2100B
Deficiency Quantity	1
Quantity Uom	EACH
Potential Action	MAINTENANCE
Urgency of Action	PRIORITY 3
Purpose of Action	LEVEL 2
Deficiency Photo1	 
Violations	Room 2100B No violations recorded.
Deficiency	WOOD: DETERIORATED DOOR
Deficiency Location/Instance	Rooms 6006, 6007
Deficiency Quantity	2
Quantity Uom	EACH
Potential Action	MAINTENANCE
Urgency of Action	PRIORITY 3
Purpose of Action	LEVEL 2
Deficiency Photo1	 
Violations	Room 6006 No violations recorded.
Floor Finish	Inspected
Condition	4 - Between Fair and Poor
Deficiency	CERAMIC TILE: BROKEN/MISSING TILES
Deficiency Location/Instance	Rooms 1118, 2100B, 4100B
Deficiency Quantity	30
Quantity Uom	S.F.
Potential Action	REPLACE
Urgency of Action	PRIORITY 3

Violations	Room 4100B No violations recorded.
Stalls	
Condition	Inspected
Deficiency	5 - Poor
Deficiency Location/Instance	RUST - MAJOR
Deficiency Quantity	Rooms 2100B, 6006
Quantity Uom	2
Potential Action	EACH
Urgency of Action	REPLACE
Purpose of Action	PRIORITY 3
Deficiency Photo1	LEVEL 2

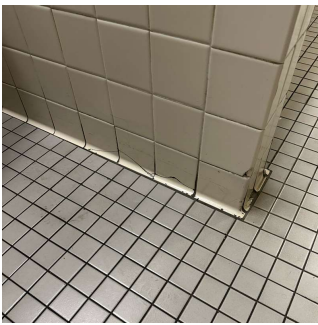
Violations	Room 6006 No violations recorded.
Walls	
Condition	Inspected
Deficiency	2 - Between Good and Fair
Deficiency Location/Instance	CERAMIC TILE: BROKEN/ MISSING
Deficiency Quantity	Rooms 1118, 2100B, 4100B
Quantity Uom	30
Potential Action	S.F.
Urgency of Action	REPLACE
Purpose of Action	PRIORITY 3
	LEVEL 2

Violations	Room 1118 No violations recorded.
TOILET ROOMS - STUDENTS	Does not Exist
LIFE SAFETY	Inspected
F.D. HOLDING AREA	Does not Exist
STEEL STAIRS	Does not Exist
SITE	Inspected
CONTAINERIZATION	Does not Exist
Drainage System for Asphalt	Does not Exist
Drainage System for Concrete	Inspected
Catch Basins/Manhole - Surrounded by concrete	Inspected
Condition	2 - Between Good and Fair
Deficiency	No deficiencies recorded
Culverts - Concrete Covering	Does not Exist
Drainage System for Soil	Does not Exist
DRINKING FOUNTAINS	Does not Exist
FENCES	Does not Exist
IRRIGATION SYSTEM	Does not Exist
PAVING	Inspected
Student Non-Use	Does not Exist
Student Use	Does not Exist
Site Sidewalks & Walkways	Inspected
Asphalt	Does not Exist
Concrete	Inspected
Condition	3 - Fair
Deficiency	CRACKS - MINOR
Deficiency Location/Instance	Main Entrance
Deficiency Quantity	50
