**NYC Department of Education  
Building Condition Assessment Survey 2023-2024**

**Architectural Inspection**

**Asset:** P.S. 1 - STATEN ISLAND, 58 SUMMIT STREET, STATEN ISLAND, NY, 10307

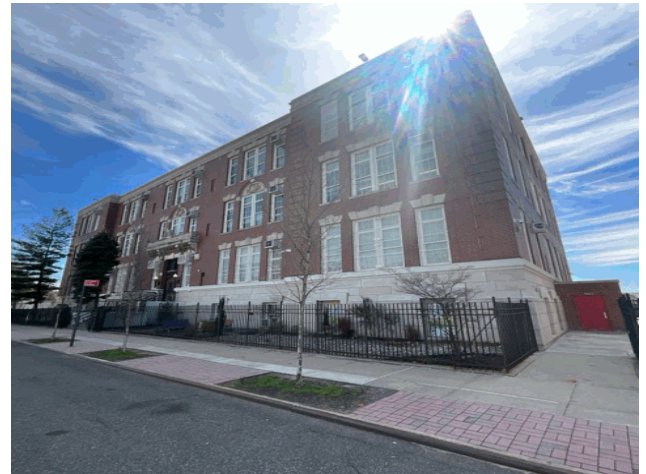
Summit Street and - East View

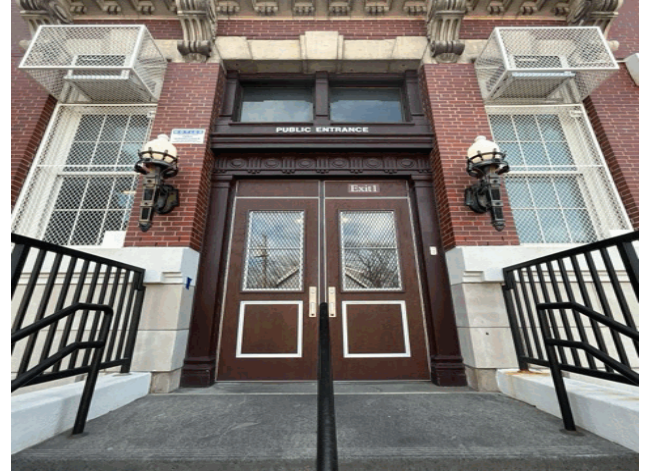
Facade A - Summit Street

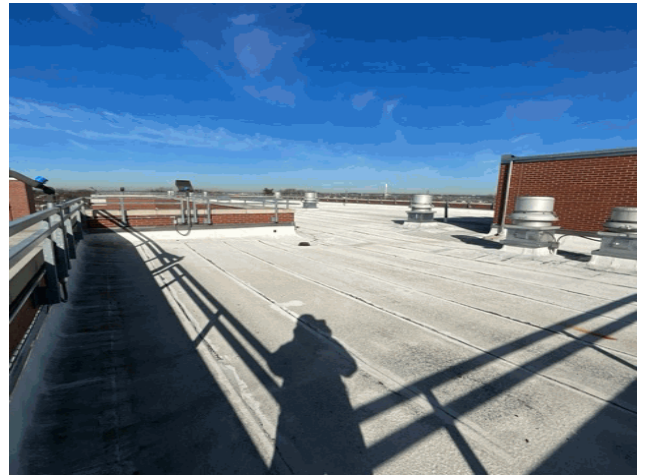
Roof 1 - West View
