**NYC Department of Education  
Building Condition Assessment Survey 2023-2024**

**Architectural Inspection**

**Asset:** P.S. 6 - STATEN ISLAND, 555 PAGE AVENUE, STATEN ISLAND, NY, 10307

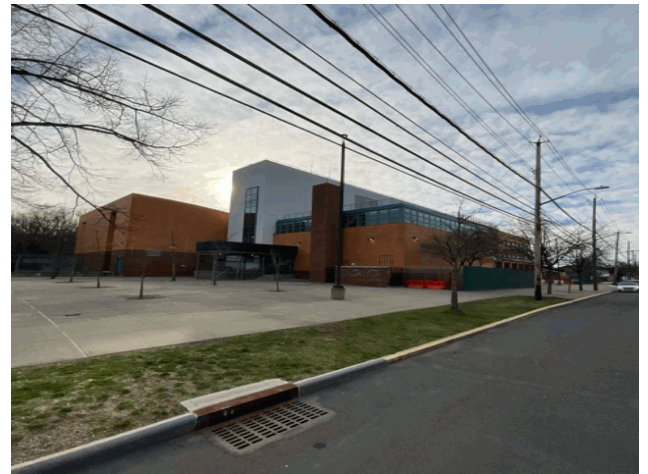
Corner of Page Avenue and Academy Avenue - East View

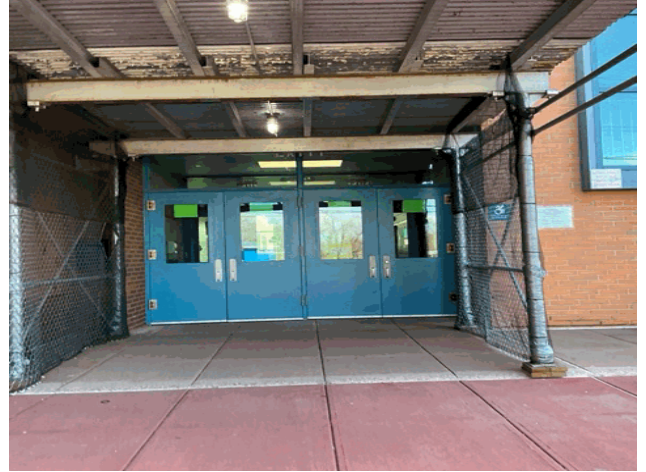
Facade A - Page Avenue

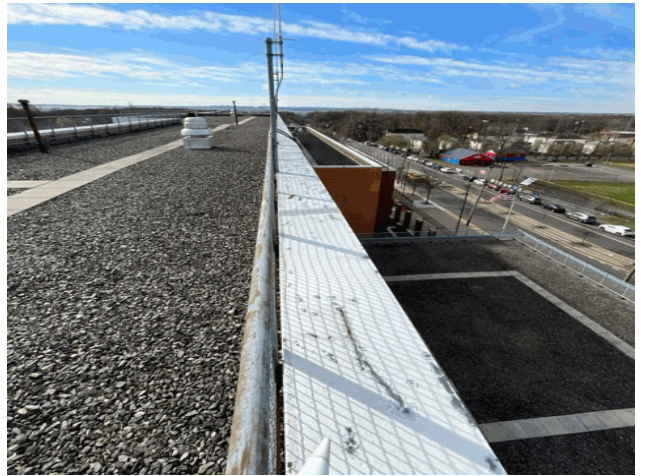
Roof 4 - South View
