**NYC Department of Education  
Building Condition Assessment Survey 2023-2024**

**Architectural Inspection**

**Asset:** P.S. 13 - STATEN ISLAND, 191 VERMONT AVENUE, STATEN ISLAND, NY, 10305

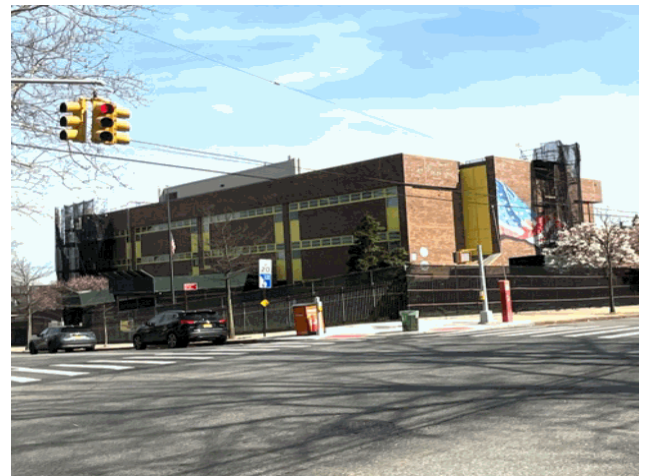
Weather	Fair
Facade Photo

Corner of Vermont Avenue and Hylan Boulevard - North View

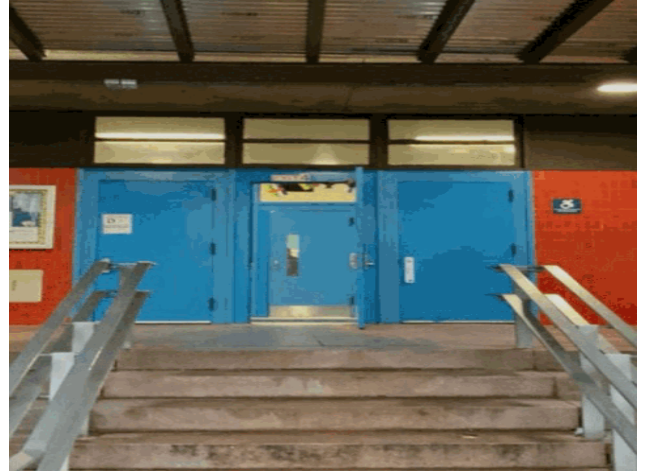
Main Entrance Photo

Facade A - Vermont Avenue

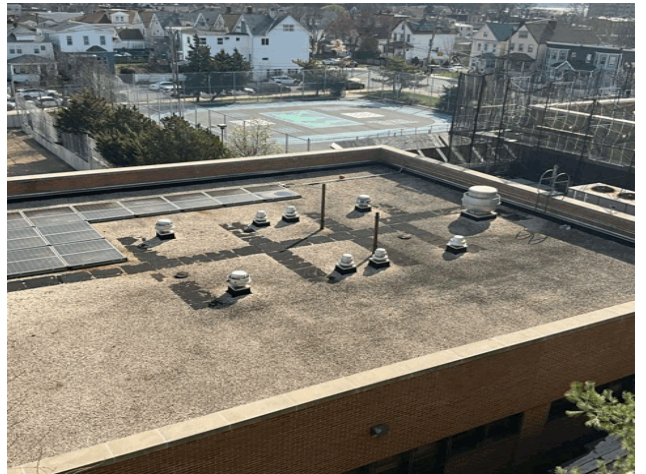
Roof Photo

Roof 3 - East View

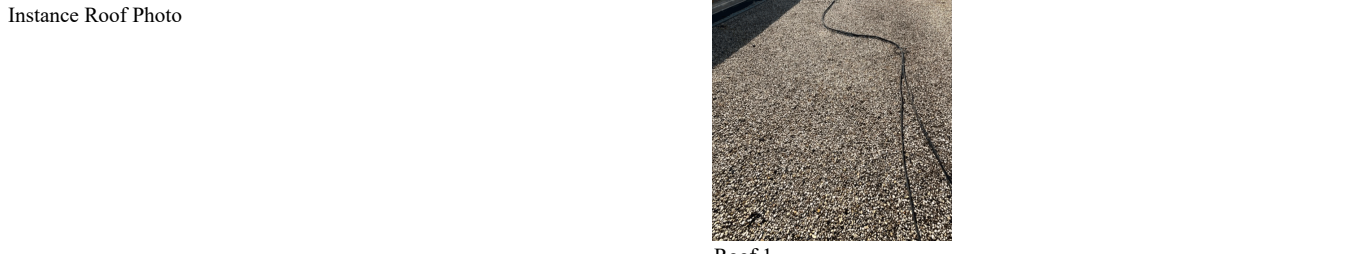
Roof 1

Roof 2
Instance Condition	3- Fair
Instance Quantity	7,000
Instance Quantity Uom	S.F.
Does the roof have major mechanical equipment sitting on Dunnage Steel less than 18" above the Roofing?	No
Does this Roof Instance have a Sustainable Roof System?	No
Do solar panels exist on these roofs?	No
Is/Are the roof(s) suitable for Solar Panel installation?	No
Installation Year	2006
Source of Installation Year	Documented
Deficiency	No deficiencies recorded
Instance on Built-Up:Roofs 1, 3, 4 and 5	Inspected

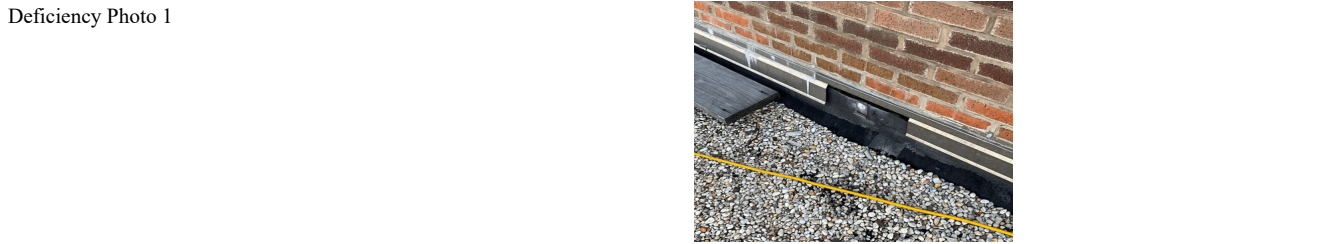
Deficiency	<b>BUILT-UP:FLASHING:CAP FLASHING MISSING</b>
------------	---

Deficiency Location/Instance

Deficiency Quantity	10
Quantity Uom	L.F.
Potential Action	<b>INSTALL NEW</b>
Urgency of Action	<b>PRIORITY 4</b>
Purpose of Action	<b>LEVEL 2</b>
