**NYC Department of Education  
Building Condition Assessment Survey 2023-2024**

**Architectural Inspection**

**Asset: P.S. 16 - STATEN ISLAND, 195 DANIEL LOW TERRACE, STATEN ISLAND, NY, 10301**

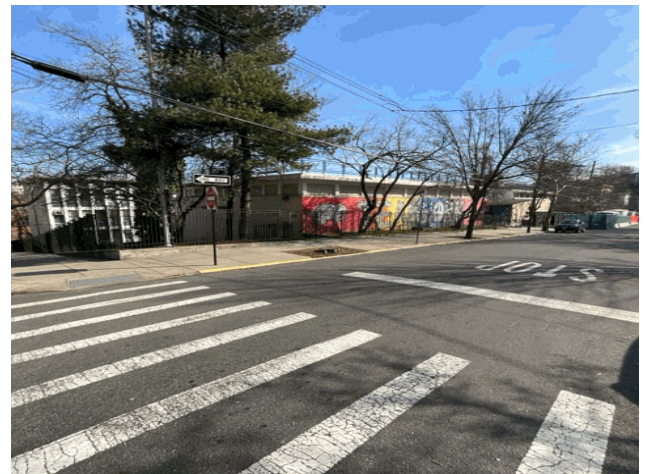
Corner of Daniel Low Terrace and Benzinger Avenue - Southeast View

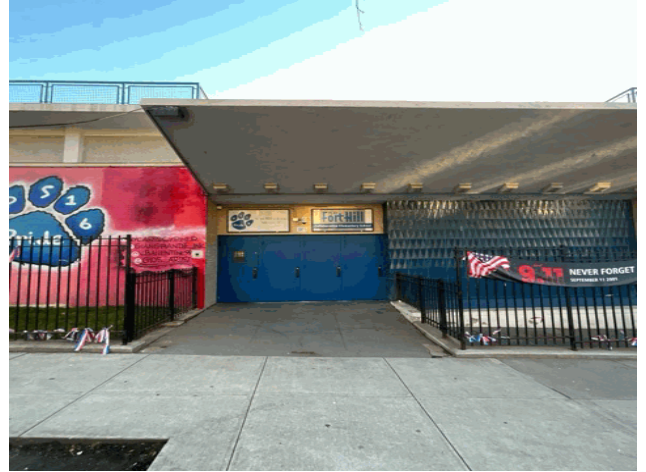
Facade A - Daniel Low Terrace

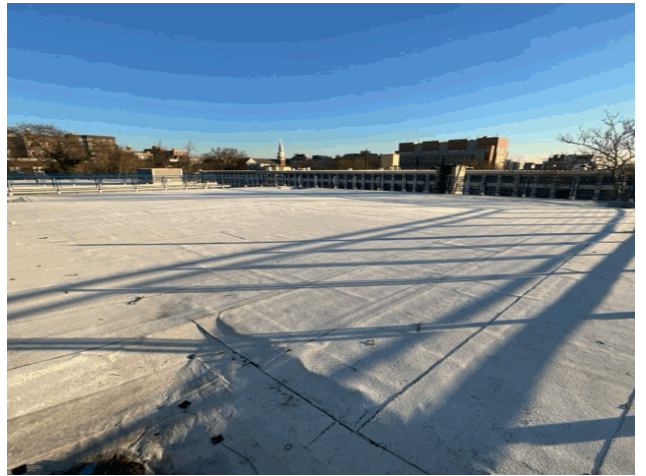
Roof 2 - North View
