**NYC Department of Education  
Building Condition Assessment Survey 2023-2024**

**Architectural Inspection**

**R054**

**Asset:** P.S. 54 - STATEN ISLAND, 1060 WILLOWBROOK ROAD, STATEN ISLAND, NY, 10314

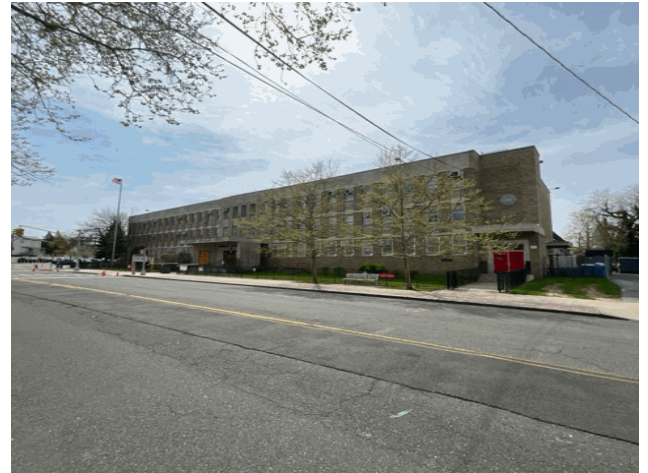
Willowbrook Road - West View

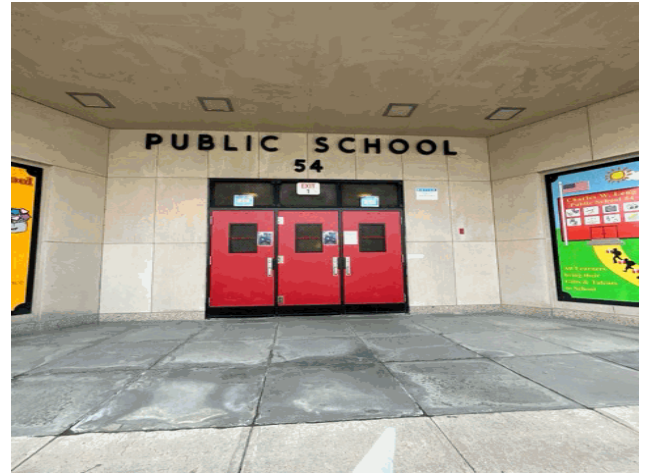
Facade A - Willowbrook Road

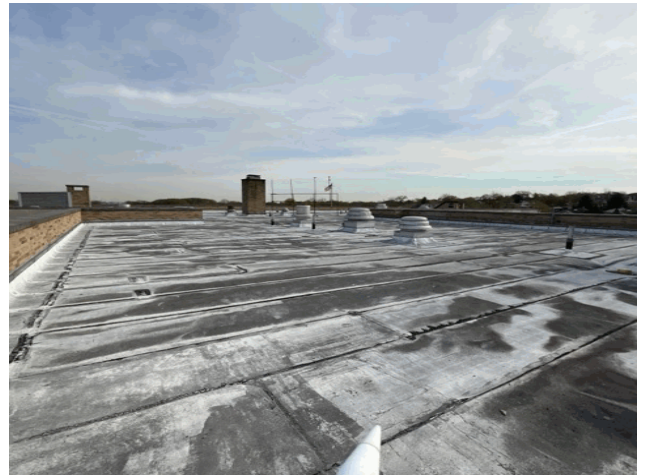
Roof 1 - North View
