**NYC Department of Education
Building Condition Assessment Survey 2023-2024**

Architectural Inspection

R061

Asset: I.S. 61 - STATEN ISLAND, 445 CASTLETON AVENUE, STATEN ISLAND, NY, 10301

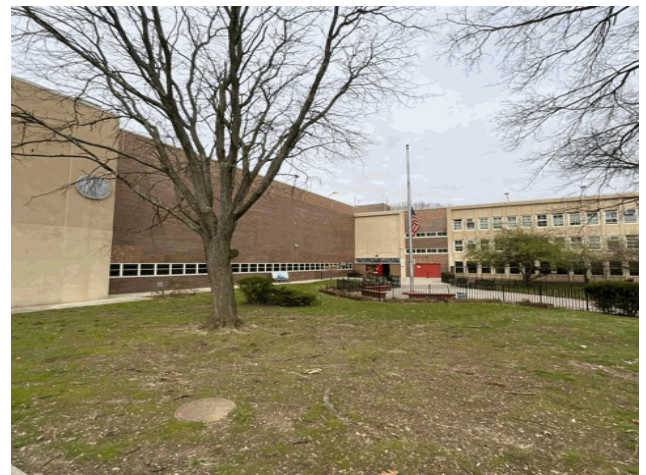
Corner of Castleton Avenue and Brighton Avenue - West View

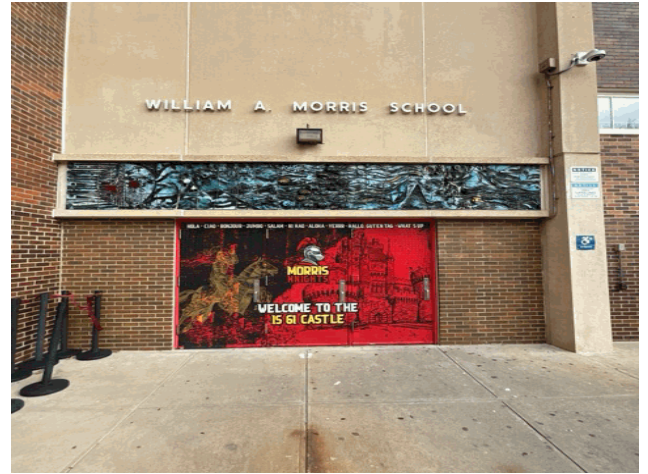
Facade A - Castleton Avenue

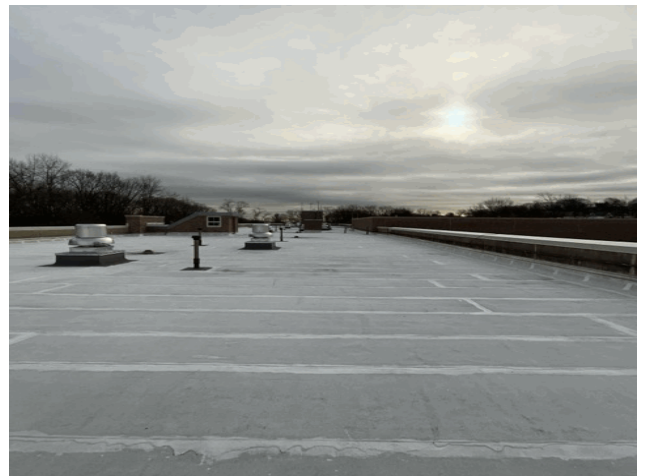
Roof 1 - East View
