**NYC Department of Education
Building Condition Assessment Survey 2023-2024**

Architectural Inspection

R074

Asset: 3K CENTER @ 10 ELM STREET - STATEN ISLAND, 10 ELM STREET, STATEN ISLAND, NY, 10310

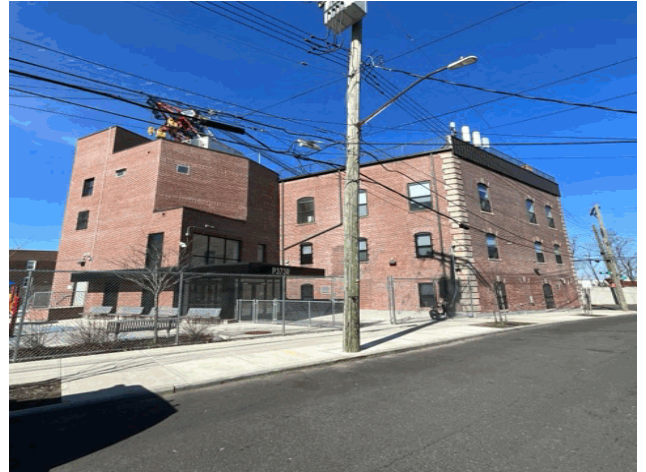
Elm Street - Northwest View

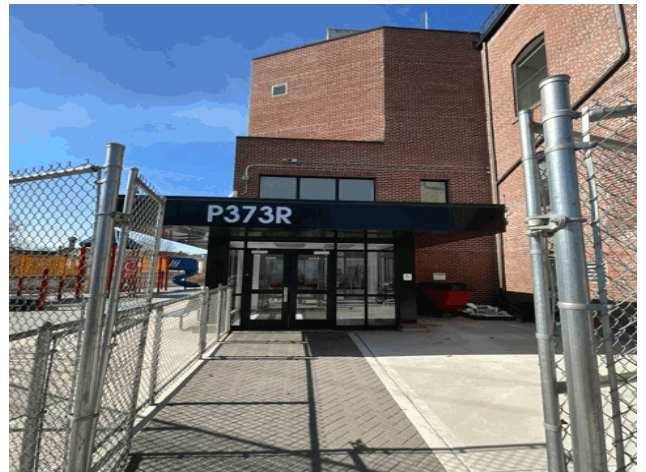
Facade A - Elm Street
