**NYC Department of Education  
Building Condition Assessment Survey 2023-2024**

**Architectural Inspection**

**R077**

**Asset:** PRE-K CENTER @ 120 STUYVESANT PLACE - STATEN ISLAND, 120 STUYVESANT PLACE, STATEN ISLAND, NY, 10301

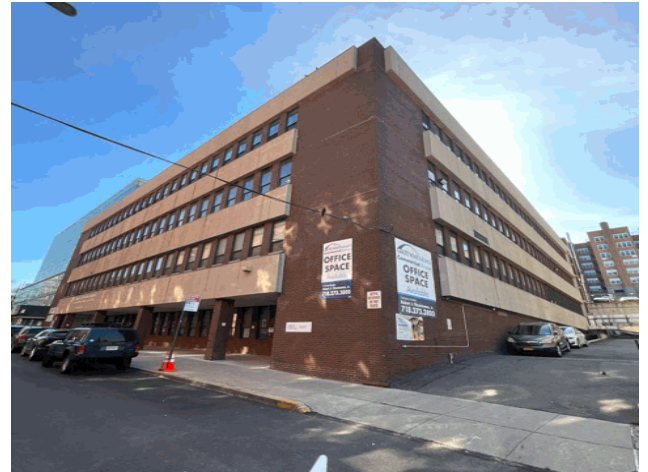
Stuyvesant Street - South View

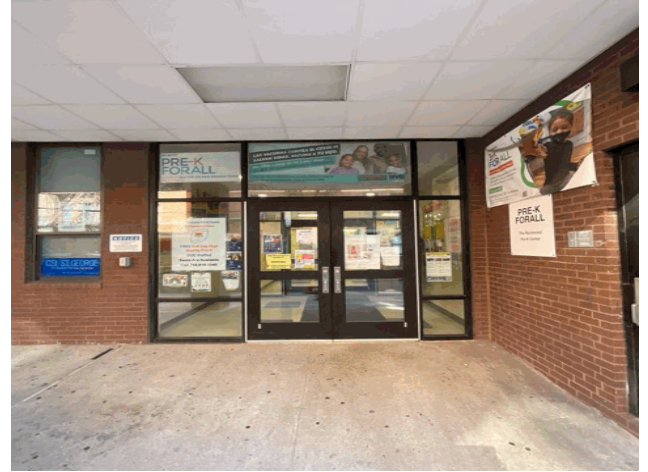
Facade A - Stuyvesant Street
