**NYC Department of Education
Building Condition Assessment Survey 2023-2024**

Architectural Inspection

R080

Asset: REGION 7/ ROC F - STATEN ISLAND, 715 OCEAN TERRACE, STATEN ISLAND, NY, 10301

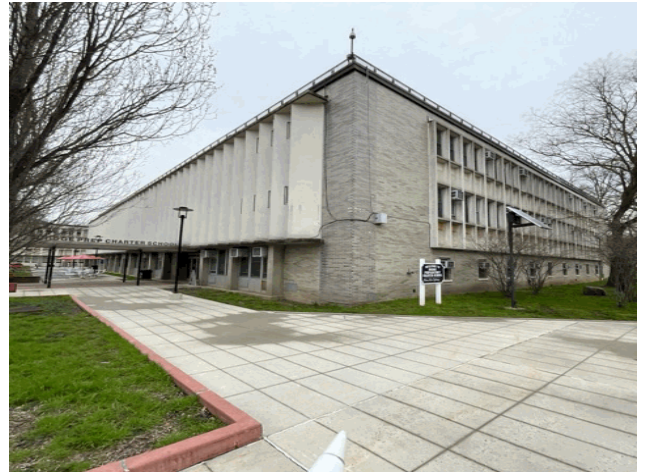
Plaza/Parking - Northeast View

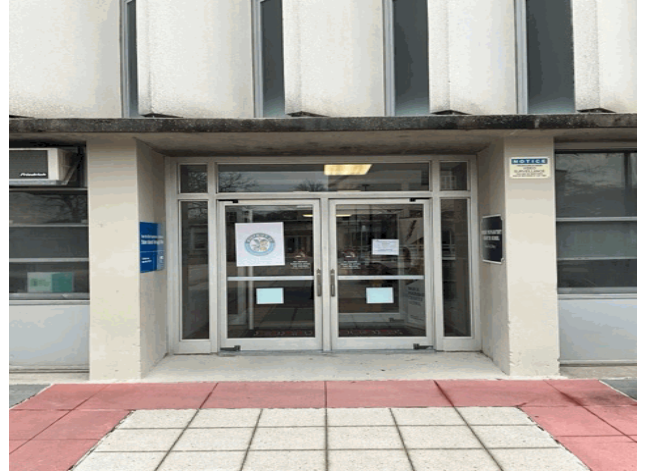
Facade A - Plaza/Parking

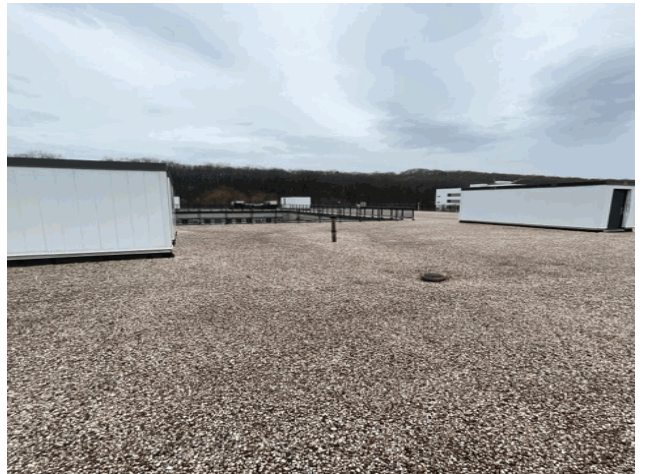
Roof 1 - South View
