**NYC Department of Education
Building Condition Assessment Survey 2023-2024**

Architectural Inspection

R100

Asset: THE RICHMOND PRE-K CENTER AT 2389 RICHMOND AVENUE - STATEN ISLAND, 2389 RICHMOND AVENUE, STATEN ISLAND, NY, 10314

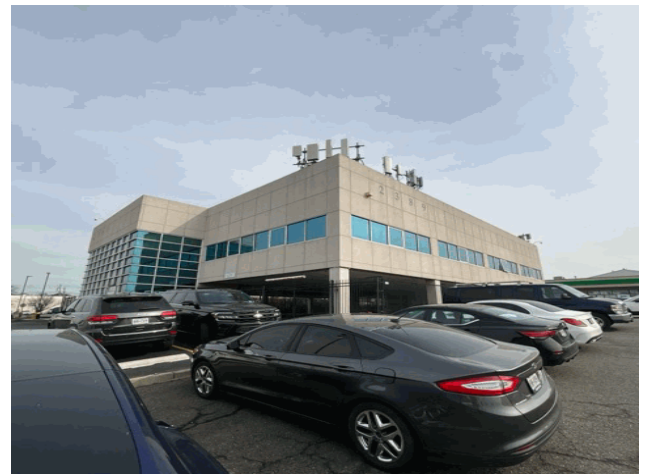
Richmond Avenue Parking Area - East View

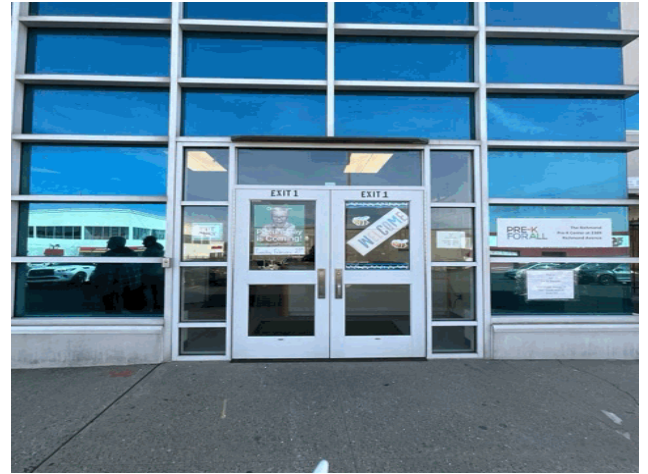
Facade A - Richmond Avenue Parking Area

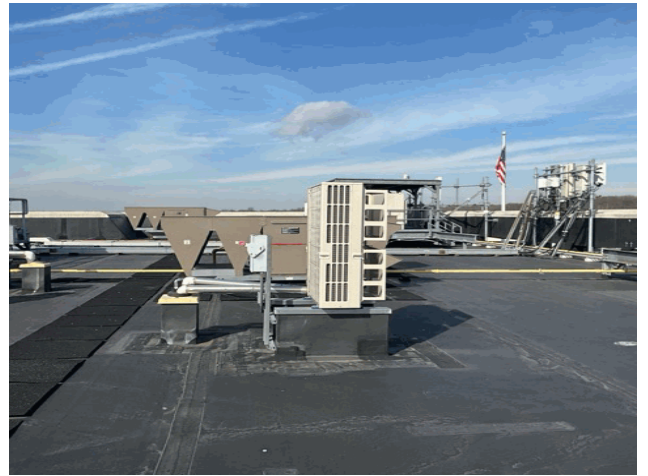
Roof 1 - Northwest View
