Building Condition Assessment Survey 2023-2024

Architectural Inspection R456

Asset:	TOTTENVILLE HS AF - STATEN ISLAND, 100 LUTEN AVENUE, STATEN ISLAND, NY, 10312				
Inspection Id	pection Type Time In Last Edited				
4968	ARCHITECTURAL - ASSOCIATE	2024-04-24 02:12PM	2024-04-26 01:35PM		
5006	ARCHITECTURAL - SENIOR	2024-04-24 08:15AM	2024-05-28 12:34PM		
set Data

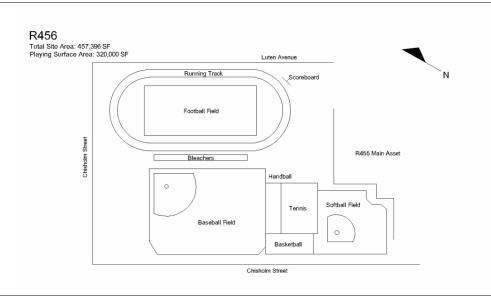
Question	Response
Architectural	
EXTERIOR	Does not exist
INTERIOR	Does not exist
ATHLETIC FIELDS	Inspected
PLAYING SURFACE	Inspected
Replacement Quantity	320,000
Replacement Uom	S.F.
Synthetic Turf Field exists?	Yes
Synthetic Turf Installation Year	2022
Instance on Baseball Field	Inspected
Instance Condition	3- Fair
Instance Quantity	120,000
Instance Quantity Uom	S.F.
Deficiency	ARTIFICIAL TURF:DAMAGED/WORN OUT

ficiency ARTIFICIAL TURF:DAMAGED/WORN OF Baseball Field

Potential Action

REPLACE

PRIORITY 3
