**NYC Department of Education
Building Condition Assessment Survey 2023-2024**

Architectural Inspection

R802

Asset: P.S. 1 ANNEX - STATEN ISLAND, 58 SUMMIT STREET, STATEN ISLAND, NY, 10307

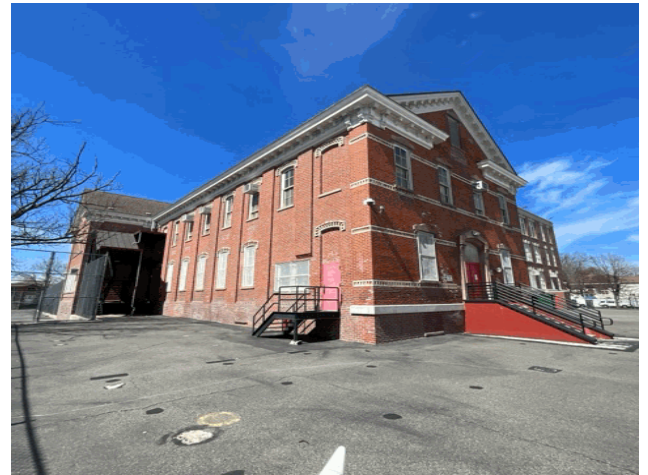
Yetman Avenue - West View

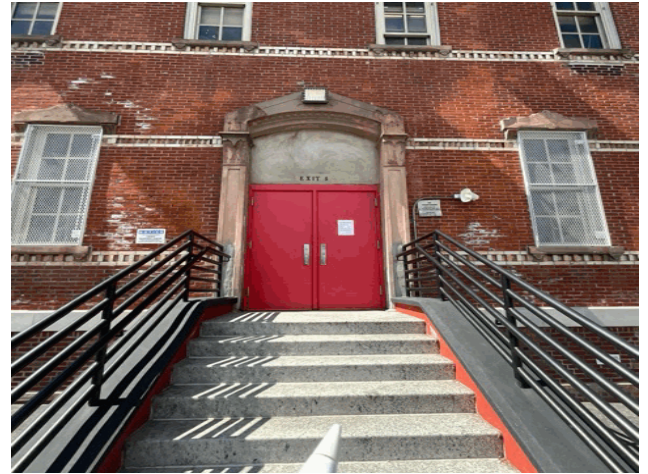
Facade A - Yetman Avenue

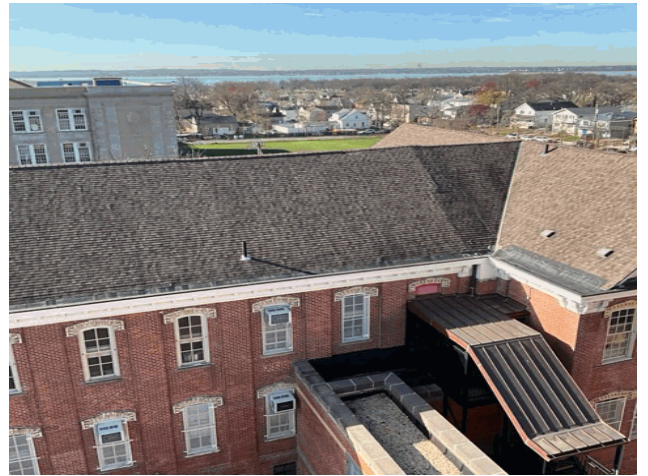
Roof 1 - South View from Main Asset R001
