**NYC Department of Education
Building Condition Assessment Survey 2023-2024**

Architectural Inspection

R883

Asset: P.S. 80 AX(PETR COMPL-BLDG K)-S.I., 715 OCEAN TERRACE, STATEN ISLAND, NY, 10301

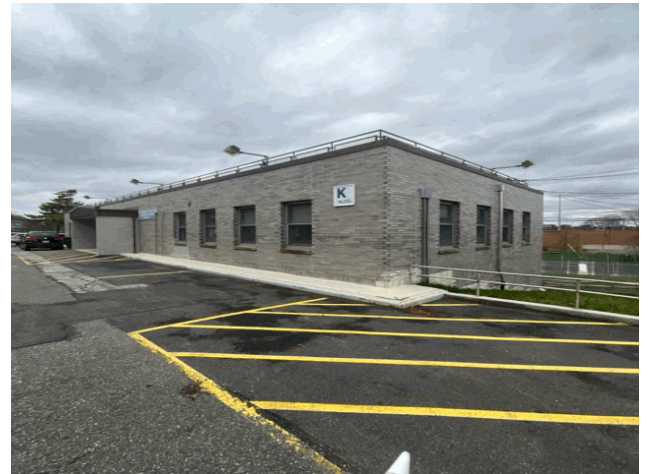
Parking Area - Northeast View

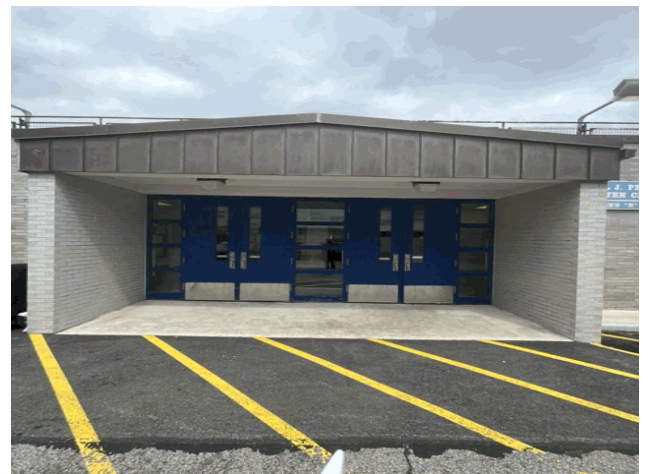
Facade A - Parking Area

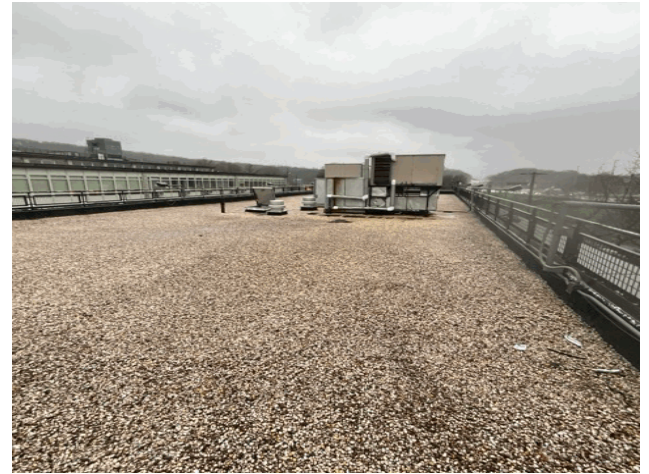
Roof 1 - West View
