**NYC Department of Education  
Building Condition Assessment Survey 2023-2024**

**Architectural Inspection**

**R973**

**Asset: P.S. 373 TEMP. C.R. BLDG. - S.I., 91 HENDERSON AVENUE, STATEN ISLAND, NY, 10301**

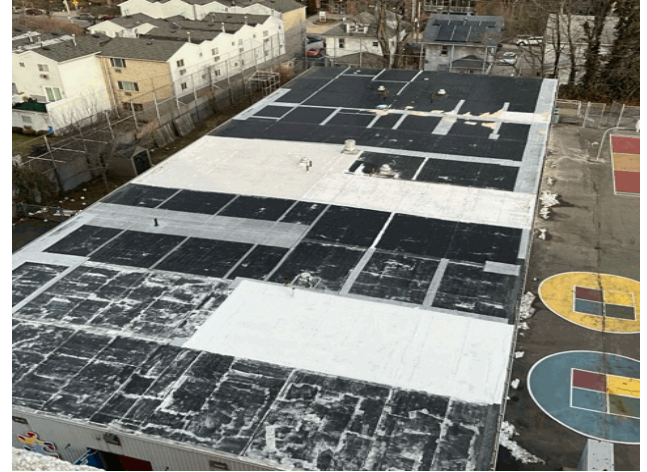
Roof 1 - North View from Main Asset

Deficiency  
SINGLE PLY, FULLY ADHERED ROOF:ROOFING:MAJOR ACTIVE ROOF LEAKS IN INSTRUCTIONAL SPACE

Room 100 shown, also Rooms 1, 2A, 3A, 4A, 5B, 6A, Toilet in 6A and Teacher Lounges 7 and 8

Deficiency Quantity	300
Quantity Uom	S.F.
Potential Action	REPLACE ROOFING WITHOUT MAJOR EQUIPMENT REMOVAL
Urgency of Action	PRIORITY 5
Purpose of Action	LEVEL 2
Deficiency Photo 1
