**NYC Department of Education
Building Condition Assessment Survey 2023-2024**

Architectural Inspection

X011

Asset: P.S. 11 - BRONX, 1257 OGDEN AVENUE, BRONX, NY, 10452

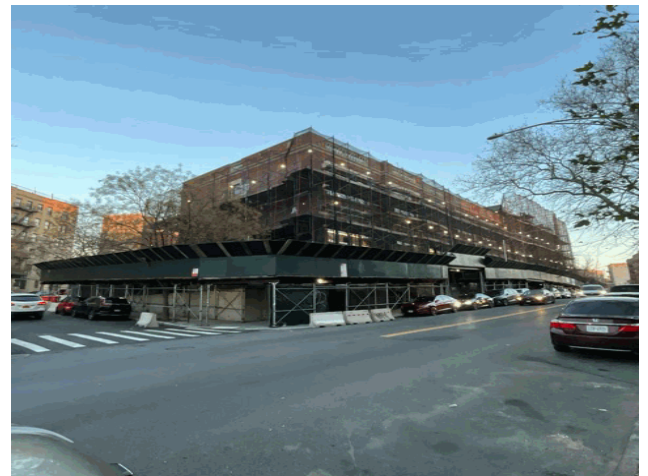
Corner of Ogden Avenue and Merrian Avenue - Southwest View

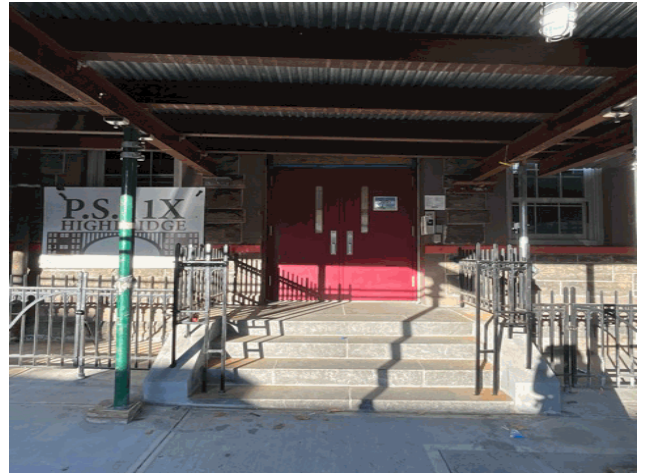
Facade A - Ogden Avenue

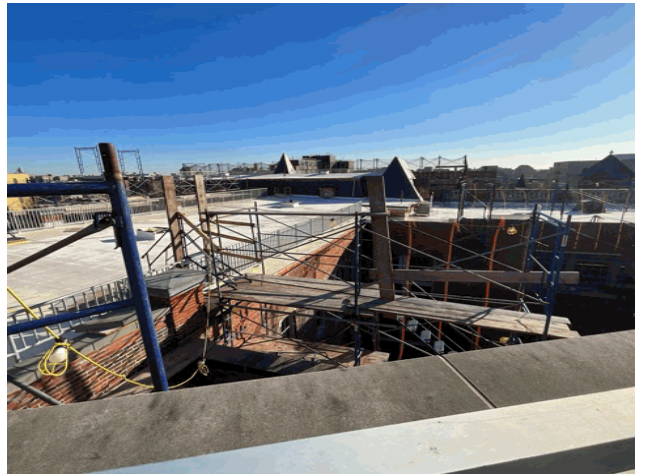
Roof 10 - Northwest View
