**NYC Department of Education
Building Condition Assessment Survey 2023-2024**

Architectural Inspection

X027

Asset: P.S. 277 - BRONX, 519 ST ANNS AVENUE, BRONX, NY, 10455

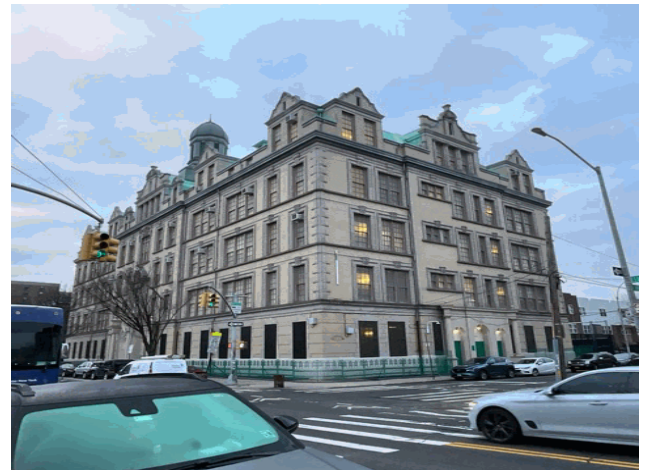
Corner of St. Ann's Avenue and East 148th Street - Southwest View

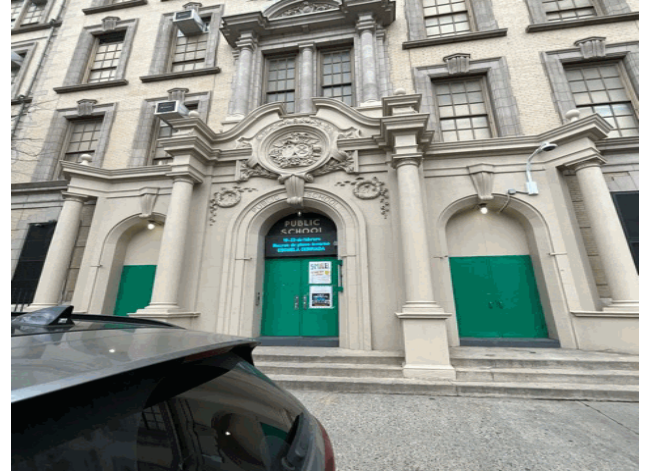
Facade A - St. Ann's Avenue

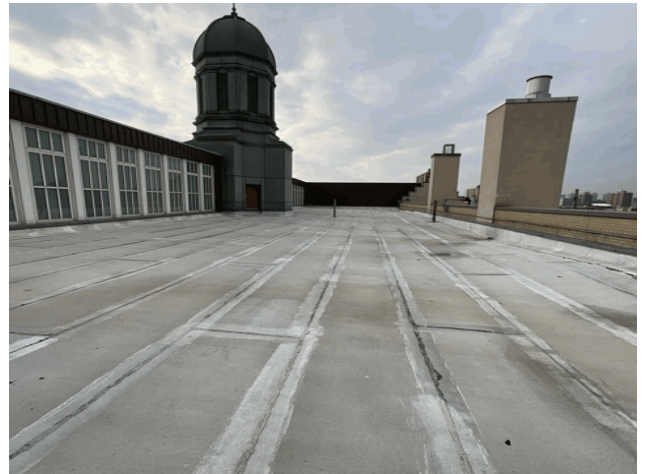
Roof 1 - Southwest View
