**NYC Department of Education
Building Condition Assessment Survey 2023-2024**

Architectural Inspection

Asset: P.S. 34 - BRONX, 770 GROTE STREET, BRONX, NY, 10460

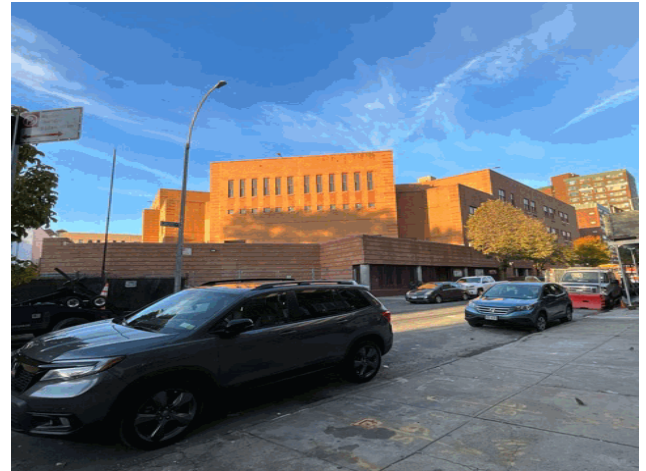
Corner of Grote Street and Old Kingsbridge Road - Northeast View

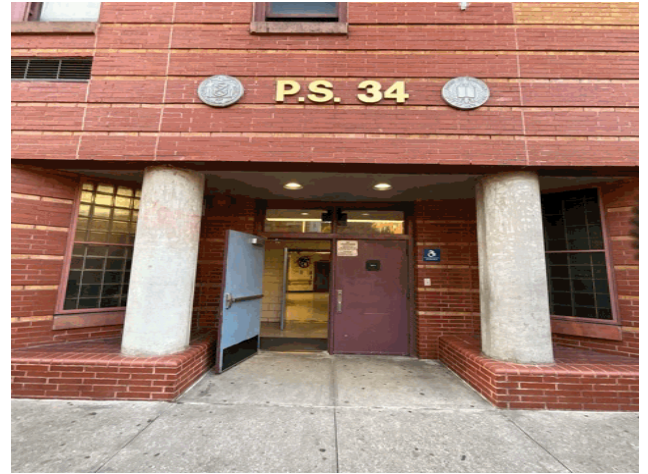
Facade A - Grote Street

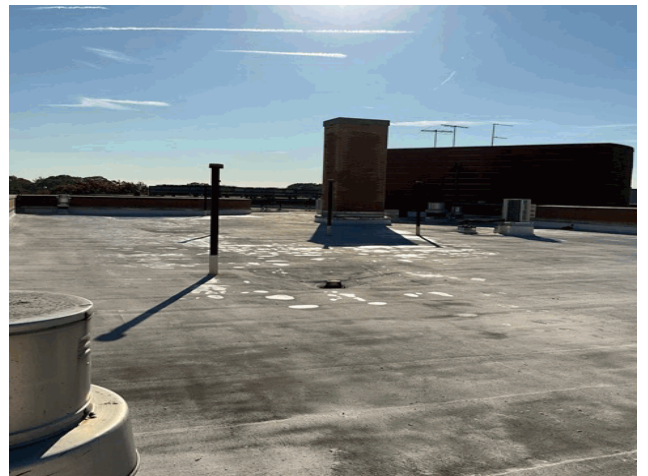
Roof 1 - Southeast View
