**NYC Department of Education  
Building Condition Assessment Survey 2023-2024**

**Architectural Inspection**

**X044**

**Asset:** P.S. 44 - BRONX, 1825 PROSPECT AVENUE, BRONX, NY, 10457

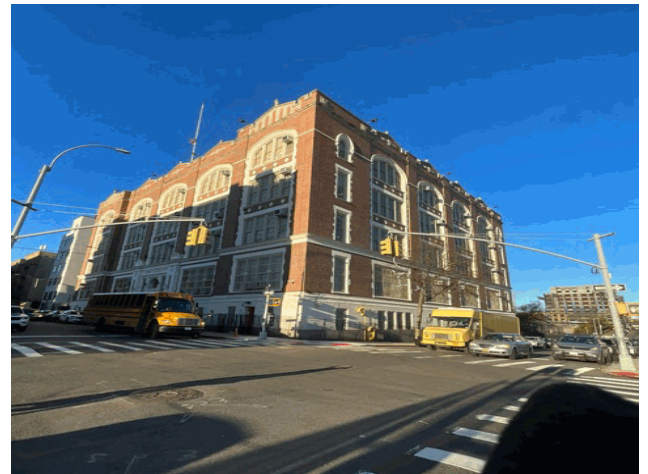
| Question | Answer |
|--|---|
| Facade Photo | |

Corner of Prospect Avenue and East 176th Street - Southwest View

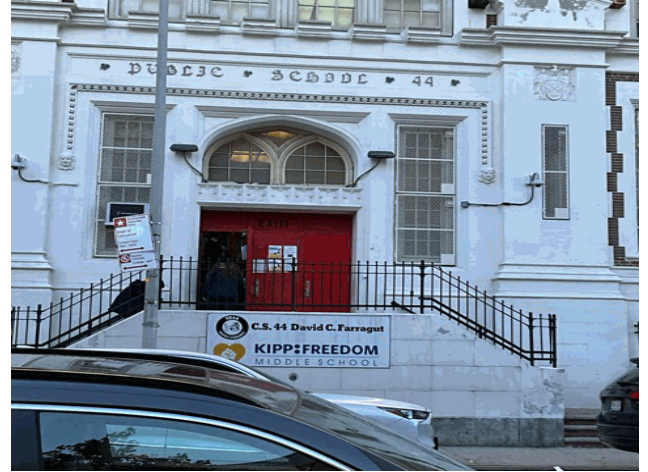
Main Entrance Photo

Facade A - Prospect Avenue

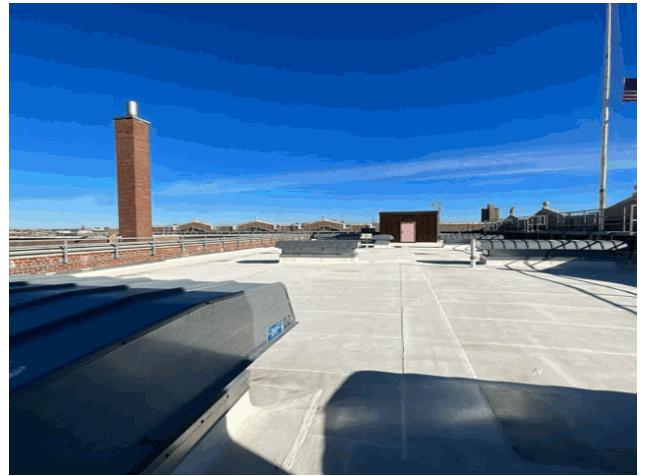
Roof Photo

Roof 1 - Northwest View
